Profile/Photo Observation Report

Date:	04/10/2018	Weather:		Coding:	PACP 6.0
Pipe Length (ft):	224.0	Owner:	NA	Pre Clean:	Not Known
P.O.#:		Surveyor:	Byrd Fitzgerald	PSR:	P-503-047-046
Customer:		Clean Date:	01/01/1900	Shape:	C

Street:	W 40th ave	Flow Control:	Not Controlled
City:	Hobart, IN	Year Renewed:	
Location:	Other	Tape/Media #:	
Purpose:	Not Known	Dia/Height:	10"
Use:	Sanitary	Material:	VCP
Drain Area:	NA	Lining:	
Category:	NA		
Comment:

Location Details:		Direction of Survey:	Upstream
US MH:	M-503-046	DS MH:	M-503-047
		Total Length Surveyed (ft):	29.1

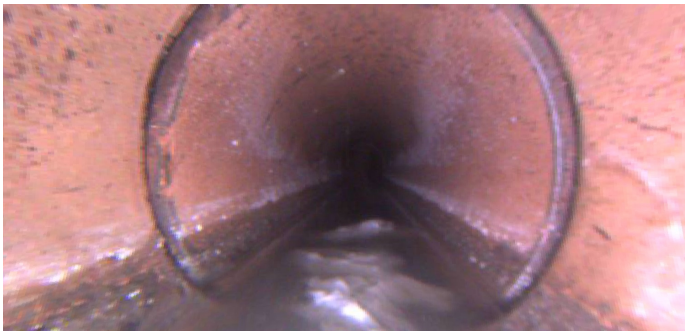
Code: **AMH**
Description: **Manhole**

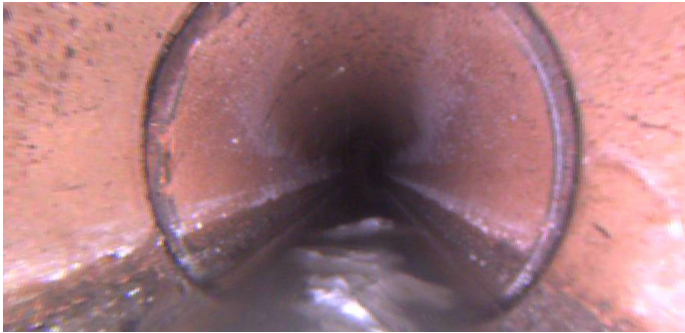
Code:	MWL
Description:	Water Level

Distance (ft):	.0
Structural Grade:	0
O&M Grade:	0
Clock Start/From:	
Clock To:	
1st Value:	
2nd Value:	
Value Percent:	5.000
Continuous Index:	
Within 8" of Joint:	NO
Remarks:

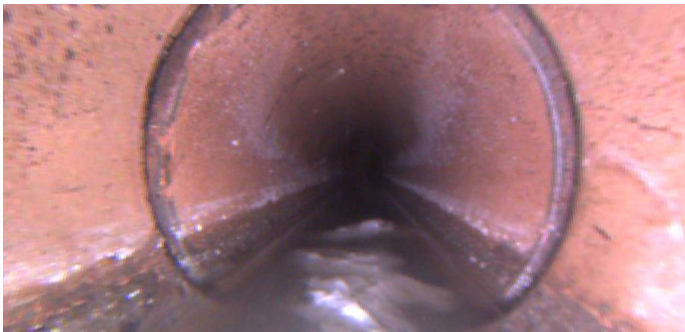
Code:	DSZ
Description:	Deposits Settled Other

Distance (ft):	.0
Structural Grade:	0
O&M Grade:	2
Clock Start/From:	6
Clock To:	
1st Value:	
2nd Value:	
Value Percent:	5.000
Continuous Index:	
Within 8" of Joint:	NO
Remarks:	tissue

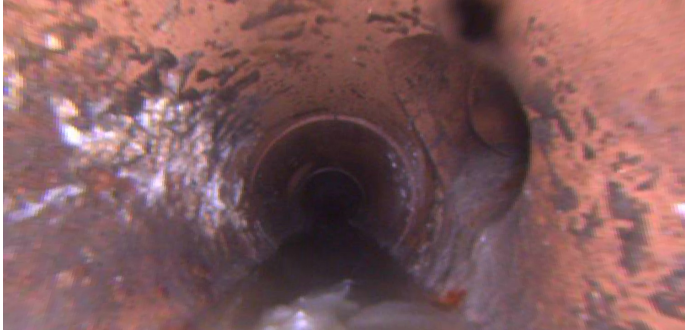
Code: **TF**
Description: **Tap Factory**

Distance (ft): **7.4**
Structural Grade: **0**
O&M Grade: **0**
Clock Start/From: **2**
Clock To:
1st Value: **4.000**
2nd Value:
Value Percent:
Continuous Index:
Within 8" of Joint: **YES**
Remarks:

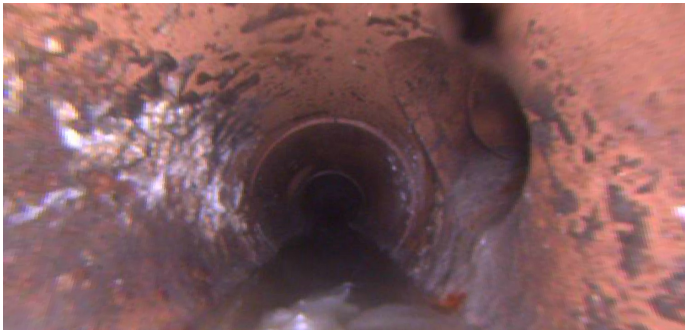
Code: **DAZ**
Description: **Deposits Attached Other**

Distance (ft): **7.4**
Structural Grade: **0**
O&M Grade: **2**
Clock Start/From: **7**
Clock To: **10**
1st Value:
2nd Value:
Value Percent: **5.000**
Continuous Index:
Within 8" of Joint: **NO**
Remarks: **tissue**

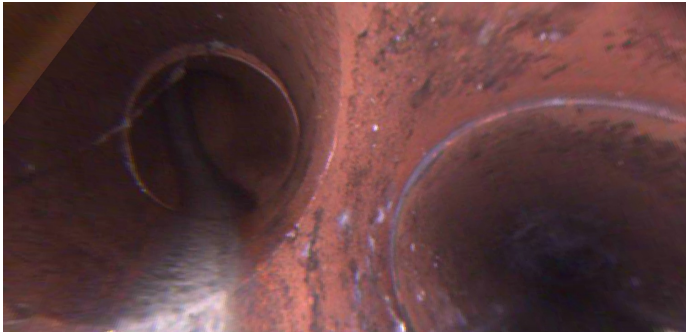
Code: **TF**
Description: **Tap Factory**

Distance (ft): **9.9**
Structural Grade: **0**
O&M Grade: **0**
Clock Start/From: **10**
Clock To:
1st Value: **4.000**
2nd Value:
Value Percent:
Continuous Index:
Within 8" of Joint: **YES**
Remarks:

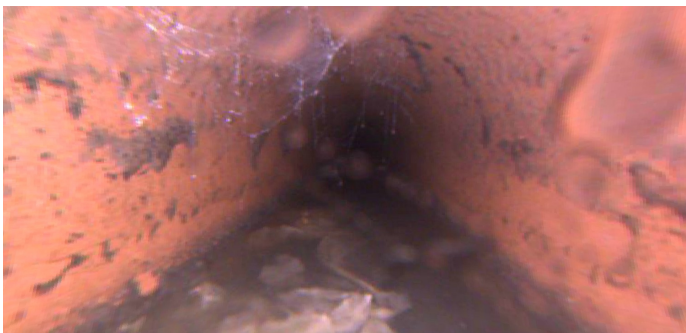
Code: **DSZ**
Description: **Deposits Settled Other**

Distance (ft): **22.2**
Structural Grade: **0**
O&M Grade: **2**
Clock Start/From: **6**
Clock To:
1st Value:
2nd Value:
Value Percent: **5.000**
Continuous Index: **S01**
Within 8" of Joint: **NO**
Remarks: **tissue**

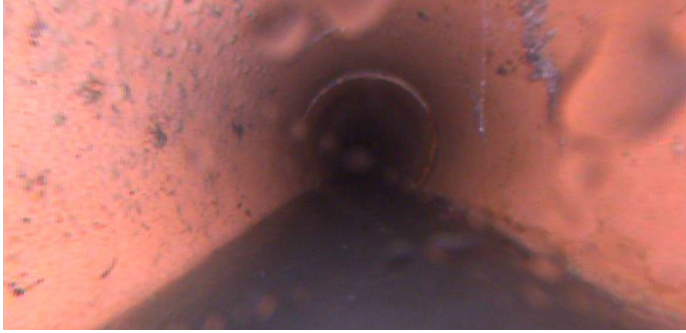
Code: **MSA**
Description: **Abandoned Survey**

Distance (ft): **29.1**
Structural Grade: **0**
O&M Grade: **0**
Clock Start/From:
Clock To:
1st Value:
2nd Value:
Value Percent:
Continuous Index:
Within 8" of Joint: **NO**
Remarks: **no blockage**

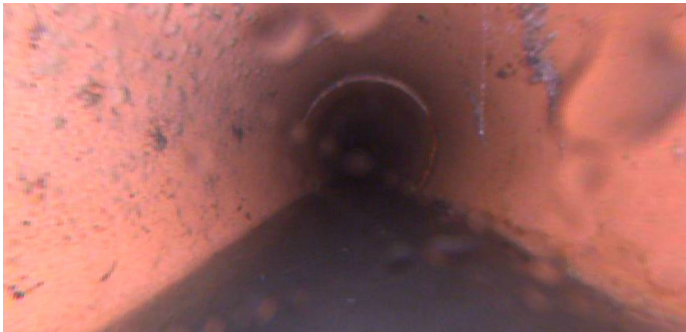
Code: **DSZ**
Description: **Deposits Settled Other**

Distance (ft): **29.1**
Structural Grade: **0**
O&M Grade: **2**
Clock Start/From: **6**
Clock To:
1st Value:
2nd Value:
Value Percent: **5.000**
Continuous Index: **F01**
Within 8" of Joint: **NO**
Remarks: **tissue**
