Profile/Photo Observation Report

Street:	W 39TH AVE & W 38TH PL	Flow Control:	Not Controlled
City:	Hobart, IN	Year Renewed:	
Location:	Other	Tape/Media #:	
Purpose:	Not Known	Dia/Height:	10"
Use:	Sanitary	Material:	VCP
Drain Area:	NA	Lining:	
Category:	NA		
Comment:

Location Details:		Direction of Survey:	Downstream
US MH:	M-503-049	DS MH:	M-503-048
		Total Length Surveyed (ft):	245.3

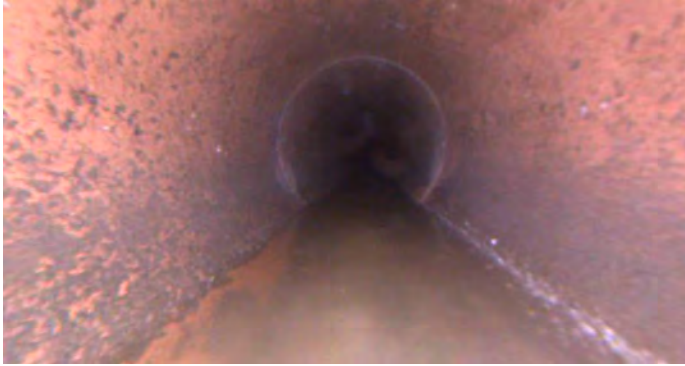
Code: **AMH**
Description: **Manhole**

Distance (ft): **.0**
Structural Grade: **0**
O&M Grade: **0**
Clock Start/From:
Clock To:
1st Value:
2nd Value:
Value Percent:
Continuous Index:
Within 8" of Joint: **NO**
Remarks: **M-503-049**

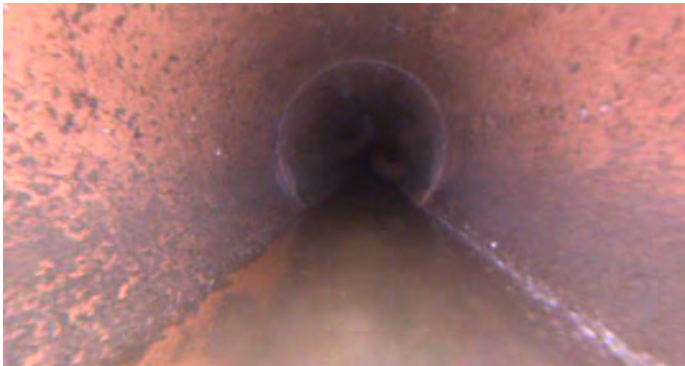
Code: **MWL**
Description: **Water Level**

Distance (ft): **.0**
Structural Grade: **0**
O&M Grade: **0**
Clock Start/From:
Clock To:
1st Value:
2nd Value:
Value Percent: **10.000**
Continuous Index:
Within 8" of Joint: **NO**
Remarks:

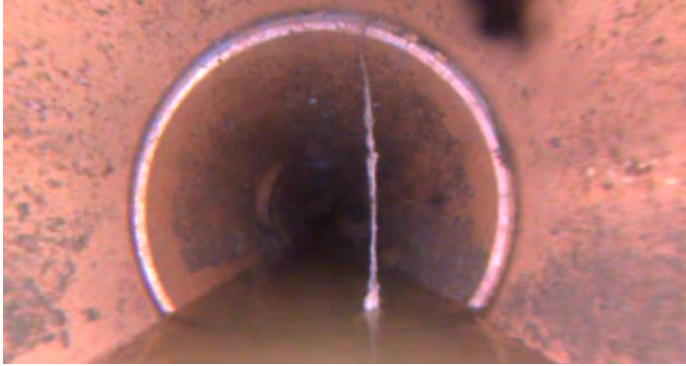
Code: **RFJ**
Description: **Roots Fine Joint**

Distance (ft): **11.9**
Structural Grade: **0**
O&M Grade: **1**
Clock Start/From: **12**
Clock To:
1st Value:
2nd Value:
Value Percent:
Continuous Index:
Within 8" of Joint: **YES**
Remarks:

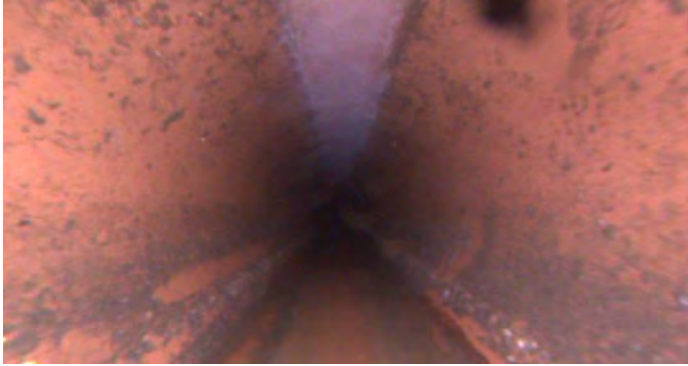
Code: **MMC**
Description: **Material Change**

Distance (ft): **44.7**
Structural Grade: **0**
O&M Grade: **0**
Clock Start/From:
Clock To:
1st Value:
2nd Value:
Value Percent:
Continuous Index:
Within 8" of Joint: **NO**
Remarks: **VCP**

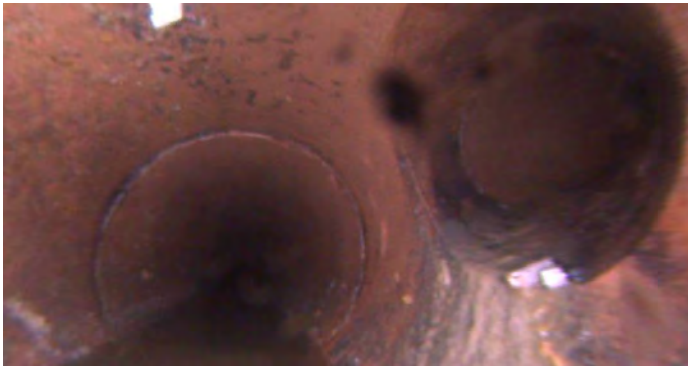
Code: **TFC**
Description: **Tap Factory Capped**

Distance (ft): **50.6**
Structural Grade: **0**
O&M Grade: **0**
Clock Start/From: **3**
Clock To:
1st Value: **4.000**
2nd Value:
Value Percent:
Continuous Index:
Within 8" of Joint:
Remarks:

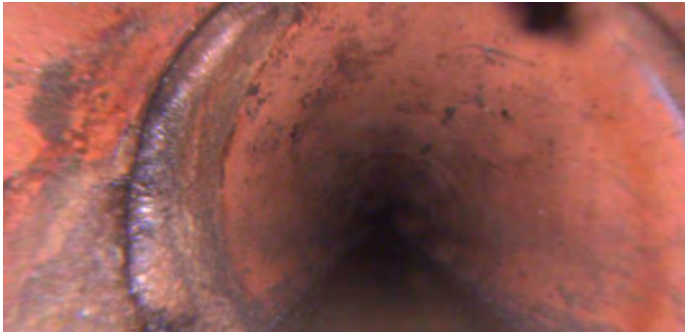
Code: **IS**
Description: **Infil Stain**

Distance (ft): **61.4**
Structural Grade: **0**
O&M Grade: **0**
Clock Start/From: **8**
Clock To: **11**
1st Value:
2nd Value:
Value Percent:
Continuous Index:
Within 8" of Joint: **YES**
Remarks:

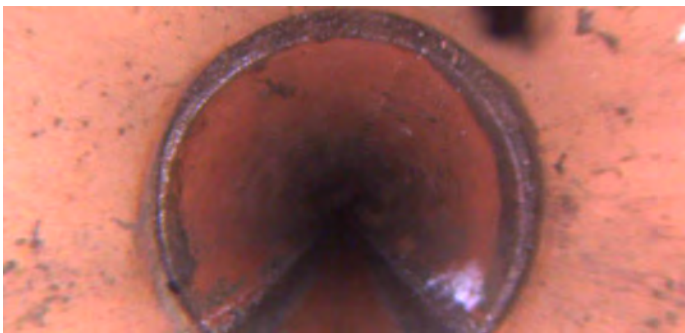
Code: **IW**
Description: **Infil Weeper**

Distance (ft): **76.3**
Structural Grade: **0**
O&M Grade: **2**
Clock Start/From: **8**
Clock To: **4**
1st Value:
2nd Value:
Value Percent:
Continuous Index:
Within 8" of Joint: **YES**
Remarks:

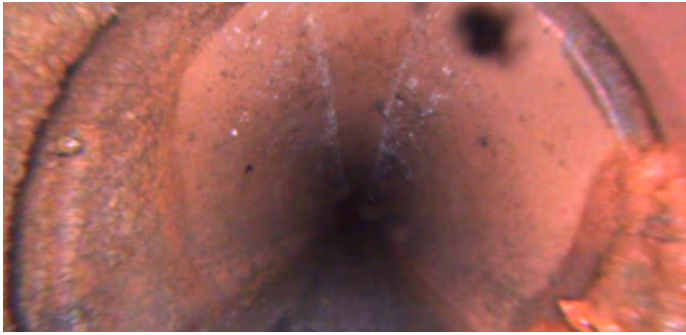
Code: **DAE**
Description: **Deposits Attached Encrustation**

Distance (ft): **93.7**
Structural Grade: **0**
O&M Grade: **2**
Clock Start/From: **8**
Clock To: **4**
1st Value:
2nd Value:
Value Percent: **5.000**
Continuous Index:
Within 8" of Joint: **YES**
Remarks:

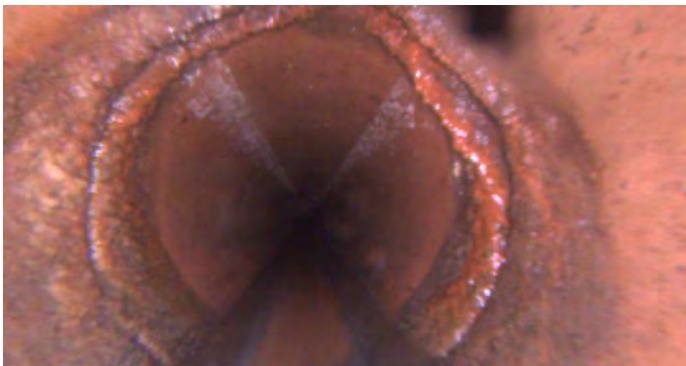
Code: **DAE**
Description: **Deposits Attached Encrustation**

Distance (ft): **98.4**
Structural Grade: **0**
O&M Grade: **2**
Clock Start/From: **7**
Clock To: **5**
1st Value:
2nd Value:
Value Percent: **5.000**
Continuous Index:
Within 8" of Joint: **YES**
Remarks:

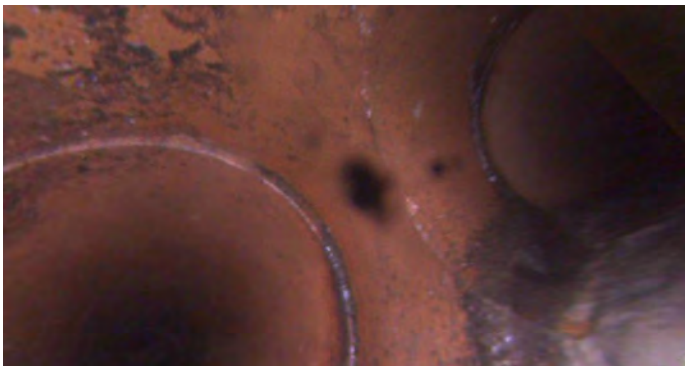
Code: **TF**
Description: **Tap Factory**

Distance (ft): **105.3**
Structural Grade: **0**
O&M Grade: **0**
Clock Start/From: **2**
Clock To:
1st Value: **4.000**
2nd Value:
Value Percent:
Continuous Index:
Within 8" of Joint:
Remarks:

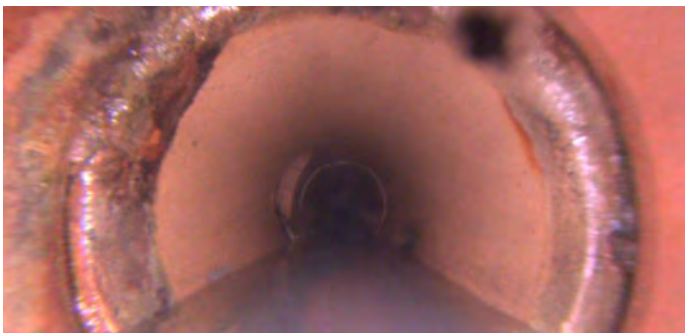
Code: **IW**
Description: **Infil Weeper**

Distance (ft): **145.9**
Structural Grade: **0**
O&M Grade: **2**
Clock Start/From: **8**
Clock To: **4**
1st Value:
2nd Value:
Value Percent:
Continuous Index:
Within 8" of Joint: **YES**
Remarks:

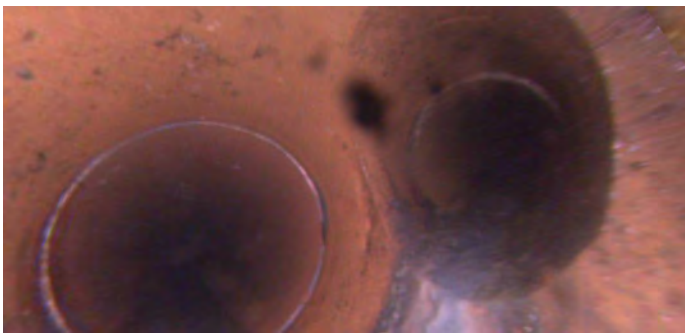
Code: **TFA**
Description: **Tap Factory Active**

Distance (ft): **174.2**
Structural Grade: **0**
O&M Grade: **0**
Clock Start/From: **2**
Clock To:
1st Value: **4.000**
2nd Value:
Value Percent:
Continuous Index:
Within 8" of Joint:
Remarks:

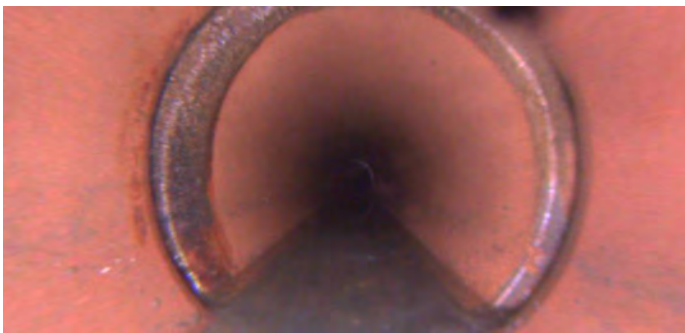
Code: **IS**
Description: **Infil Stain**

Distance (ft): **194.9**
Structural Grade: **0**
O&M Grade: **0**
Clock Start/From: **8**
Clock To: **4**
1st Value:
2nd Value:
Value Percent:
Continuous Index:
Within 8" of Joint: **YES**
Remarks:

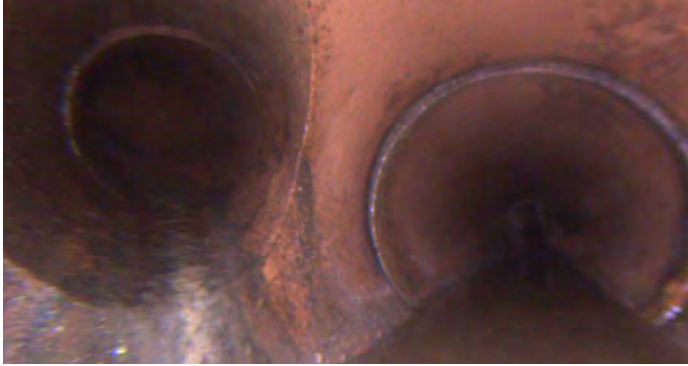
Code: **TF**
Description: **Tap Factory**

Distance (ft): **231.4**
Structural Grade: **0**
O&M Grade: **0**
Clock Start/From: **9**
Clock To:
1st Value: **4.000**
2nd Value:
Value Percent:
Continuous Index:
Within 8" of Joint:
Remarks:

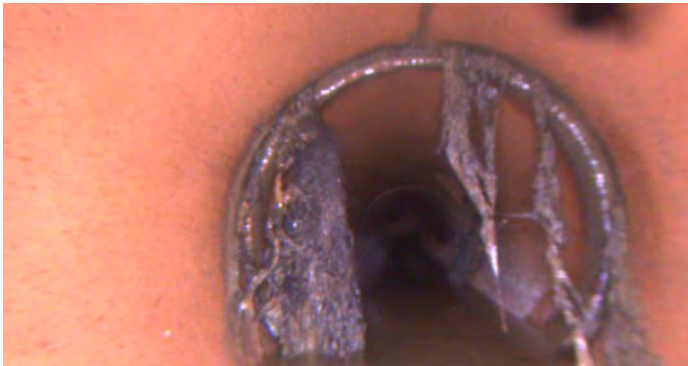
Code: **RMJ**
Description: **Roots Medium Joint**

Distance (ft): **236.7**
Structural Grade: **0**
O&M Grade: **3**
Clock Start/From: **8**
Clock To: **4**
1st Value:
2nd Value:
Value Percent: **20.000**
Continuous Index:
Within 8" of Joint: **YES**
Remarks:

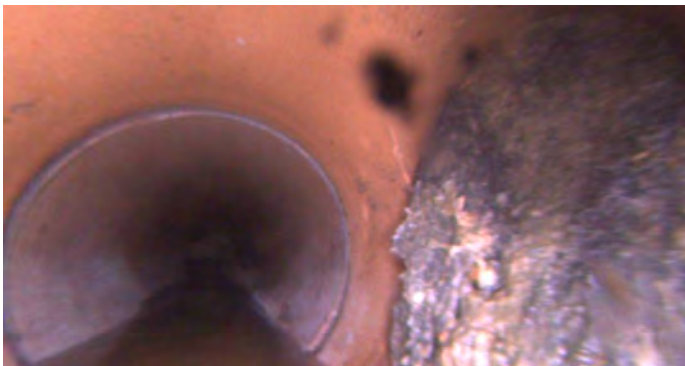
Code: **TFD**
Description: **Tap Factory Defective**

Distance (ft): **238.6**
Structural Grade: **0**
O&M Grade: **2**
Clock Start/From: **2**
Clock To:
1st Value: **4.000**
2nd Value:
Value Percent:
Continuous Index:
Within 8" of Joint:
Remarks: **Roots**

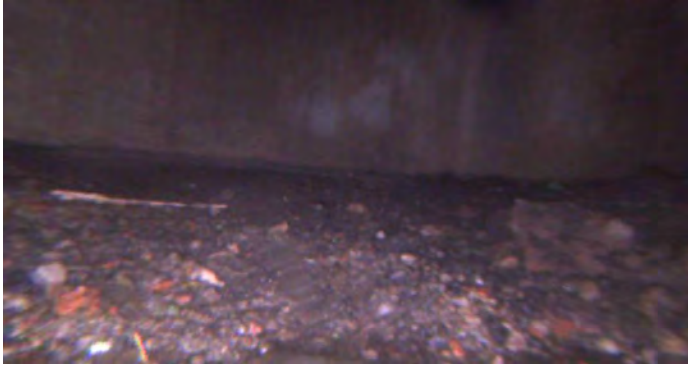
Code:	AMH
Description:	Manhole
Distance (ft):	245.3
Structural Grade:	0
O&M Grade:	0
Clock Start/From:	
Clock To:	
1st Value:	
2nd Value:	
Value Percent:	
Continuous Index:	
Within 8" of Joint:	NO
Remarks:	M-503-048
