Profile/Photo Observation Report

| Street: | W 40th ave | Flow Control: | Not Controlled |
| City: | Hobart, IN | Year Renewed: | |

| US MH: | M-503-049 | DS MH: | M-503-048 |

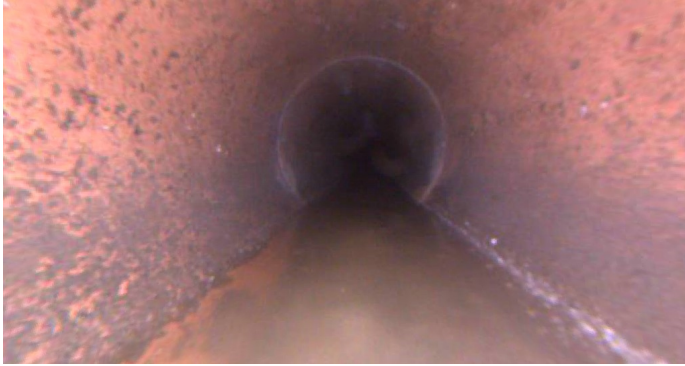
Code: **AMH**
Description: **Manhole**

Distance (ft): **.0**
Structural Grade: **0**
O&M Grade: **0**
Clock Start/From:
Clock To:
1st Value:
2nd Value:
Value Percent:
Continuous Index:
Within 8" of Joint: **NO**
Remarks: **M-503-049**

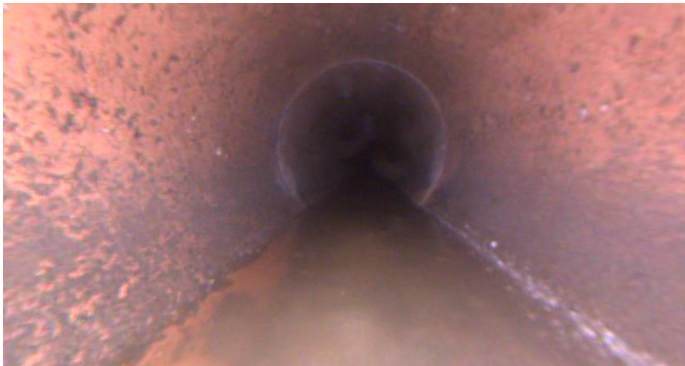
Code: **MWL**
Description: **Water Level**

Distance (ft): **.0**
Structural Grade: **0**
O&M Grade: **0**
Clock Start/From:
Clock To:
1st Value:
2nd Value:
Value Percent: **10.000**
Continuous Index:
Within 8" of Joint: **NO**
Remarks:

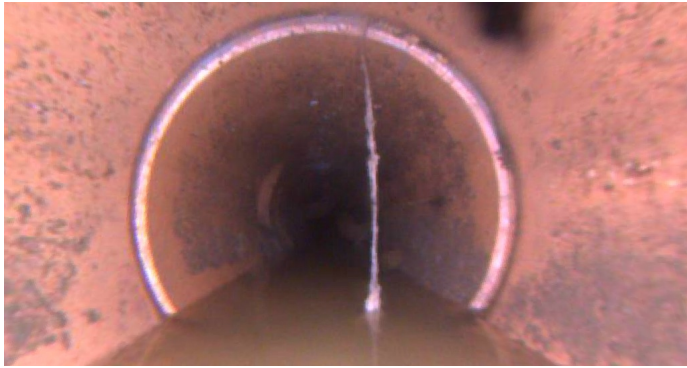
Code: **RFJ**
Description: **Roots Fine Joint**

Distance (ft): **11.9**
Structural Grade: **0**
O&M Grade: **1**
Clock Start/From: **12**
Clock To:
1st Value:
2nd Value:
Value Percent:
Continuous Index:
Within 8" of Joint: **YES**
Remarks:

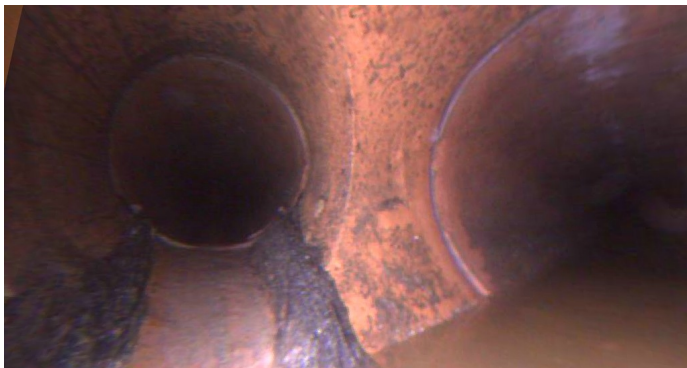
Code: **TFD**
Description: **Tap Factory Defective**

Distance (ft): **13.7**
Structural Grade: **0**
O&M Grade: **2**
Clock Start/From: **8**
Clock To:
1st Value: **4.000**
2nd Value:
Value Percent:
Continuous Index:
Within 8" of Joint:
Remarks: **rfl**

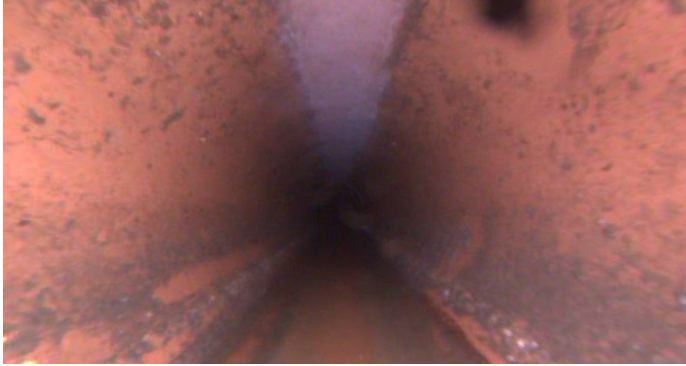
Code: **MMC**
Description: **Material Change**

Distance (ft): **44.7**
Structural Grade: **0**
O&M Grade: **0**
Clock Start/From:
Clock To:
1st Value:
2nd Value:
Value Percent:
Continuous Index:
Within 8" of Joint: **NO**
Remarks: **VCP**

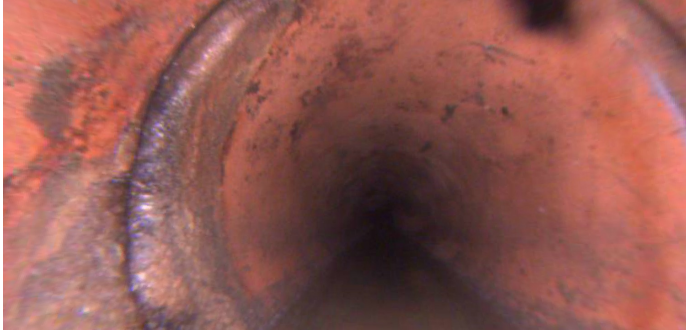
Code: **IS**
Description: **Infil Stain**

Distance (ft): **61.4**
Structural Grade: **0**
O&M Grade: **0**
Clock Start/From: **8**
Clock To: **11**
1st Value:
2nd Value:
Value Percent:
Continuous Index:
Within 8" of Joint: **YES**
Remarks:

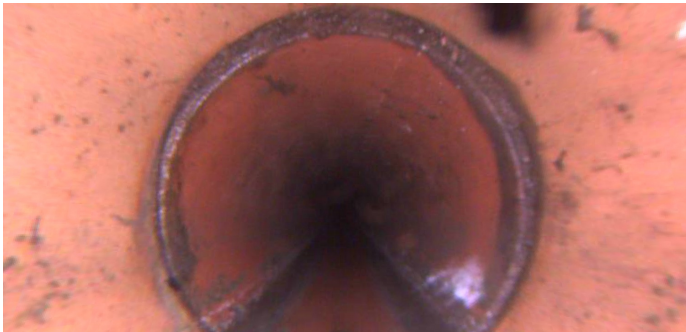
Code: **IW**
Description: **Infil Weeper**

Distance (ft): **76.3**
Structural Grade: **0**
O&M Grade: **2**
Clock Start/From: **8**
Clock To: **4**
1st Value:
2nd Value:
Value Percent:
Continuous Index:
Within 8" of Joint: **YES**
Remarks:

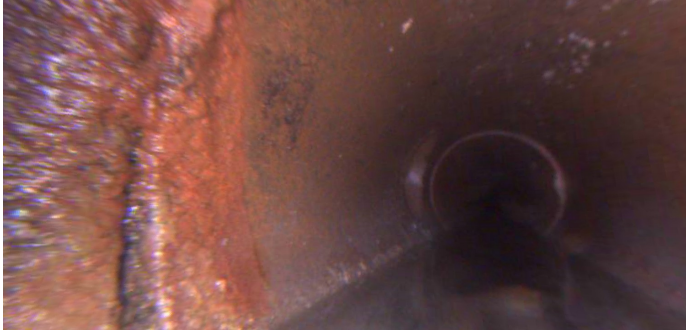
Code: **IW**
Description: **Infil Weeper**

Distance (ft): **81.7**
Structural Grade: **0**
O&M Grade: **2**
Clock Start/From: **8**
Clock To: **11**
1st Value:
2nd Value:
Value Percent:
Continuous Index:
Within 8" of Joint: **YES**
Remarks:

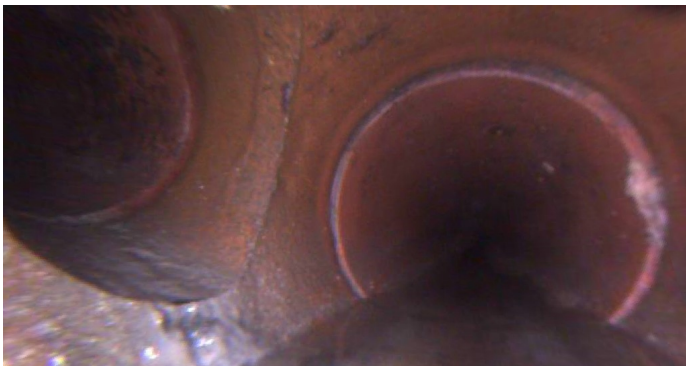
Code: **TF**
Description: **Tap Factory**

Distance (ft): **83.0**
Structural Grade: **0**
O&M Grade: **0**
Clock Start/From: **8**
Clock To:
1st Value: **4.000**
2nd Value:
Value Percent:
Continuous Index:
Within 8" of Joint:
Remarks:

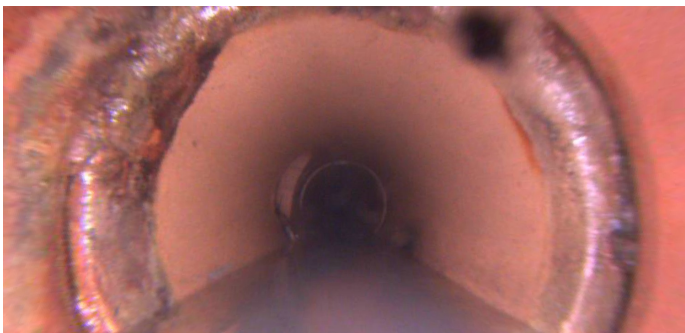
Code: **IW**
Description: **Infil Weeper**

Distance (ft): **145.9**
Structural Grade: **0**
O&M Grade: **2**
Clock Start/From: **8**
Clock To: **4**
1st Value:
2nd Value:
Value Percent:
Continuous Index:
Within 8" of Joint: **YES**
Remarks:

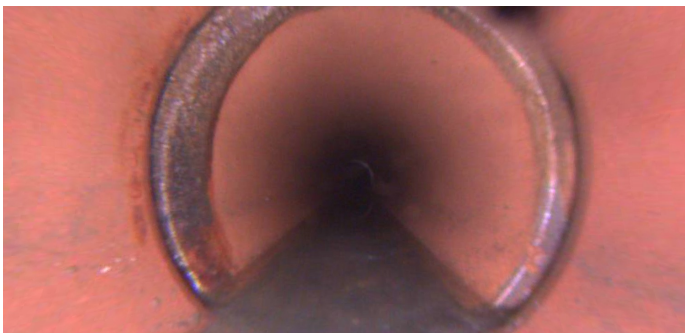
Code: **IS**
Description: **Infil Stain**

Distance (ft): **194.9**
Structural Grade: **0**
O&M Grade: **0**
Clock Start/From: **8**
Clock To: **4**
1st Value:
2nd Value:
Value Percent:
Continuous Index:
Within 8" of Joint: **YES**
Remarks:

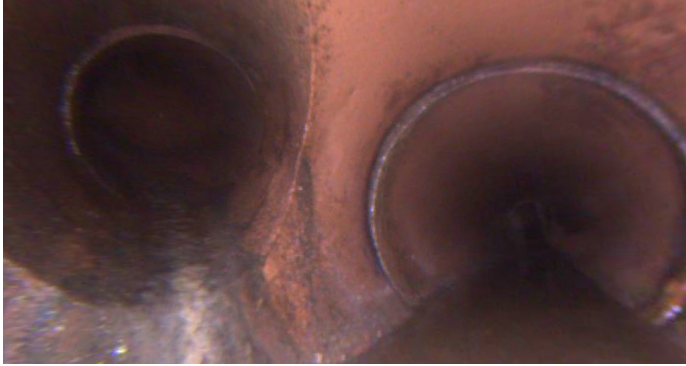
Code: **TF**
Description: **Tap Factory**

Distance (ft): **231.4**
Structural Grade: **0**
O&M Grade: **0**
Clock Start/From: **9**
Clock To:
1st Value: **4.000**
2nd Value:
Value Percent:
Continuous Index:
Within 8" of Joint:
Remarks:

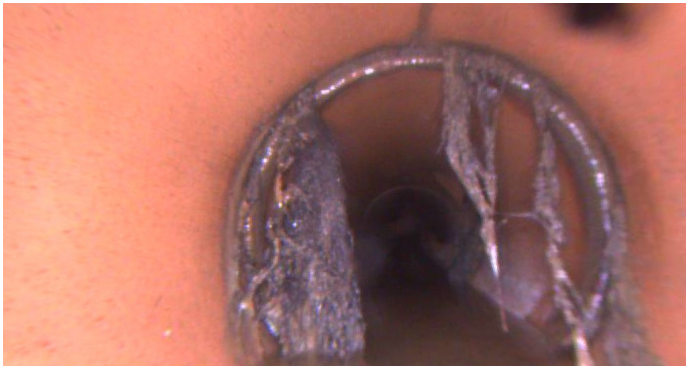
Code: **RMJ**
Description: **Roots Medium Joint**

Distance (ft): **236.7**
Structural Grade: **0**
O&M Grade: **3**
Clock Start/From: **8**
Clock To: **4**
1st Value:
2nd Value:
Value Percent: **20.000**
Continuous Index:
Within 8" of Joint: **YES**
Remarks:

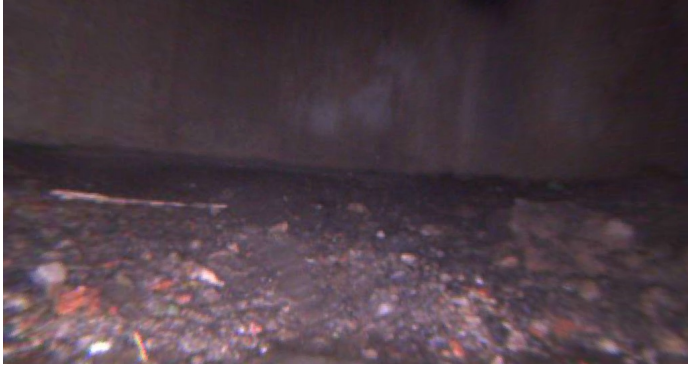
| Code: | AMH |
| Description: | Manhole |
| Distance (ft): | 245.3 |
| Remarks: | M-503-048 |
