Profile/Photo Observation Report

Street:	W 39TH AVE & W 38TH PL	Flow Control:	Not Controlled
City:	Hobart, IN	Year Renewed:	
Location:	Other	Tape/Media #:	
Purpose:	Not Known	Dia/Height:	10"
Use:	Sanitary	Material:	VCP
Drain Area:	NA	Lining:	
Category:	NA		
Comment:

Location Details:		Direction of Survey:	Downstream
US MH:	M-503-049	DS MH:	M-503-048
		Total Length Surveyed (ft):	248.3

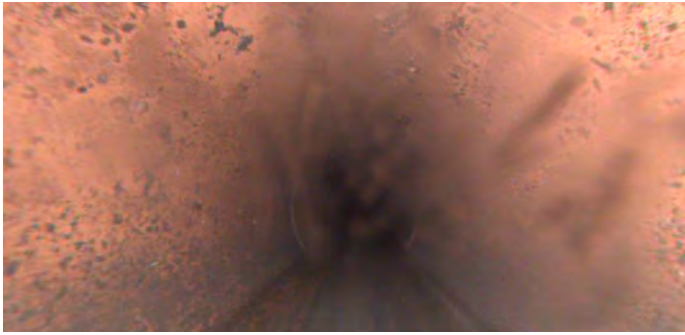
Code: **AMH**
Description: **Manhole**

Distance (ft): **.0**
Structural Grade: **0**
O&M Grade: **0**
Clock Start/From:
Clock To:
1st Value:
2nd Value:
Value Percent:
Continuous Index:
Within 8" of Joint: **NO**
Remarks: **M-503-049**

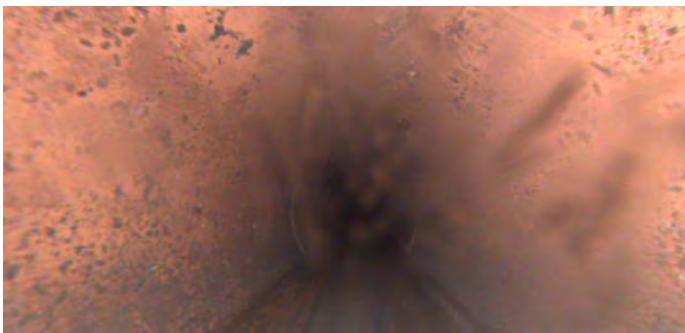
Code: **MWL**
Description: **Water Level**

Distance (ft): **.0**
Structural Grade: **0**
O&M Grade: **0**
Clock Start/From:
Clock To:
1st Value:
2nd Value:
Value Percent: **5.000**
Continuous Index:
Within 8" of Joint: **NO**
Remarks:

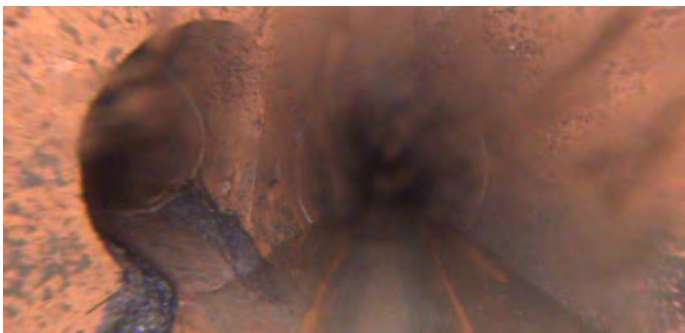
Code: **TFD**
Description: **Tap Factory Defective**

Distance (ft): **14.2**
Structural Grade: **0**
O&M Grade: **2**
Clock Start/From: **9**
Clock To:
1st Value: **4.000**
2nd Value:
Value Percent:
Continuous Index:
Within 8" of Joint:
Remarks: **roots**

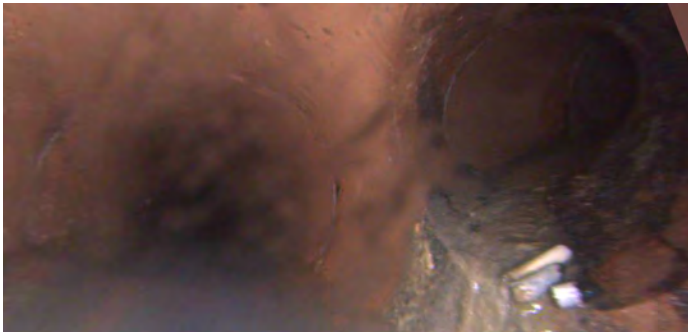
Code: **TFA**
Description: **Tap Factory Active**

Distance (ft): **51.7**
Structural Grade: **0**
O&M Grade: **0**
Clock Start/From: **3**
Clock To:
1st Value: **4.000**
2nd Value:
Value Percent:
Continuous Index:
Within 8" of Joint:
Remarks:

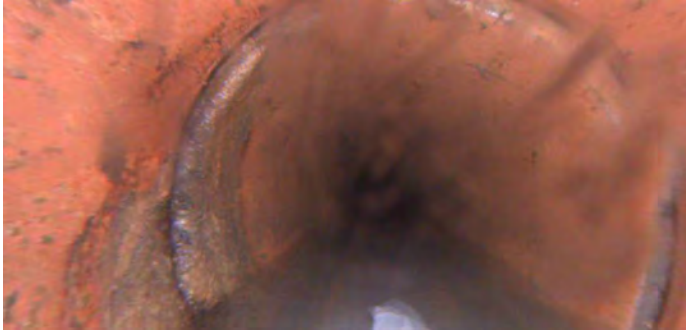
Code: **DAE**
Description: **Deposits Attached Encrustation**

Distance (ft): **62.2**
Structural Grade: **0**
O&M Grade: **2**
Clock Start/From: **8**
Clock To: **11**
1st Value:
2nd Value:
Value Percent: **5.000**
Continuous Index:
Within 8" of Joint: **YES**
Remarks:

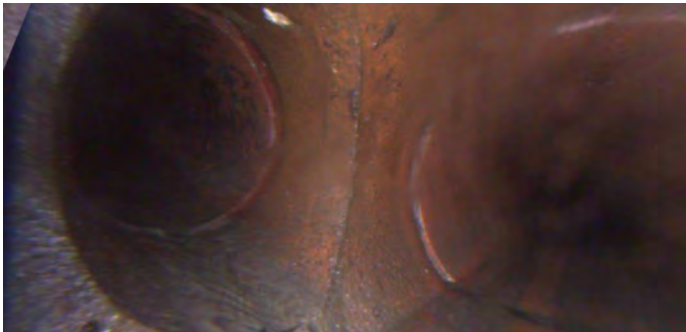
Code: **TFA**
Description: **Tap Factory Active**

Distance (ft): **84.0**
Structural Grade: **0**
O&M Grade: **0**
Clock Start/From: **9**
Clock To:
1st Value: **4.000**
2nd Value:
Value Percent:
Continuous Index:
Within 8" of Joint:
Remarks:

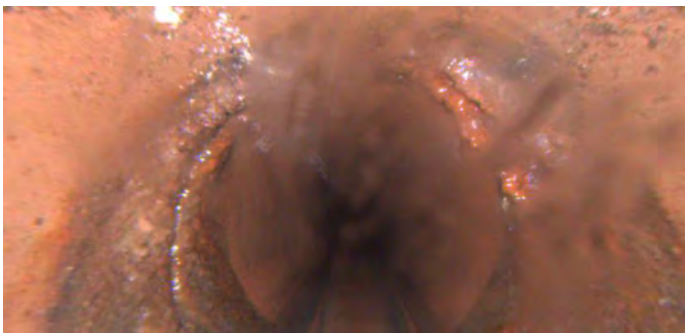
Code: **DAE**
Description: **Deposits Attached Encrustation**

Distance (ft): **99.4**
Structural Grade: **0**
O&M Grade: **2**
Clock Start/From: **8**
Clock To: **4**
1st Value:
2nd Value:
Value Percent: **5.000**
Continuous Index:
Within 8" of Joint: **YES**
Remarks:

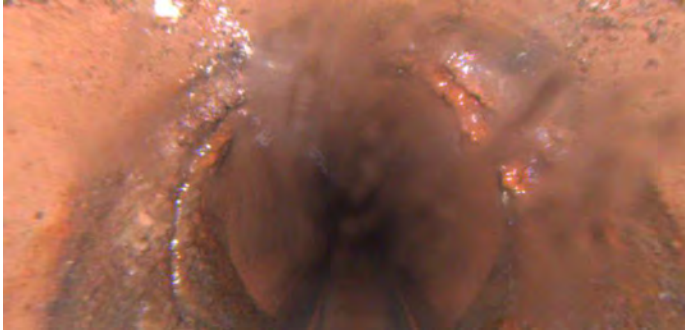
Code: **IW**
Description: **Infil Weeper**

Distance (ft): **99.4**
Structural Grade: **0**
O&M Grade: **2**
Clock Start/From: **8**
Clock To: **4**
1st Value:
2nd Value:
Value Percent:
Continuous Index:
Within 8" of Joint: **YES**
Remarks:

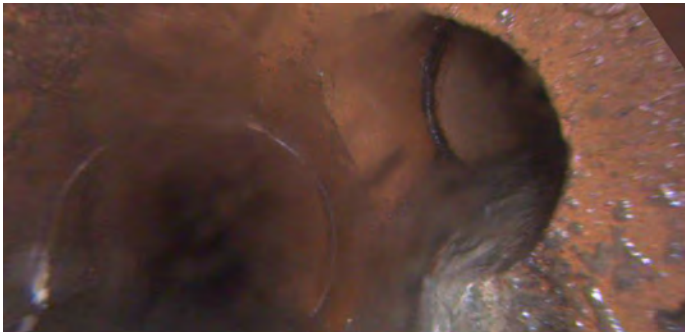
Code: **TFA**
Description: **Tap Factory Active**

Distance (ft): **106.1**
Structural Grade: **0**
O&M Grade: **0**
Clock Start/From: **2**
Clock To:
1st Value: **4.000**
2nd Value:
Value Percent:
Continuous Index:
Within 8" of Joint:
Remarks:

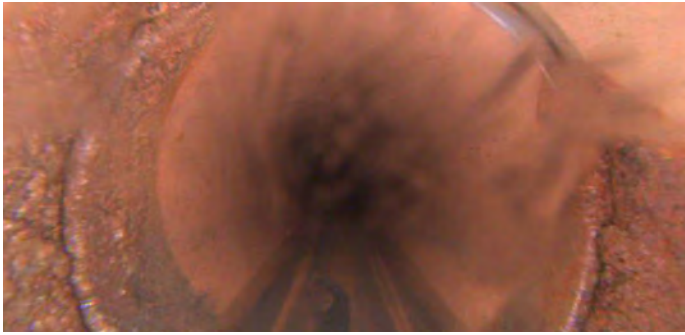
Code: **DAE**
Description: **Deposits Attached Encrustation**

Distance (ft): **126.2**
Structural Grade: **0**
O&M Grade: **2**
Clock Start/From: **8**
Clock To: **4**
1st Value:
2nd Value:
Value Percent: **5.000**
Continuous Index:
Within 8" of Joint: **YES**
Remarks:

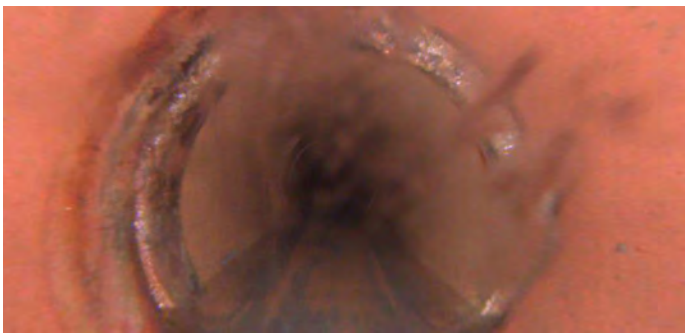
Code: **IW**
Description: **Infil Weeper**

Distance (ft): **146.4**
Structural Grade: **0**
O&M Grade: **2**
Clock Start/From: **8**
Clock To: **4**
1st Value:
2nd Value:
Value Percent:
Continuous Index:
Within 8" of Joint: **YES**
Remarks:

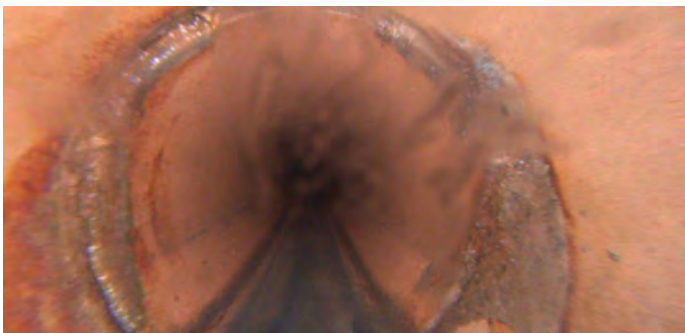
Code: **DAE**
Description: **Deposits Attached Encrustation**

Distance (ft): **153.6**
Structural Grade: **0**
O&M Grade: **2**
Clock Start/From: **8**
Clock To: **4**
1st Value:
2nd Value:
Value Percent: **5.000**
Continuous Index:
Within 8" of Joint: **YES**
Remarks:

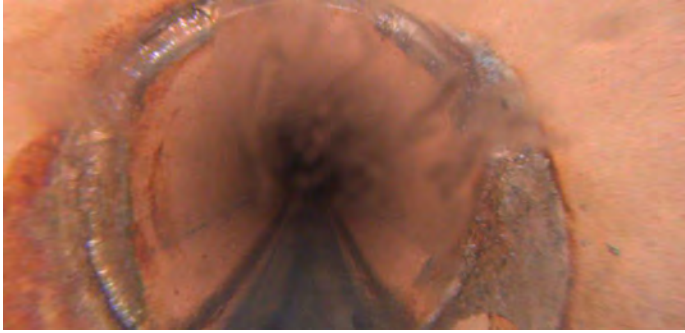
Code: **IW**
Description: **Infil Weeper**

Distance (ft): **153.6**
Structural Grade: **0**
O&M Grade: **2**
Clock Start/From: **8**
Clock To: **4**
1st Value:
2nd Value:
Value Percent:
Continuous Index:
Within 8" of Joint: **YES**
Remarks:

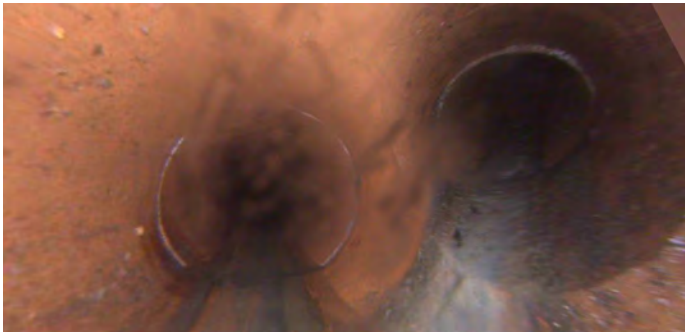
Code: **TFA**
Description: **Tap Factory Active**

Distance (ft): **175.2**
Structural Grade: **0**
O&M Grade: **0**
Clock Start/From: **2**
Clock To:
1st Value: **4.000**
2nd Value:
Value Percent:
Continuous Index:
Within 8" of Joint:
Remarks:

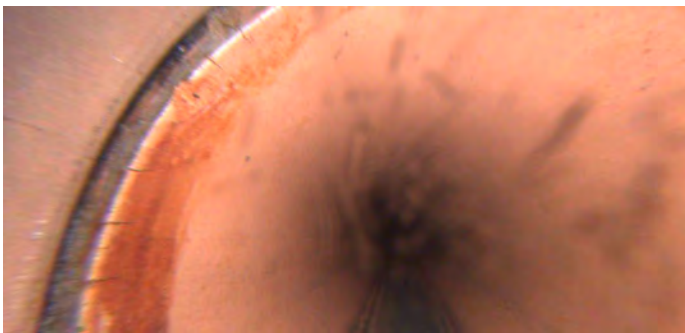
Code: **FM**
Description: **Fracture Multiple**

Distance (ft): **186.3**
Structural Grade: **4**
O&M Grade: **0**
Clock Start/From: **9**
Clock To: **12**
1st Value:
2nd Value:
Value Percent:
Continuous Index:
Within 8" of Joint: **YES**
Remarks:

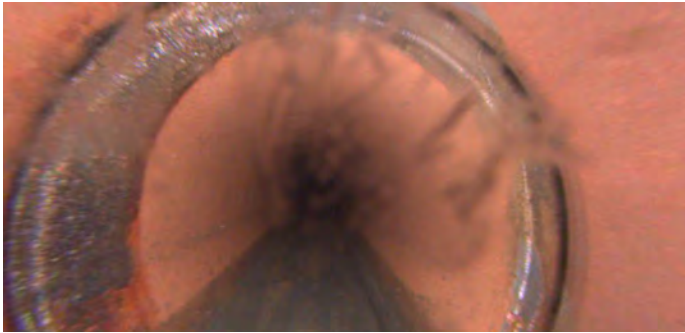
Code: **IW**
Description: **Infil Weeper**

Distance (ft): **196.2**
Structural Grade: **0**
O&M Grade: **2**
Clock Start/From: **8**
Clock To: **12**
1st Value:
2nd Value:
Value Percent:
Continuous Index:
Within 8" of Joint: **YES**
Remarks:

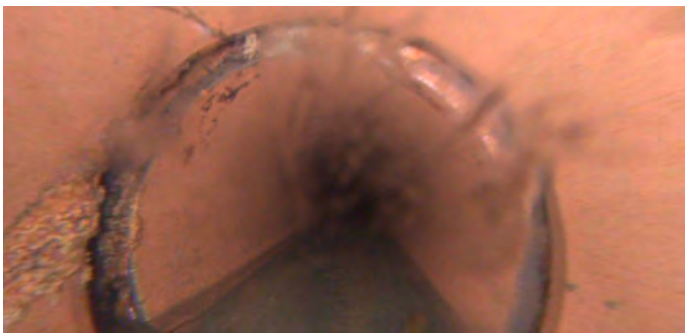
Code: **DAE**
Description: **Deposits Attached Encrustation**

Distance (ft): **201.2**
Structural Grade: **0**
O&M Grade: **2**
Clock Start/From: **8**
Clock To: **9**
1st Value:
2nd Value:
Value Percent: **5.000**
Continuous Index:
Within 8" of Joint: **YES**
Remarks:

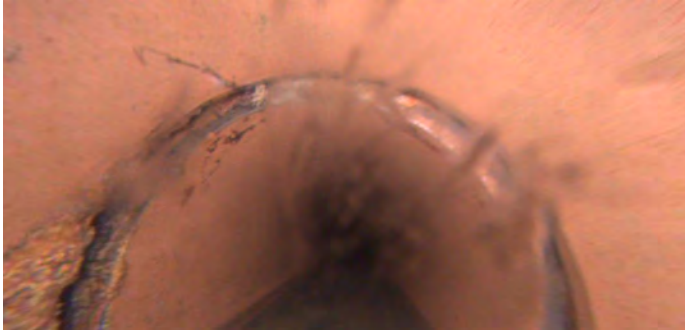
Code: **RFJ**
Description: **Roots Fine Joint**

Distance (ft): **201.2**
Structural Grade: **0**
O&M Grade: **1**
Clock Start/From: **11**
Clock To:
1st Value:
2nd Value:
Value Percent:
Continuous Index:
Within 8" of Joint: **YES**
Remarks:

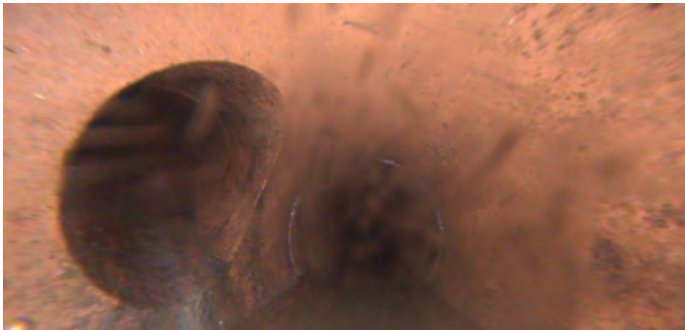
Code: **TFA**
Description: **Tap Factory Active**

Distance (ft): **232.9**
Structural Grade: **0**
O&M Grade: **0**
Clock Start/From: **9**
Clock To:
1st Value: **4.000**
2nd Value:
Value Percent:
Continuous Index:
Within 8" of Joint:
Remarks:

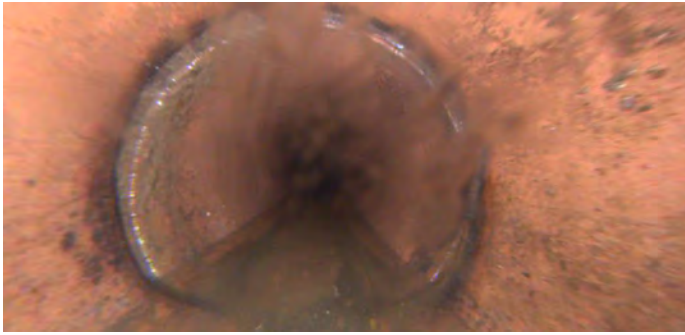
Code: **IW**
Description: **Infil Weeper**

Distance (ft): **233.5**
Structural Grade: **0**
O&M Grade: **2**
Clock Start/From: **8**
Clock To: **4**
1st Value:
2nd Value:
Value Percent:
Continuous Index:
Within 8" of Joint: **YES**
Remarks:

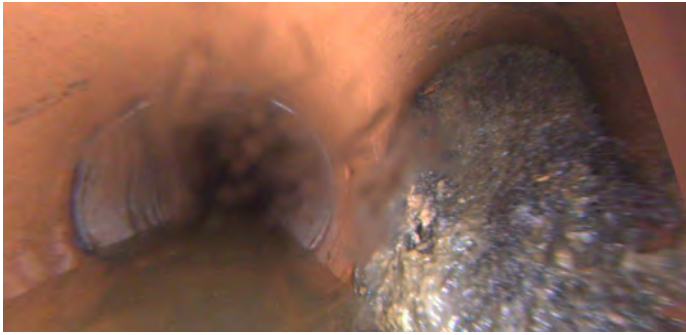
Code: **TFD**
Description: **Tap Factory Defective**

Distance (ft): **240.3**
Structural Grade: **0**
O&M Grade: **2**
Clock Start/From: **3**
Clock To:
1st Value: **4.000**
2nd Value:
Value Percent:
Continuous Index:
Within 8" of Joint:
Remarks: **roots**

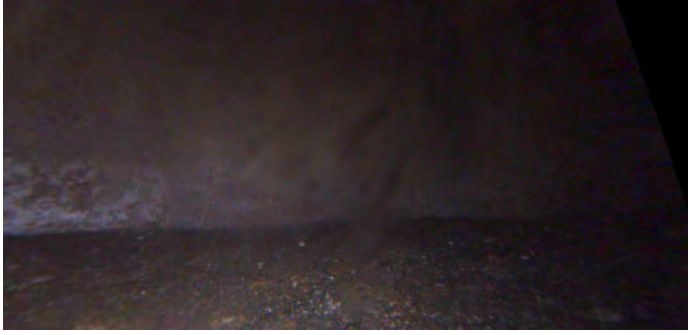
Code:	AMH
Description:	Manhole
Distance (ft):	248.3
Structural Grade:	0
O&M Grade:	0
Clock Start/From:	
Clock To:	
1st Value:	
2nd Value:	
Value Percent:	
Continuous Index:	
Within 8" of Joint:	NO
Remarks:	M-503-048
