Profile/Photo Observation Report

Street:	W 40th ave	Flow Control:	Not Controlled
City:	Hobart, IN	Year Renewed:	
Location:	Other	Tape/Media #:	
Purpose:	Not Known	Dia/Height:	10"
Use:	Sanitary	Material:	VCP
Drain Area:	NA	Lining:	
Category:	NA		
Comment:

Location Details:		Direction of Survey:	Downstream
US MH:	M-503-049	DS MH:	M-503-048
		Total Length Surveyed (ft):	248.3

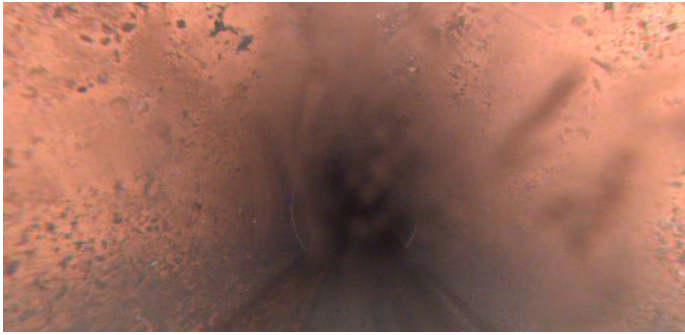
Code: **AMH**
Description: **Manhole**

Distance (ft): **.0**
Structural Grade: **0**
O&M Grade: **0**
Clock Start/From:
Clock To:
1st Value:
2nd Value:
Value Percent:
Continuous Index:
Within 8" of Joint: **NO**
Remarks: **M-503-049**

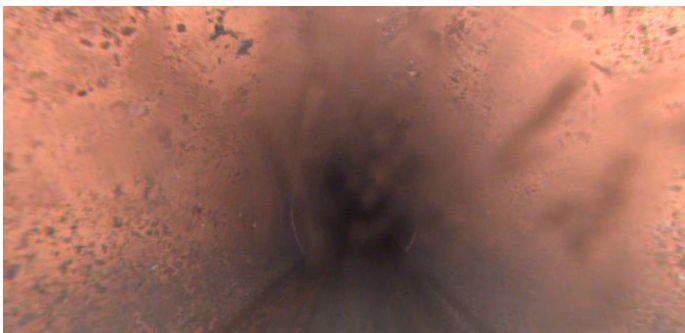
Code: **MWL**
Description: **Water Level**

Distance (ft): **.0**
Structural Grade: **0**
O&M Grade: **0**
Clock Start/From:
Clock To:
1st Value:
2nd Value:
Value Percent: **5.000**
Continuous Index:
Within 8" of Joint: **NO**
Remarks:

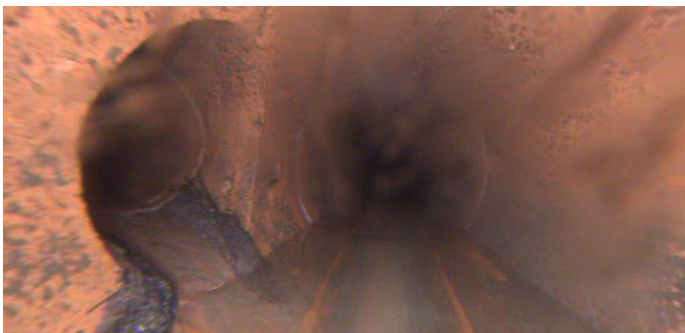
Code: **TFD**
Description: **Tap Factory Defective**

Distance (ft): **14.2**
Structural Grade: **0**
O&M Grade: **2**
Clock Start/From: **9**
Clock To:
1st Value: **4.000**
2nd Value:
Value Percent:
Continuous Index:
Within 8" of Joint:
Remarks: **roots**

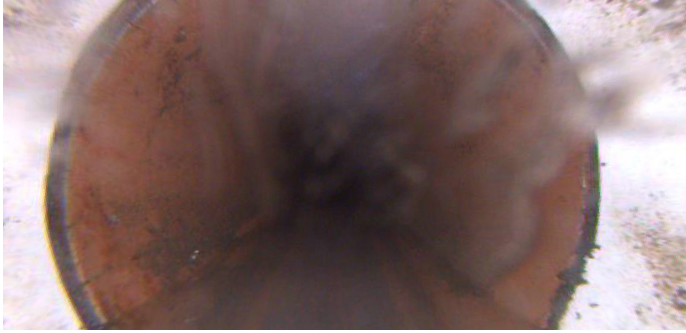
Code: **MMC**
Description: **Material Change**

Distance (ft): **45.2**
Structural Grade: **0**
O&M Grade: **0**
Clock Start/From:
Clock To:
1st Value:
2nd Value:
Value Percent:
Continuous Index:
Within 8" of Joint: **NO**
Remarks: **vcp**

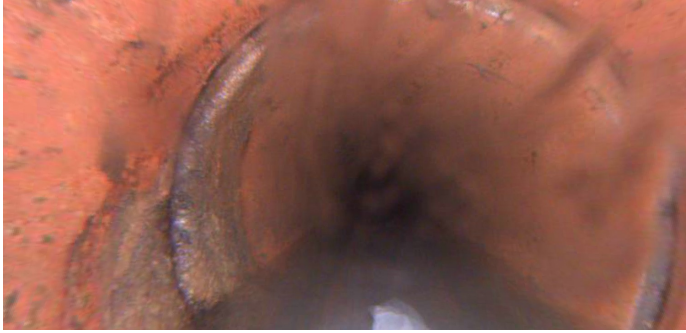
Code: **DAE**
Description: **Deposits Attached Encrustation**

Distance (ft): **62.2**
Structural Grade: **0**
O&M Grade: **2**
Clock Start/From: **8**
Clock To: **11**
1st Value:
2nd Value:
Value Percent: **5.000**
Continuous Index:
Within 8" of Joint: **YES**
Remarks:

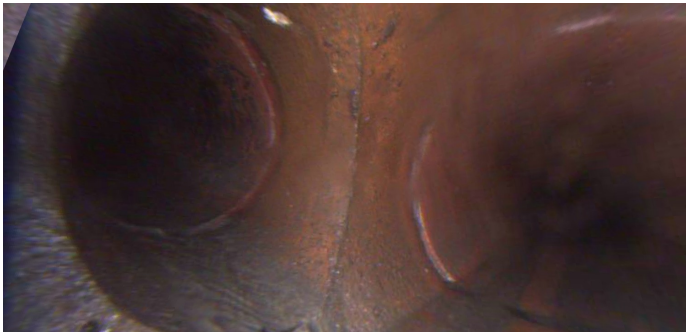
Code: **TFA**
Description: **Tap Factory Active**

Distance (ft): **84.0**
Structural Grade: **0**
O&M Grade: **0**
Clock Start/From: **9**
Clock To:
1st Value: **4.000**
2nd Value:
Value Percent:
Continuous Index:
Within 8" of Joint:
Remarks:

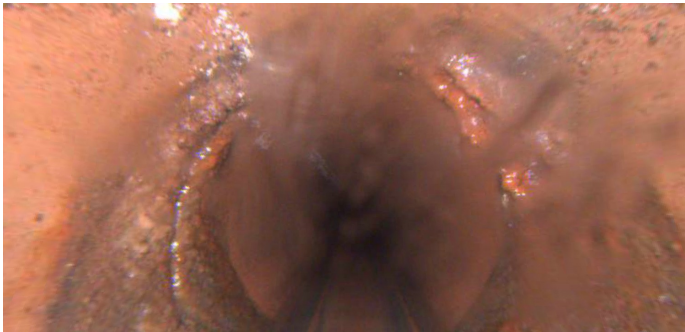
Code: **DAE**
Description: **Deposits Attached Encrustation**

Distance (ft): **99.4**
Structural Grade: **0**
O&M Grade: **2**
Clock Start/From: **8**
Clock To: **4**
1st Value:
2nd Value:
Value Percent: **5.000**
Continuous Index:
Within 8" of Joint: **YES**
Remarks:

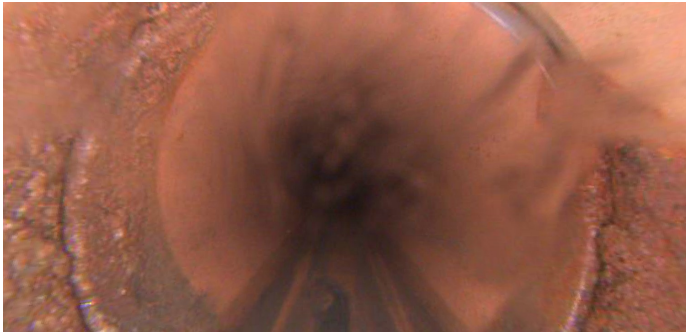
Code: **DAE**
Description: **Deposits Attached Encrustation**

Distance (ft): **126.2**
Structural Grade: **0**
O&M Grade: **2**
Clock Start/From: **8**
Clock To: **4**
1st Value:
2nd Value:
Value Percent: **5.000**
Continuous Index:
Within 8" of Joint: **YES**
Remarks:

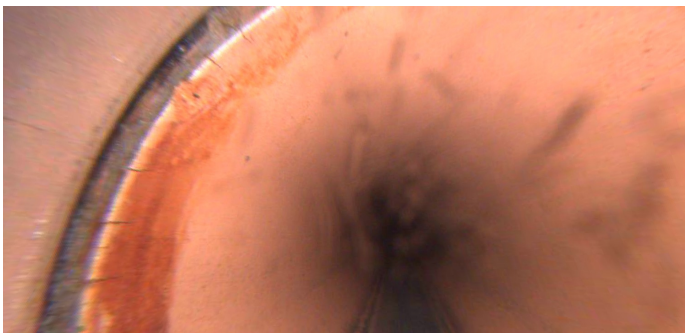
Code: **FM**
Description: **Fracture Multiple**

Distance (ft): **186.3**
Structural Grade: **4**
O&M Grade: **0**
Clock Start/From: **9**
Clock To: **12**
1st Value:
2nd Value:
Value Percent:
Continuous Index:
Within 8" of Joint: **YES**
Remarks:

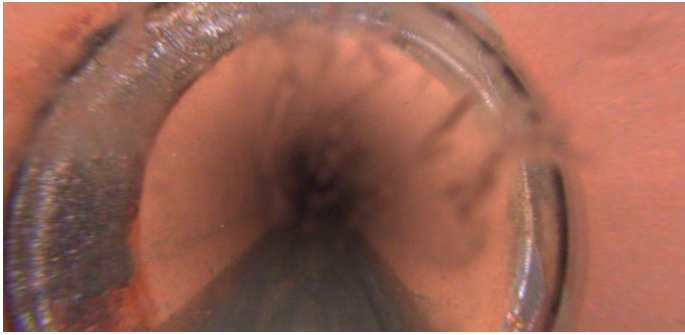
Code: **IW**
Description: **Infil Weeper**

Distance (ft): **196.2**
Structural Grade: **0**
O&M Grade: **2**
Clock Start/From: **8**
Clock To: **12**
1st Value:
2nd Value:
Value Percent:
Continuous Index:
Within 8" of Joint: **YES**
Remarks:

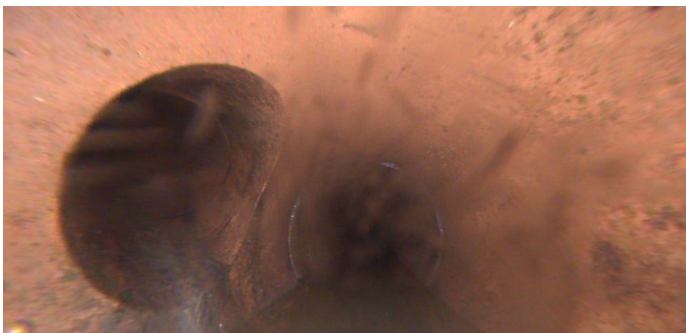
Code: **TFA**
Description: **Tap Factory Active**

Distance (ft): **232.9**
Structural Grade: **0**
O&M Grade: **0**
Clock Start/From: **9**
Clock To:
1st Value: **4.000**
2nd Value:
Value Percent:
Continuous Index:
Within 8" of Joint:
Remarks:

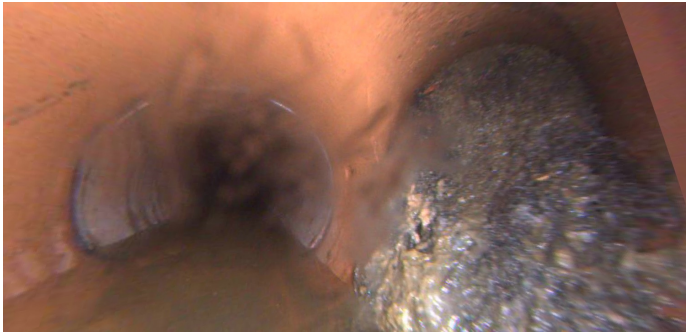
Code: **TFD**
Description: **Tap Factory Defective**

Distance (ft): **240.3**
Structural Grade: **0**
O&M Grade: **2**
Clock Start/From: **3**
Clock To:
1st Value: **4.000**
2nd Value:
Value Percent:
Continuous Index:
Within 8" of Joint:
Remarks: **roots**

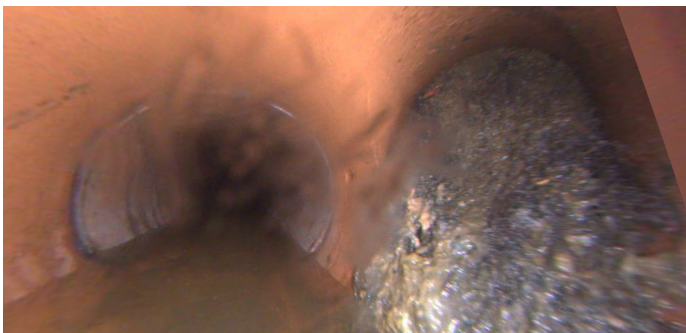
Code: **RML**
Description: **Roots Medium Lateral**

Distance (ft): **240.3**
Structural Grade: **0**
O&M Grade: **3**
Clock Start/From: **3**
Clock To: **4**
1st Value:
2nd Value:
Value Percent: **10.000**
Continuous Index:
Within 8" of Joint: **NO**
Remarks:

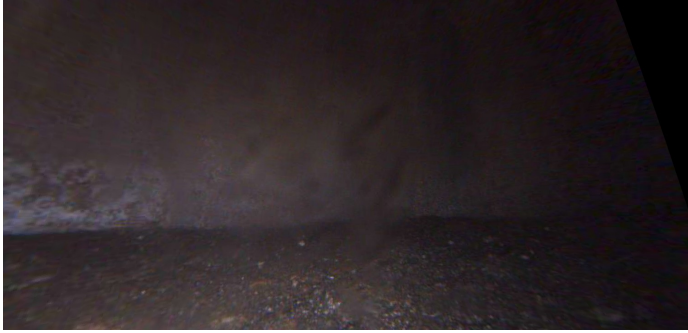
Code:	AMH
Description:	Manhole
Distance (ft):	248.3
Structural Grade:	0
O&M Grade:	0
Clock Start/From:	
Clock To:	
1st Value:	
2nd Value:	
Value Percent:	
Continuous Index:	
Within 8" of Joint:	NO
Remarks:	M-503-048
