## Profile/Photo Observation Report

Date:	<b>04/10/2018</b>	Weather:		Coding:	<b>PACP 6.0</b>
Pipe Length (ft):	<b>279.4</b>	Owner:	<b>NA</b>	Pre Clean:	<b>Not Known</b>
P.O.#:		Surveyor:	<b>Mark Ruby</b>	PSR:	<b>P-503-049-050</b>
Customer:		Clean Date:	<b>01/01/1900</b>	Shape:	<b>C</b>

Street:	<b>N COLORADO ST</b>	Flow Control:	<b>Not Controlled</b>
City:	<b>Hobart, IN</b>	Year Renewed:	
Location:	<b>Other</b>	Tape/Media #:	
Purpose:	<b>Not Known</b>	Dia/Height:	<b>10"</b>
Use:	<b>Sanitary</b>	Material:	<b>VCP</b>
Drain Area:	<b>NA</b>	Lining:	
Category:	<b>NA</b>		
Comment:

Location Details:		Direction of Survey:	<b>Downstream</b>
US MH:	<b>M-503-050</b>	DS MH:	<b>M-503-049</b>
		Total Length Surveyed (ft):	<b>239.1</b>

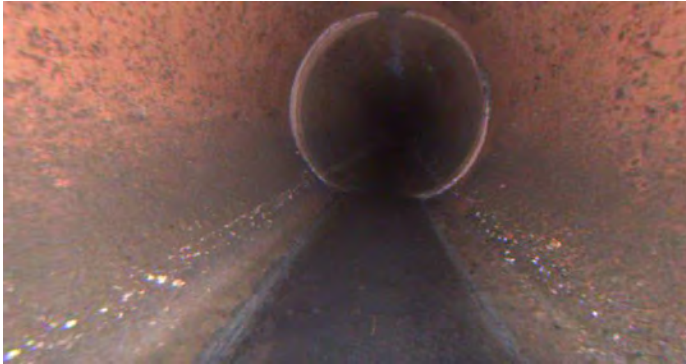
Code: **AMH**  
Description: **Manhole**

Distance (ft): **.0**  
Structural Grade: **0**  
O&M Grade: **0**  
Clock Start/From:  
Clock To:  
1st Value:  
2nd Value:  
Value Percent:  
Continuous Index:  
Within 8" of Joint: **NO**  
Remarks: **M-503-050**

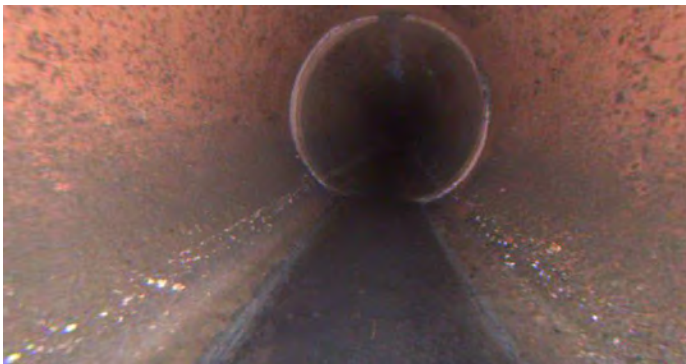
Code: **MWL**  
Description: **Water Level**

Distance (ft): **.0**  
Structural Grade: **0**  
O&M Grade: **0**  
Clock Start/From:  
Clock To:  
1st Value:  
2nd Value:  
Value Percent: **10.000**  
Continuous Index:  
Within 8" of Joint: **NO**  
Remarks:

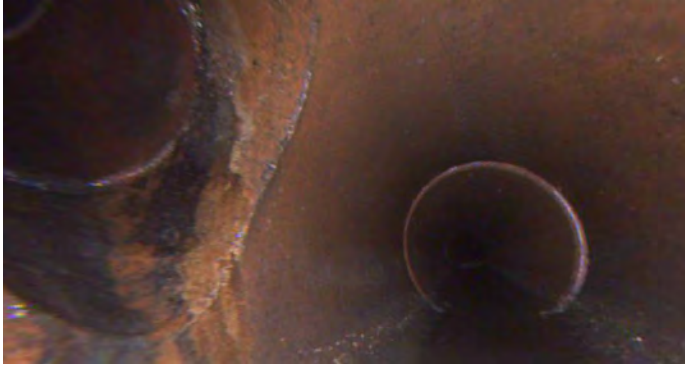
Code: **TF**  
Description: **Tap Factory**

Distance (ft): **12.6**  
Structural Grade: **0**  
O&M Grade: **0**  
Clock Start/From: **10**  
Clock To:  
1st Value: **4.000**  
2nd Value:  
Value Percent:  
Continuous Index:  
Within 8" of Joint:  
Remarks:

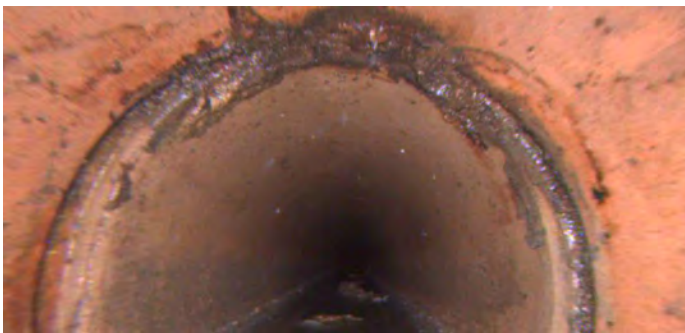
Code: **IS**  
Description: **Infil Stain**

Distance (ft): **18.8**  
Structural Grade: **0**  
O&M Grade: **0**  
Clock Start/From: **10**  
Clock To: **2**  
1st Value:  
2nd Value:  
Value Percent:  
Continuous Index:  
Within 8" of Joint: **YES**  
Remarks:

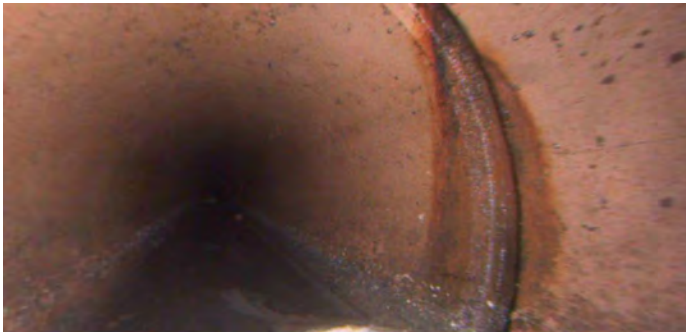
Code: **IS**  
Description: **Infil Stain**

Distance (ft): **23.8**  
Structural Grade: **0**  
O&M Grade: **0**  
Clock Start/From: **1**  
Clock To: **4**  
1st Value:  
2nd Value:  
Value Percent:  
Continuous Index:  
Within 8" of Joint: **YES**  
Remarks:

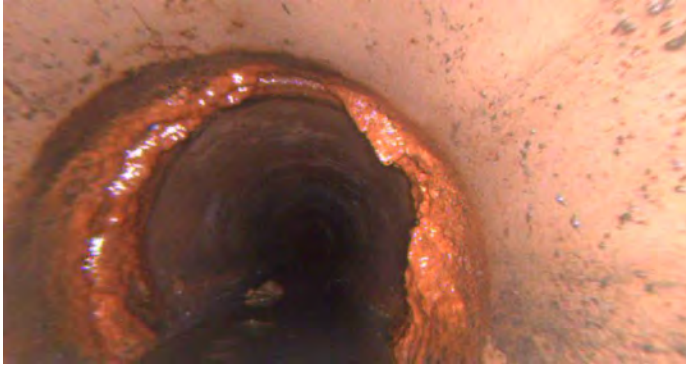
Code: **DAE**  
Description: **Deposits Attached Encrustation**

Distance (ft): **33.3**  
Structural Grade: **0**  
O&M Grade: **2**  
Clock Start/From: **7**  
Clock To: **5**  
1st Value:  
2nd Value:  
Value Percent: **5.000**  
Continuous Index:  
Within 8" of Joint: **YES**  
Remarks:

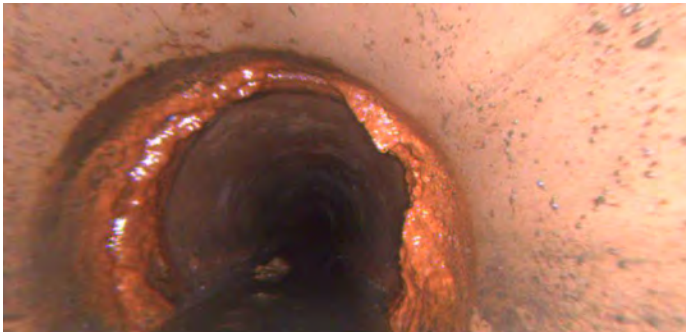
Code: **ID**  
Description: **Infil Dripper**

Distance (ft): **33.3**  
Structural Grade: **0**  
O&M Grade: **3**  
Clock Start/From: **12**  
Clock To: **1**  
1st Value:  
2nd Value:  
Value Percent:  
Continuous Index:  
Within 8" of Joint: **YES**  
Remarks:

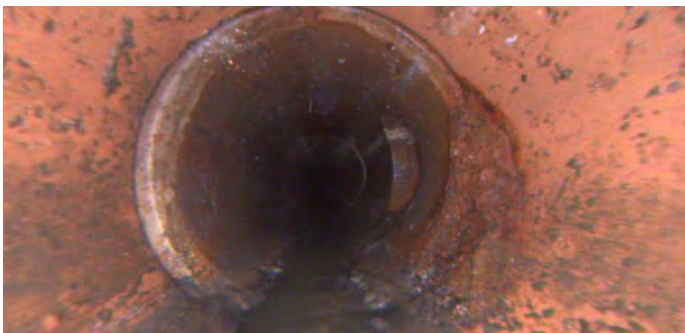
Code: **DAE**  
Description: **Deposits Attached Encrustation**

Distance (ft): **58.2**  
Structural Grade: **0**  
O&M Grade: **2**  
Clock Start/From: **2**  
Clock To: **4**  
1st Value:  
2nd Value:  
Value Percent: **5.000**  
Continuous Index:  
Within 8" of Joint: **YES**  
Remarks:

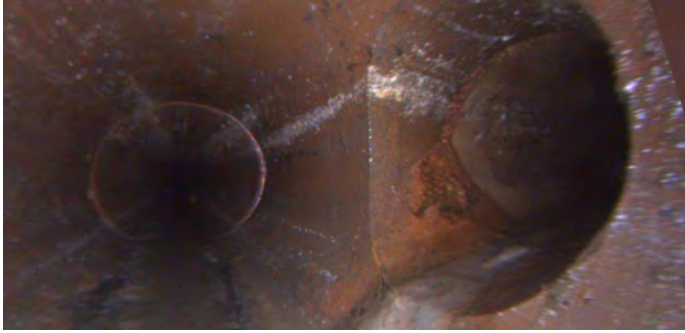
Code: **TFA**  
Description: **Tap Factory Active**

Distance (ft): **59.2**  
Structural Grade: **0**  
O&M Grade: **0**  
Clock Start/From: **3**  
Clock To:  
1st Value: **4.000**  
2nd Value:  
Value Percent:  
Continuous Index:  
Within 8" of Joint:  
Remarks:

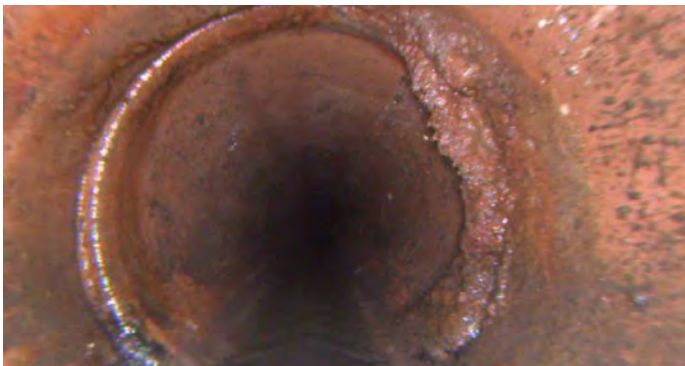
Code: **DAZ**  
Description: **Deposits Attached Other**

Distance (ft): **70.2**  
Structural Grade: **0**  
O&M Grade: **2**  
Clock Start/From: **1**  
Clock To: **5**  
1st Value:  
2nd Value:  
Value Percent: **5.000**  
Continuous Index:  
Within 8" of Joint: **YES**  
Remarks:

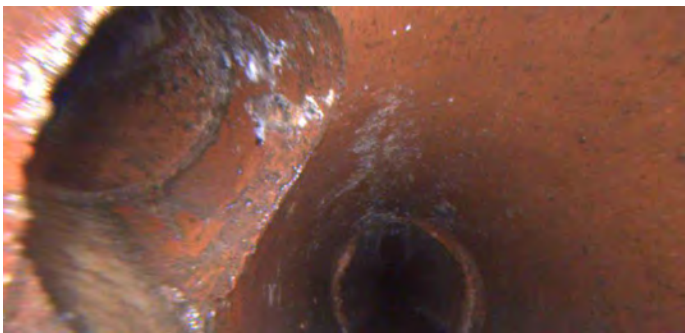
Code: **TF**  
Description: **Tap Factory**

Distance (ft): **85.8**  
Structural Grade: **0**  
O&M Grade: **0**  
Clock Start/From: **9**  
Clock To:  
1st Value: **4.000**  
2nd Value:  
Value Percent:  
Continuous Index:  
Within 8" of Joint:  
Remarks:

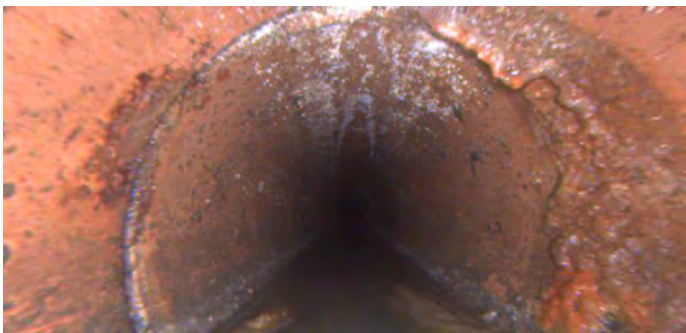
Code: **ID**  
Description: **Infil Dripper**

Distance (ft): **97.0**  
Structural Grade: **0**  
O&M Grade: **3**  
Clock Start/From: **1**  
Clock To:  
1st Value:  
2nd Value:  
Value Percent:  
Continuous Index:  
Within 8" of Joint: **YES**  
Remarks:

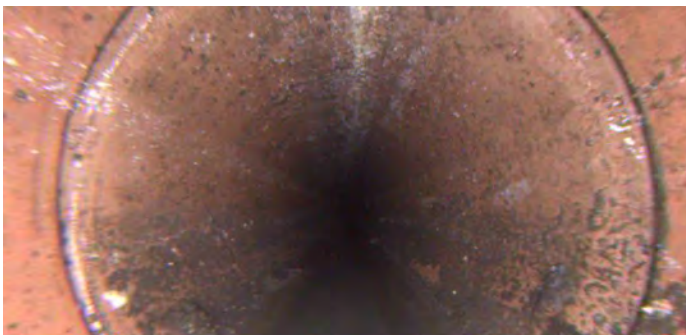
Code: **IW**  
Description: **Infil Weeper**

Distance (ft): **116.7**  
Structural Grade: **0**  
O&M Grade: **2**  
Clock Start/From: **8**  
Clock To: **4**  
1st Value:  
2nd Value:  
Value Percent:  
Continuous Index: **F02**  
Within 8" of Joint: **YES**  
Remarks:

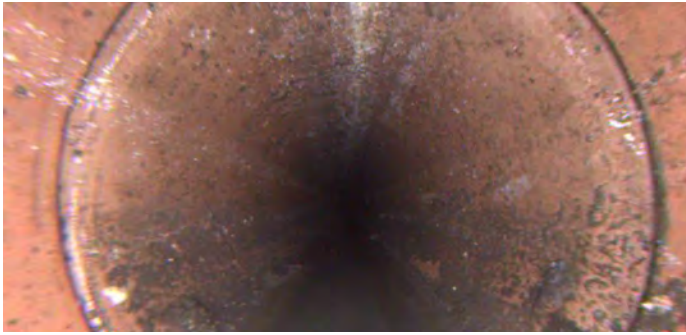
Code: **DAE**  
Description: **Deposits Attached Encrustation**

Distance (ft): **116.7**  
Structural Grade: **0**  
O&M Grade: **2**  
Clock Start/From: **8**  
Clock To: **4**  
1st Value:  
2nd Value:  
Value Percent: **5.000**  
Continuous Index: **F01**  
Within 8" of Joint: **YES**  
Remarks:

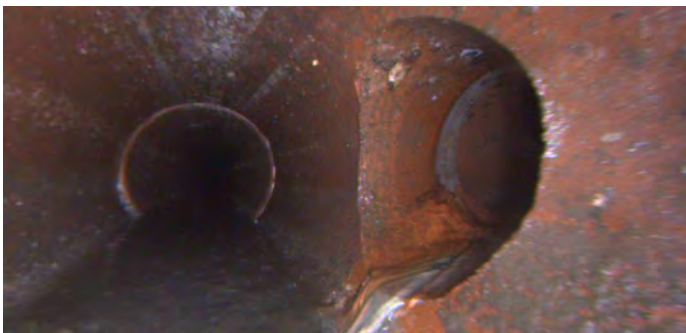
Code: **TFA**  
Description: **Tap Factory Active**

Distance (ft): **122.0**  
Structural Grade: **0**  
O&M Grade: **0**  
Clock Start/From: **3**  
Clock To:  
1st Value: **4.000**  
2nd Value:  
Value Percent:  
Continuous Index:  
Within 8" of Joint:  
Remarks:

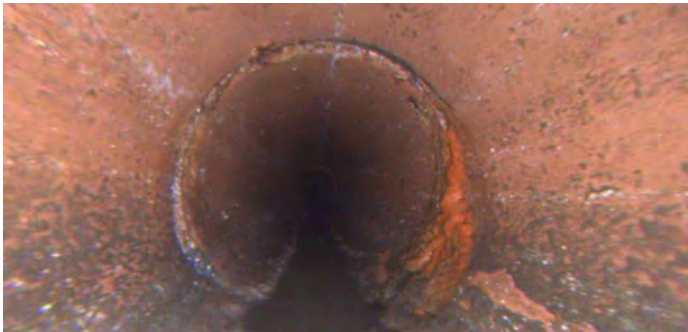
Code: **RFJ**  
Description: **Roots Fine Joint**

Distance (ft): **174.5**  
Structural Grade: **0**  
O&M Grade: **1**  
Clock Start/From: **2**  
Clock To:  
1st Value:  
2nd Value:  
Value Percent:  
Continuous Index:  
Within 8" of Joint: **YES**  
Remarks:

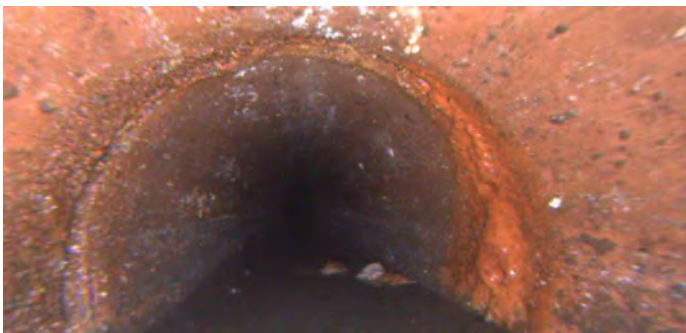
Code: **IW**  
Description: **Infil Weeper**

Distance (ft): **199.5**  
Structural Grade: **0**  
O&M Grade: **2**  
Clock Start/From: **1**  
Clock To: **4**  
1st Value:  
2nd Value:  
Value Percent:  
Continuous Index:  
Within 8" of Joint: **YES**  
Remarks:

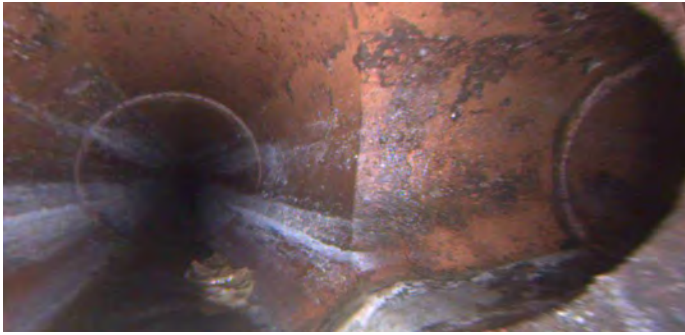
Code: **TFA**  
Description: **Tap Factory Active**

Distance (ft): **210.1**  
Structural Grade: **0**  
O&M Grade: **0**  
Clock Start/From: **3**  
Clock To:  
1st Value: **4.000**  
2nd Value:  
Value Percent:  
Continuous Index:  
Within 8" of Joint:  
Remarks:

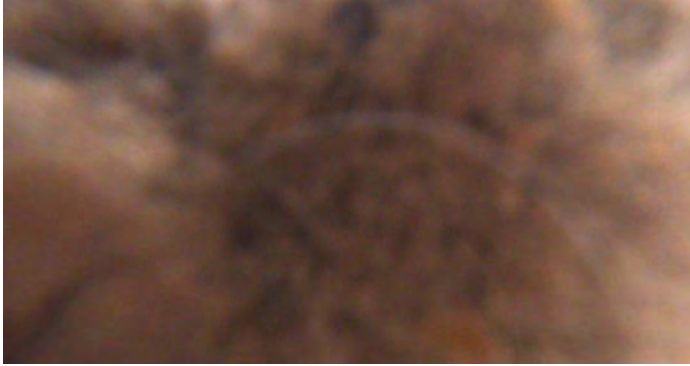
Code:	<b>MSA</b>
Description:	<b>Abandoned Survey</b>
Distance (ft):	<b>239.1</b>
Structural Grade:	<b>0</b>
O&M Grade:	<b>0</b>
Clock Start/From:	
Clock To:	
1st Value:	
2nd Value:	
Value Percent:	
Continuous Index:	
Within 8" of Joint:	<b>NO</b>
Remarks:	<b>DAZ</b>
