## Profile/Photo Observation Report

Street:	<b>W 40th ave</b>	Flow Control:	<b>Not Controlled</b>
City:	<b>Hobart, IN</b>	Year Renewed:	
Location:	<b>Other</b>	Tape/Media #:	
Purpose:	<b>Not Known</b>	Dia/Height:	<b>10"</b>
Use:	<b>Sanitary</b>	Material:	<b>VCP</b>
Drain Area:	<b>NA</b>	Lining:	
Category:	<b>NA</b>		
Comment:

Location Details:		Direction of Survey:	<b>Downstream</b>
US MH:	<b>M-503-050</b>	DS MH:	<b>M-503-049</b>
		Total Length Surveyed (ft):	<b>239.1</b>

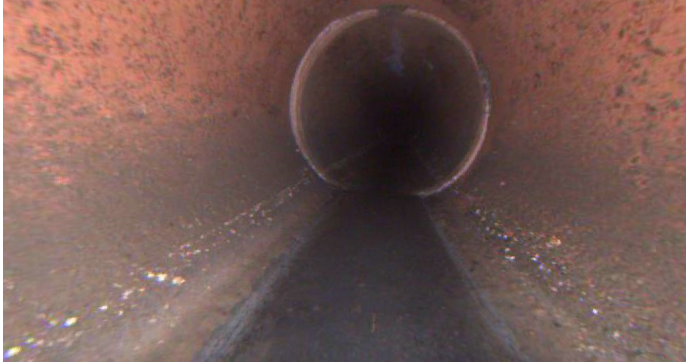
Code: **AMH**  
Description: **Manhole**

Distance (ft): **.0**  
Structural Grade: **0**  
O&M Grade: **0**  
Clock Start/From:  
Clock To:  
1st Value:  
2nd Value:  
Value Percent:  
Continuous Index:  
Within 8" of Joint: **NO**  
Remarks: **M-503-050**

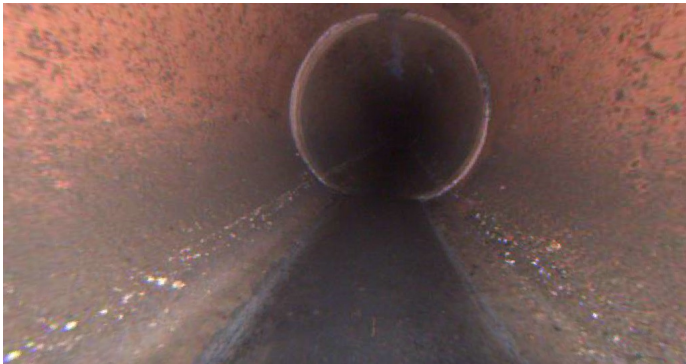
Code: **MWL**  
Description: **Water Level**

Distance (ft): **.0**  
Structural Grade: **0**  
O&M Grade: **0**  
Clock Start/From:  
Clock To:  
1st Value:  
2nd Value:  
Value Percent: **10.000**  
Continuous Index:  
Within 8" of Joint: **NO**  
Remarks:

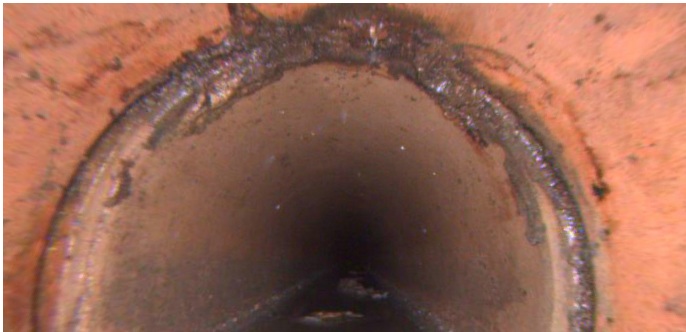
Code: **IS**  
Description: **Infil Stain**

Distance (ft): **18.8**  
Structural Grade: **0**  
O&M Grade: **0**  
Clock Start/From: **10**  
Clock To: **2**  
1st Value:  
2nd Value:  
Value Percent:  
Continuous Index:  
Within 8" of Joint: **YES**  
Remarks:

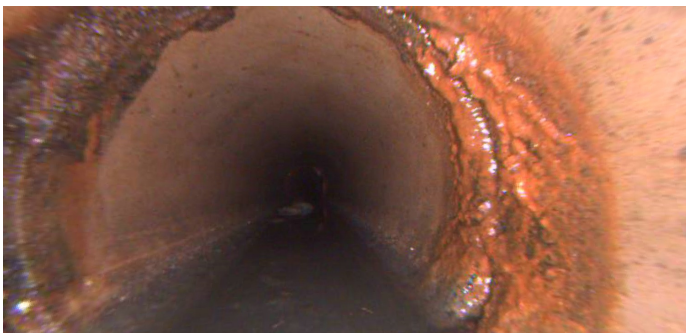
Code: **IW**  
Description: **Infil Weeper**

Distance (ft): **28.5**  
Structural Grade: **0**  
O&M Grade: **2**  
Clock Start/From: **8**  
Clock To: **4**  
1st Value:  
2nd Value:  
Value Percent:  
Continuous Index:  
Within 8" of Joint: **YES**  
Remarks:

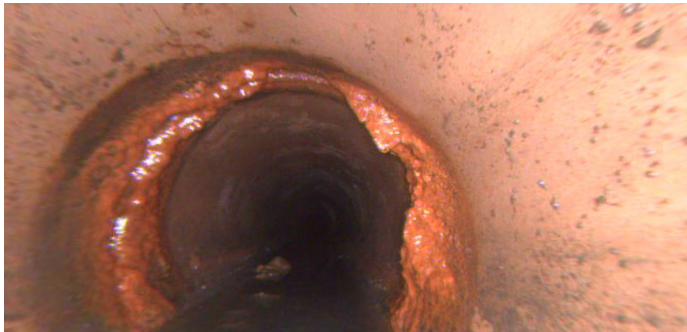
Code:	<b>ID</b>
Description:	<b>Infil Dripper</b>
Distance (ft):	<b>33.3</b>
Structural Grade:	<b>0</b>
O&M Grade:	<b>3</b>
Clock Start/From:	<b>12</b>
Clock To:	<b>1</b>
1st Value:	
2nd Value:	
Value Percent:	
Continuous Index:	
Within 8" of Joint:	<b>YES</b>
Remarks:

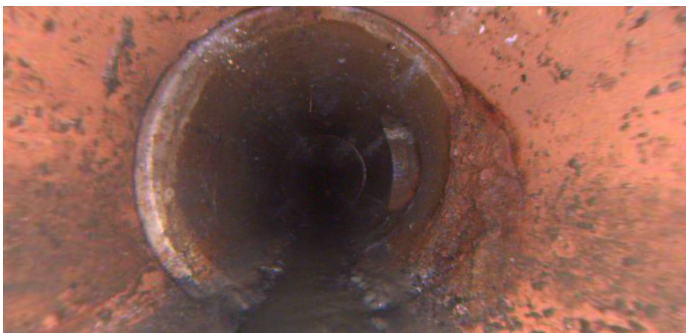
Code: **DAE**  
Description: **Deposits Attached Encrustation**

Distance (ft): **58.2**  
Structural Grade: **0**  
O&M Grade: **2**  
Clock Start/From: **2**  
Clock To: **4**  
1st Value:  
2nd Value:  
Value Percent: **5.000**  
Continuous Index:  
Within 8" of Joint: **YES**  
Remarks:

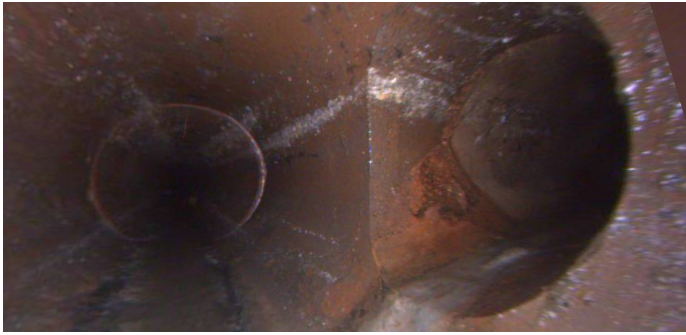
Code: **TFA**  
Description: **Tap Factory Active**

Distance (ft): **59.2**  
Structural Grade: **0**  
O&M Grade: **0**  
Clock Start/From: **3**  
Clock To:  
1st Value: **4.000**  
2nd Value:  
Value Percent:  
Continuous Index:  
Within 8" of Joint:  
Remarks:

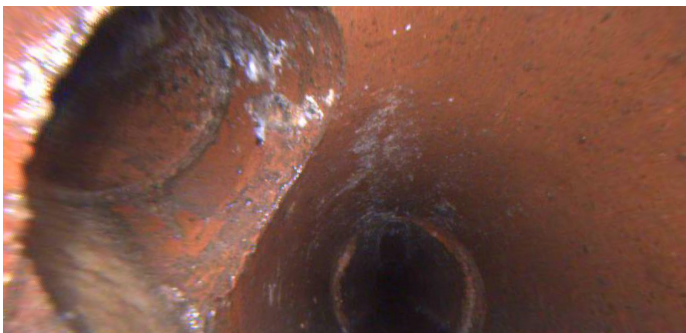
Code: **TF**  
Description: **Tap Factory**

Distance (ft): **85.8**  
Structural Grade: **0**  
O&M Grade: **0**  
Clock Start/From: **9**  
Clock To:  
1st Value: **4.000**  
2nd Value:  
Value Percent:  
Continuous Index:  
Within 8" of Joint:  
Remarks:

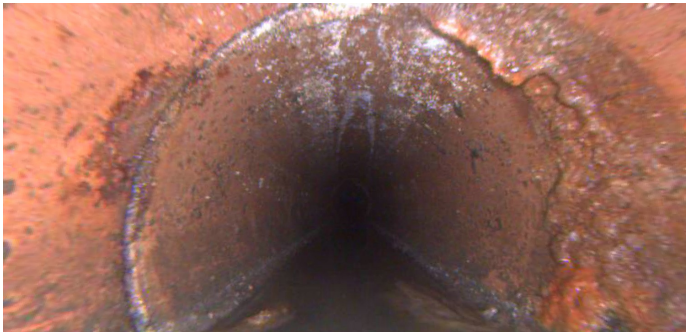
Code: **ID**  
Description: **Infil Dripper**

Distance (ft): **97.0**  
Structural Grade: **0**  
O&M Grade: **3**  
Clock Start/From: **1**  
Clock To:  
1st Value:  
2nd Value:  
Value Percent:  
Continuous Index:  
Within 8" of Joint: **YES**  
Remarks:

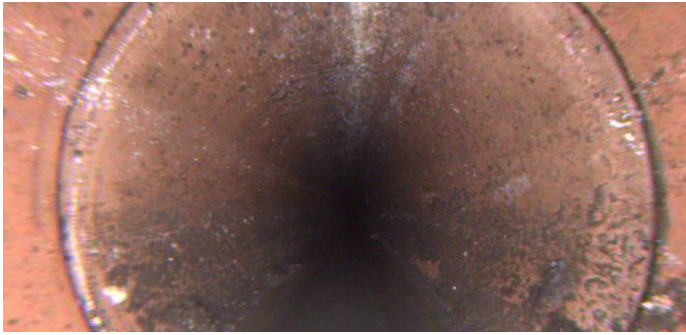
Code: **DAE**  
Description: **Deposits Attached Encrustation**

Distance (ft): **116.7**  
Structural Grade: **0**  
O&M Grade: **2**  
Clock Start/From: **8**  
Clock To: **4**  
1st Value:  
2nd Value:  
Value Percent: **5.000**  
Continuous Index: **F01**  
Within 8" of Joint: **YES**  
Remarks:

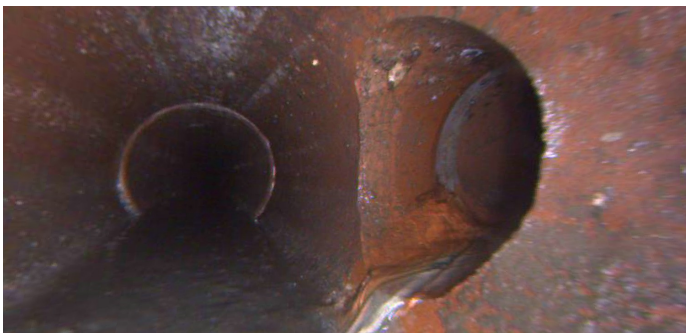
Code: **TFA**  
Description: **Tap Factory Active**

Distance (ft): **122.0**  
Structural Grade: **0**  
O&M Grade: **0**  
Clock Start/From: **3**  
Clock To:  
1st Value: **4.000**  
2nd Value:  
Value Percent:  
Continuous Index:  
Within 8" of Joint:  
Remarks:

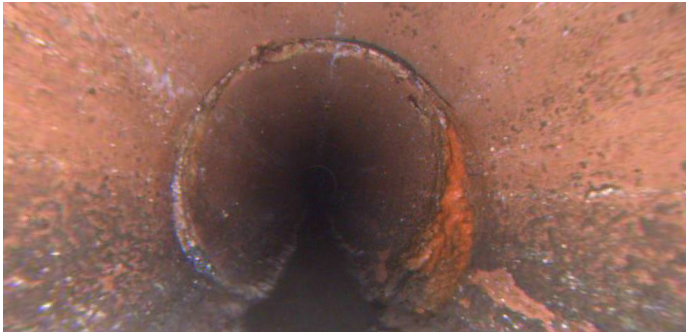
Code: **IW**  
Description: **Infil Weeper**

Distance (ft): **174.5**  
Structural Grade: **0**  
O&M Grade: **2**  
Clock Start/From: **2**  
Clock To: **4**  
1st Value:  
2nd Value:  
Value Percent:  
Continuous Index:  
Within 8" of Joint: **YES**  
Remarks:

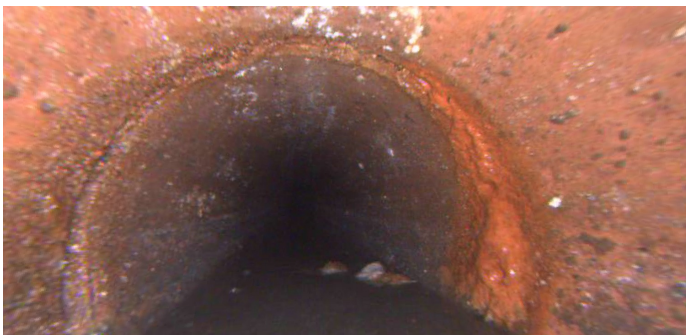
Code: **IW**  
Description: **Infil Weeper**

Distance (ft): **199.5**  
Structural Grade: **0**  
O&M Grade: **2**  
Clock Start/From: **1**  
Clock To: **4**  
1st Value:  
2nd Value:  
Value Percent:  
Continuous Index:  
Within 8" of Joint: **YES**  
Remarks:

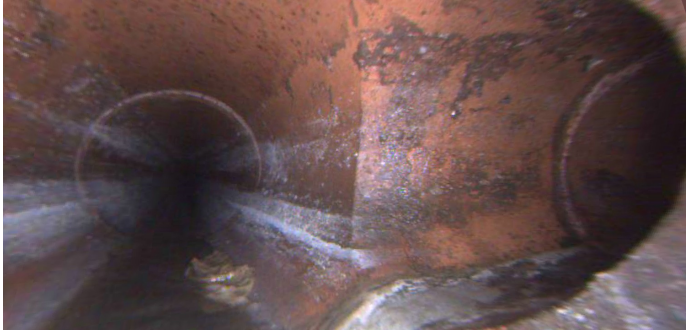
Code: **TFA**  
Description: **Tap Factory Active**

Distance (ft): **210.1**  
Structural Grade: **0**  
O&M Grade: **0**  
Clock Start/From: **3**  
Clock To:  
1st Value: **4.000**  
2nd Value:  
Value Percent:  
Continuous Index:  
Within 8" of Joint:  
Remarks:

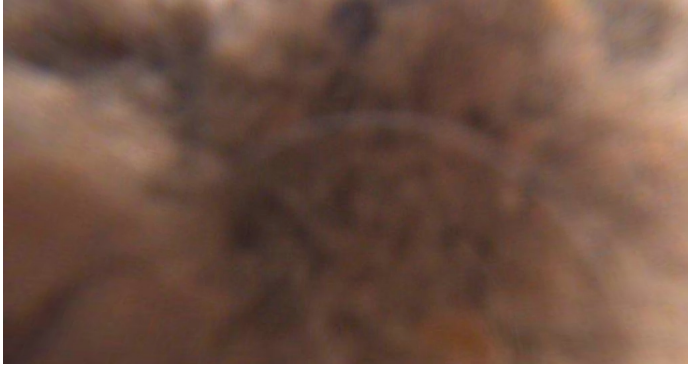
Code:	<b>MSA</b>
Description:	<b>Abandoned Survey</b>
Distance (ft):	<b>239.1</b>
Structural Grade:	<b>0</b>
O&M Grade:	<b>0</b>
Clock Start/From:	
Clock To:	
1st Value:	
2nd Value:	
Value Percent:	
Continuous Index:	
Within 8" of Joint:	<b>NO</b>
Remarks:	<b>DAZ</b>
