Profile/Photo Observation Report

Date:	04/14/2018	Weather:		Coding:	PACP 6.0
Pipe Length (ft):	279.4	Owner:	NA	Pre Clean:	Not Known
P.O.#:		Surveyor:	Jen Costello	PSR:	P-503-049-050
Customer:		Clean Date:	01/01/1900	Shape:	C

Street:	N COLORADO ST	Flow Control:	Not Controlled
City:	Hobart, IN	Year Renewed:	
Location:	Other	Tape/Media #:	
Purpose:	Not Known	Dia/Height:	10"
Use:	Sanitary	Material:	VCP
Drain Area:	NA	Lining:	
Category:	NA		
Comment:

Location Details:		Direction of Survey:	Downstream
US MH:	M-503-050	DS MH:	M-503-049
		Total Length Surveyed (ft):	40.2

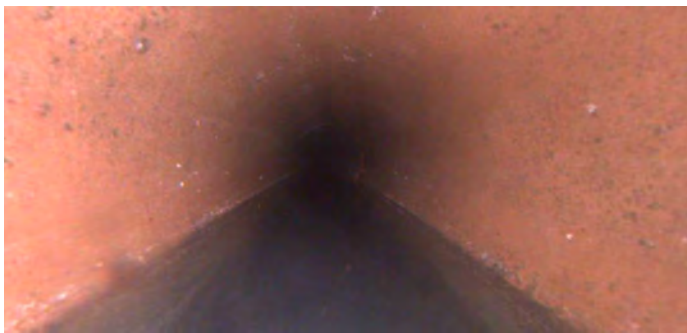
Code: **AMH**
 Description: **Manhole**

Distance (ft): **.0**
 Structural Grade: **0**
 O&M Grade: **0**
 Clock Start/From:
 Clock To:
 1st Value:
 2nd Value:
 Value Percent:
 Continuous Index:
 Within 8" of Joint: **NO**
 Remarks: **M-503-050**

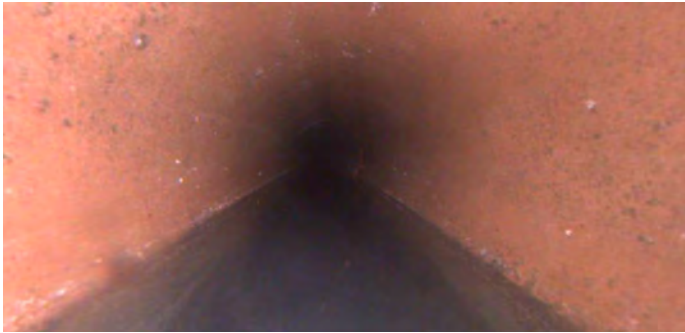
Code:	MWL
Description:	Water Level

Distance (ft):	.0
Structural Grade:	0
O&M Grade:	0
Clock Start/From:	
Clock To:	
1st Value:	
2nd Value:	
Value Percent:	20.000
Continuous Index:	
Within 8" of Joint:	NO
Remarks:

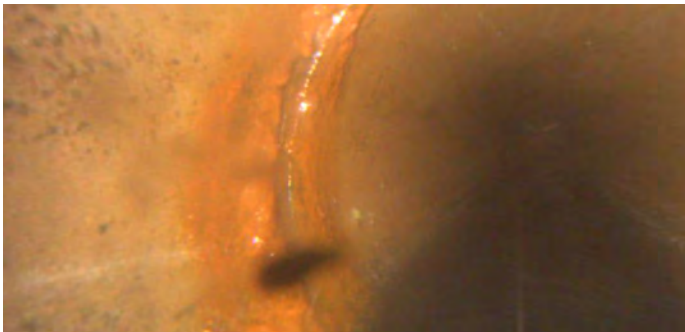
Code:	IW
Description:	Infil Weeper

Distance (ft):	5.1
Structural Grade:	0
O&M Grade:	2
Clock Start/From:	1
Clock To:	4
1st Value:	
2nd Value:	
Value Percent:	
Continuous Index:	
Within 8" of Joint:	YES
Remarks:

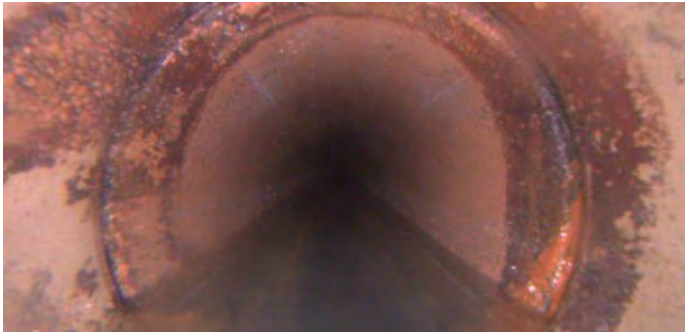
Code: **IW**
Description: **Infil Weeper**

Distance (ft): **9.2**
Structural Grade: **0**
O&M Grade: **2**
Clock Start/From: **8**
Clock To: **4**
1st Value:
2nd Value:
Value Percent:
Continuous Index:
Within 8" of Joint: **YES**
Remarks:

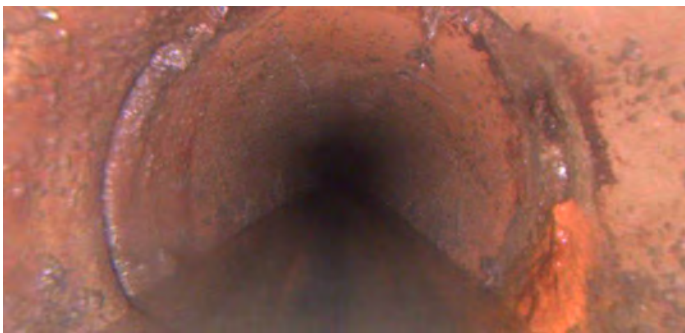
Code: **IW**
Description: **Infil Weeper**

Distance (ft): **19.5**
Structural Grade: **0**
O&M Grade: **2**
Clock Start/From: **8**
Clock To: **4**
1st Value:
2nd Value:
Value Percent:
Continuous Index:
Within 8" of Joint: **YES**
Remarks:

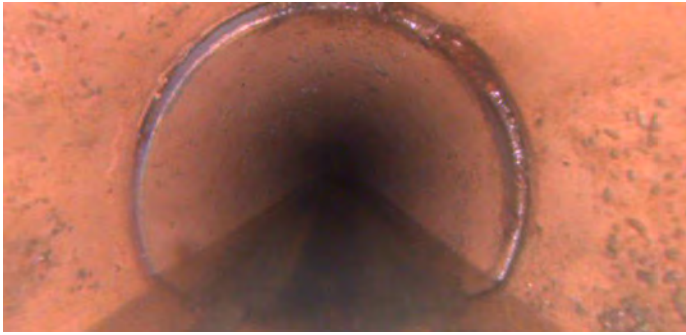
Code: **IW**
Description: **Infil Weeper**

Distance (ft): **24.6**
Structural Grade: **0**
O&M Grade: **2**
Clock Start/From: **12**
Clock To: **4**
1st Value:
2nd Value:
Value Percent:
Continuous Index:
Within 8" of Joint: **YES**
Remarks:

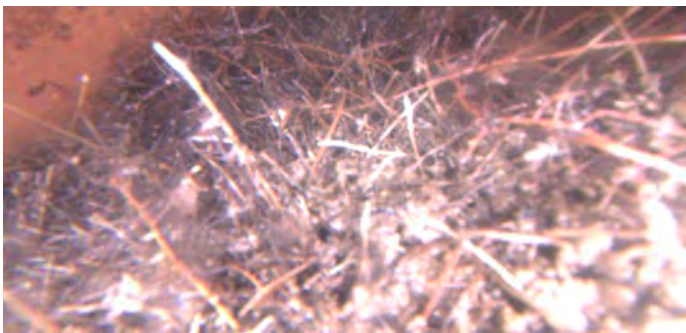
Code: **RBB**
Description: **Roots Ball Barrel**

Distance (ft): **40.2**
Structural Grade: **0**
O&M Grade: **5**
Clock Start/From: **12**
Clock To: **12**
1st Value:
2nd Value:
Value Percent: **100.000**
Continuous Index:
Within 8" of Joint: **NO**
Remarks:

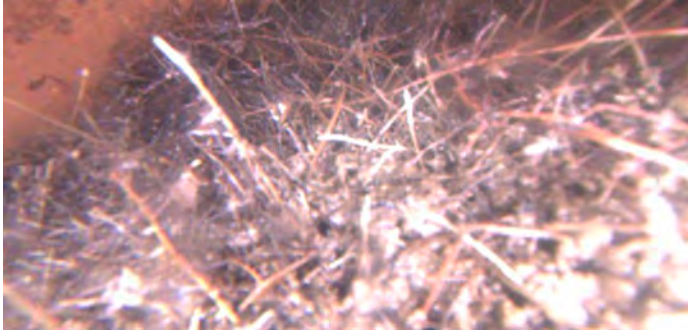
Code:	MSA
Description:	Abandoned Survey
Distance (ft):	40.2
Structural Grade:	0
O&M Grade:	0
Clock Start/From:	
Clock To:	
1st Value:	
2nd Value:	
Value Percent:	
Continuous Index:	
Within 8" of Joint:	NO
Remarks:	ROOTS
