Profile/Photo Observation Report

Street:	W 40th ave	Flow Control:	Not Controlled
City:	Hobart, IN	Year Renewed:	
Location:	Other	Tape/Media #:	
Purpose:	Not Known	Dia/Height:	10"
Use:	Sanitary	Material:	VCP
Drain Area:	NA	Lining:	
Category:	NA		
Comment:

Location Details:		Direction of Survey:	Downstream
US MH:	M-503-050	DS MH:	M-503-049
		Total Length Surveyed (ft):	40.2

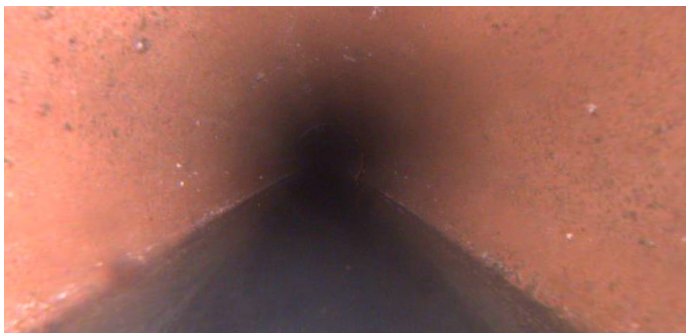
Code: **AMH**
Description: **Manhole**

Distance (ft): **.0**
Structural Grade: **0**
O&M Grade: **0**
Clock Start/From:
Clock To:
1st Value:
2nd Value:
Value Percent:
Continuous Index:
Within 8" of Joint: **NO**
Remarks: **M-503-050**

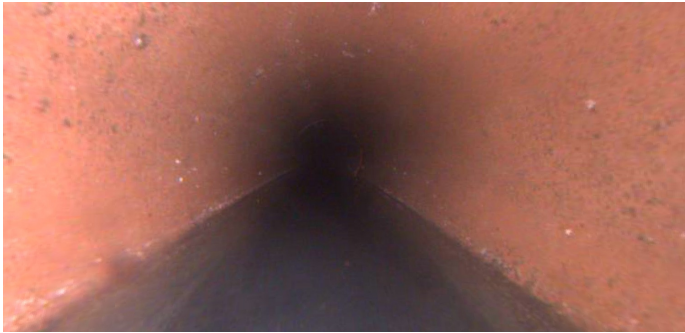
Code:	MWL
Description:	Water Level

Distance (ft):	.0
Structural Grade:	0
O&M Grade:	0
Clock Start/From:	
Clock To:	
1st Value:	
2nd Value:	
Value Percent:	20.000
Continuous Index:	
Within 8" of Joint:	NO
Remarks:

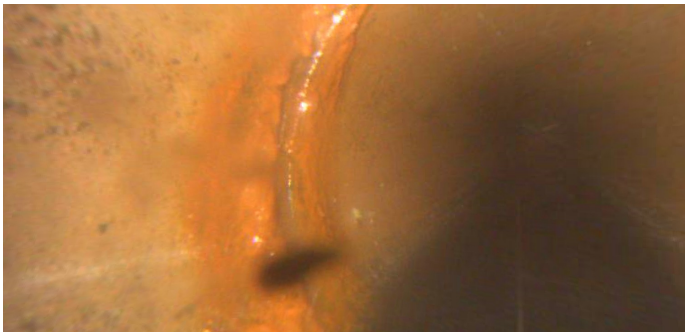
Code:	IW
Description:	Infil Weeper

Distance (ft):	5.1
Structural Grade:	0
O&M Grade:	2
Clock Start/From:	1
Clock To:	4
1st Value:	
2nd Value:	
Value Percent:	
Continuous Index:	
Within 8" of Joint:	YES
Remarks:

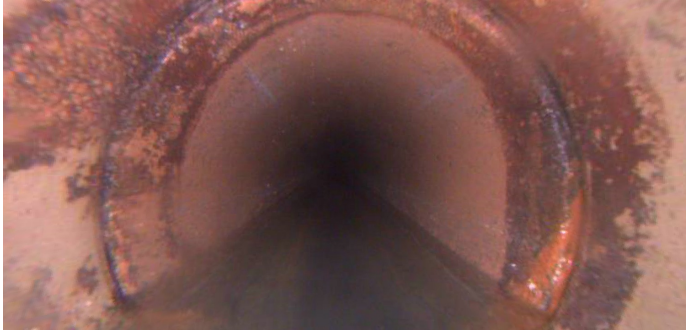
Code: **IW**
Description: **Infil Weeper**

Distance (ft): **9.2**
Structural Grade: **0**
O&M Grade: **2**
Clock Start/From: **8**
Clock To: **4**
1st Value:
2nd Value:
Value Percent:
Continuous Index:
Within 8" of Joint: **YES**
Remarks:

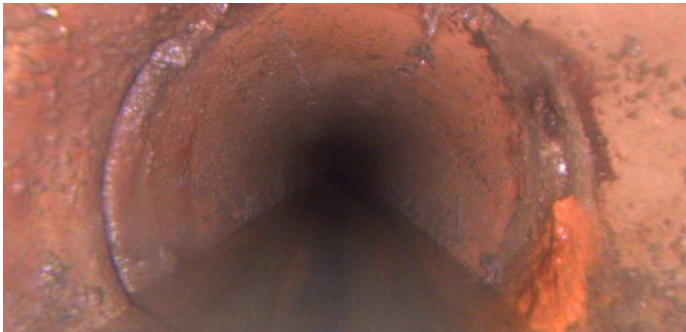
Code: **IW**
Description: **Infil Weeper**

Distance (ft): **19.5**
Structural Grade: **0**
O&M Grade: **2**
Clock Start/From: **8**
Clock To: **4**
1st Value:
2nd Value:
Value Percent:
Continuous Index:
Within 8" of Joint: **YES**
Remarks:

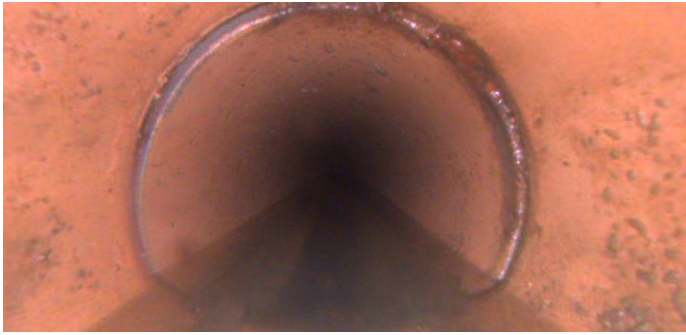
Code: **IW**
Description: **Infil Weeper**

Distance (ft): **24.6**
Structural Grade: **0**
O&M Grade: **2**
Clock Start/From: **12**
Clock To: **4**
1st Value:
2nd Value:
Value Percent:
Continuous Index:
Within 8" of Joint: **YES**
Remarks:

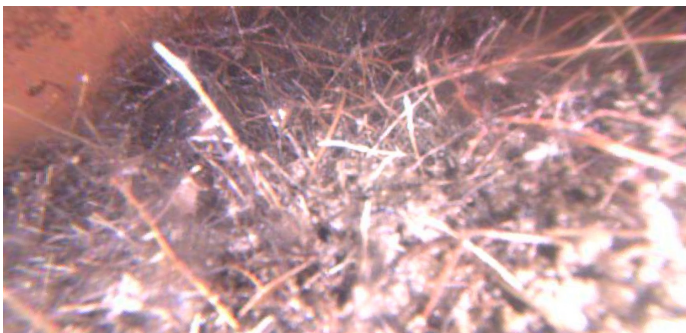
Code: **RBB**
Description: **Roots Ball Barrel**

Distance (ft): **40.2**
Structural Grade: **0**
O&M Grade: **5**
Clock Start/From: **12**
Clock To: **12**
1st Value:
2nd Value:
Value Percent: **100.000**
Continuous Index:
Within 8" of Joint: **NO**
Remarks:

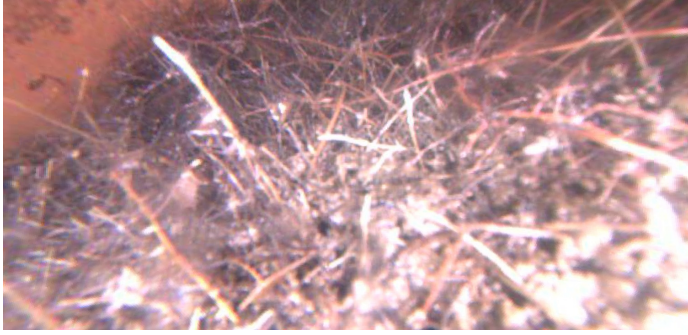
Code:	MSA
Description:	Abandoned Survey
Distance (ft):	40.2
Structural Grade:	0
O&M Grade:	0
Clock Start/From:	
Clock To:	
1st Value:	
2nd Value:	
Value Percent:	
Continuous Index:	
Within 8" of Joint:	NO
Remarks:	ROOTS
