## Profile/Photo Observation Report

Street:	<b>W 40th ave</b>	Flow Control:	<b>Not Controlled</b>
City:	<b>Hobart, IN</b>	Year Renewed:	
Location:	<b>Other</b>	Tape/Media #:	
Purpose:	<b>Not Known</b>	Dia/Height:	<b>10"</b>
Use:	<b>Sanitary</b>	Material:	<b>VCP</b>
Drain Area:	<b>NA</b>	Lining:	
Category:	<b>NA</b>		
Comment:

Location Details:		Direction of Survey:	<b>Upstream</b>
US MH:	<b>M-503-050</b>	DS MH:	<b>M-503-049</b>
		Total Length Surveyed (ft):	<b>69.7</b>

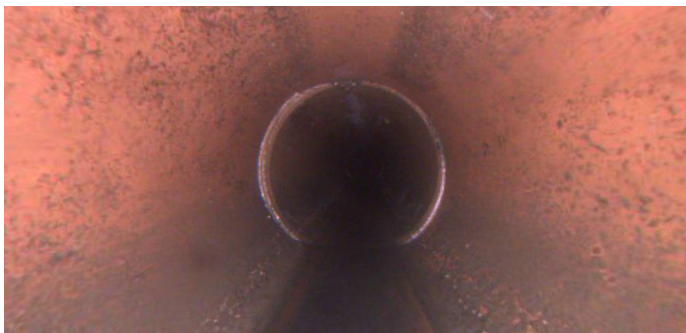
Code: **AMH**  
Description: **Manhole**

Distance (ft): **.0**  
Structural Grade: **0**  
O&M Grade: **0**  
Clock Start/From:  
Clock To:  
1st Value:  
2nd Value:  
Value Percent:  
Continuous Index:  
Within 8" of Joint: **NO**  
Remarks: **M-503-050**

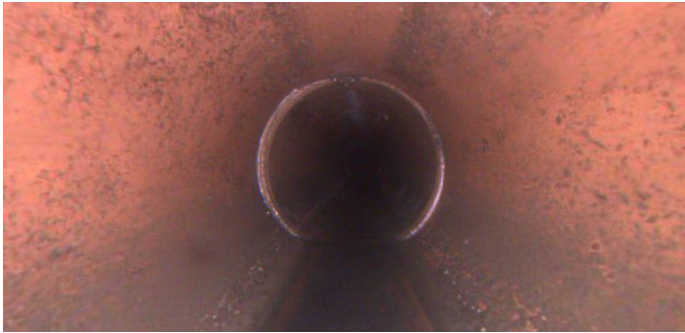
Code:	<b>MWL</b>
Description:	<b>Water Level</b>

Distance (ft):	<b>.0</b>
Structural Grade:	<b>0</b>
O&M Grade:	<b>0</b>
Clock Start/From:	
Clock To:	
1st Value:	
2nd Value:	
Value Percent:	<b>5.000</b>
Continuous Index:	
Within 8" of Joint:	<b>NO</b>
Remarks:

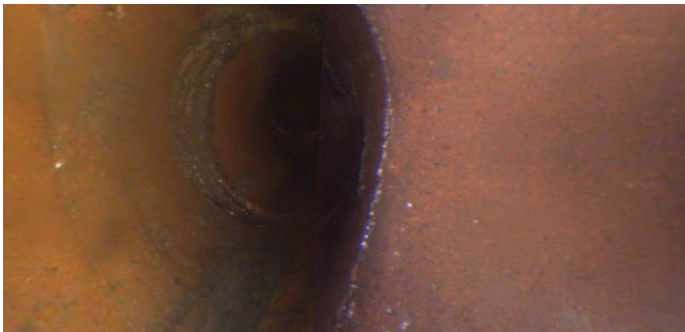
Code:	<b>TF</b>
Description:	<b>Tap Factory</b>

Distance (ft):	<b>13.7</b>
Structural Grade:	<b>0</b>
O&M Grade:	<b>0</b>
Clock Start/From:	<b>9</b>
Clock To:	
1st Value:	<b>4.000</b>
2nd Value:	
Value Percent:	
Continuous Index:	
Within 8" of Joint:	
Remarks:

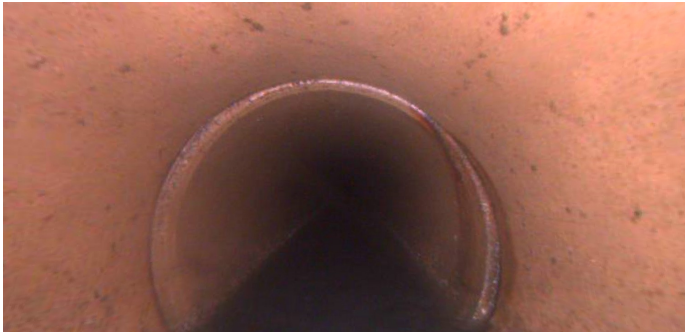
Code: **IW**  
Description: **Infil Weeper**

Distance (ft): **24.8**  
Structural Grade: **0**  
O&M Grade: **2**  
Clock Start/From: **1**  
Clock To: **4**  
1st Value:  
2nd Value:  
Value Percent:  
Continuous Index:  
Within 8" of Joint: **YES**  
Remarks:

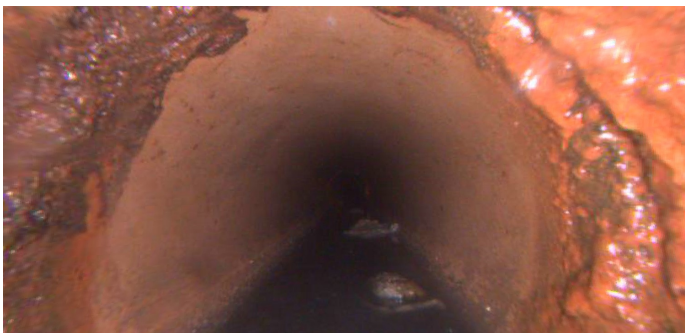
Code: **DAE**  
Description: **Deposits Attached Encrustation**

Distance (ft): **30.4**  
Structural Grade: **0**  
O&M Grade: **2**  
Clock Start/From: **8**  
Clock To: **4**  
1st Value:  
2nd Value:  
Value Percent: **5.000**  
Continuous Index:  
Within 8" of Joint: **YES**  
Remarks:

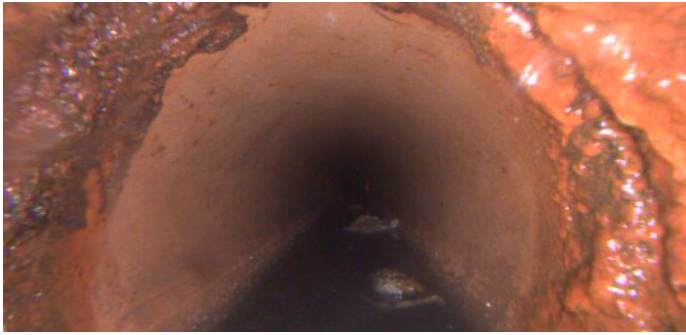
Code: **IW**  
Description: **Infil Weeper**

Distance (ft): **30.4**  
Structural Grade: **0**  
O&M Grade: **2**  
Clock Start/From: **8**  
Clock To: **4**  
1st Value:  
2nd Value:  
Value Percent:  
Continuous Index:  
Within 8" of Joint: **YES**  
Remarks:

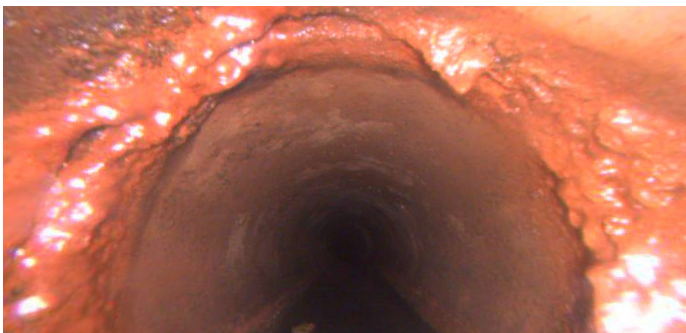
Code: **DAE**  
Description: **Deposits Attached Encrustation**

Distance (ft): **35.6**  
Structural Grade: **0**  
O&M Grade: **2**  
Clock Start/From: **8**  
Clock To: **4**  
1st Value:  
2nd Value:  
Value Percent: **10.000**  
Continuous Index:  
Within 8" of Joint: **YES**  
Remarks:

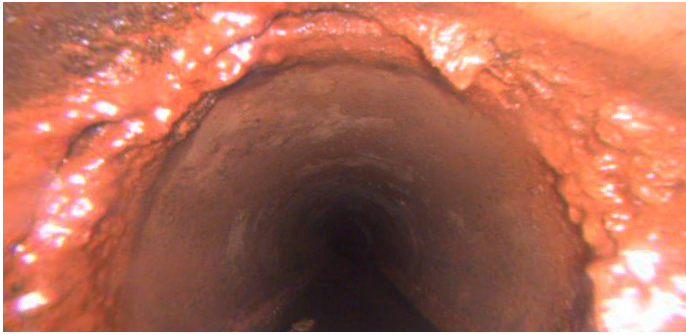
Code: **IW**  
Description: **Infil Weeper**

Distance (ft): **35.6**  
Structural Grade: **0**  
O&M Grade: **2**  
Clock Start/From: **8**  
Clock To: **4**  
1st Value:  
2nd Value:  
Value Percent:  
Continuous Index:  
Within 8" of Joint: **YES**  
Remarks:

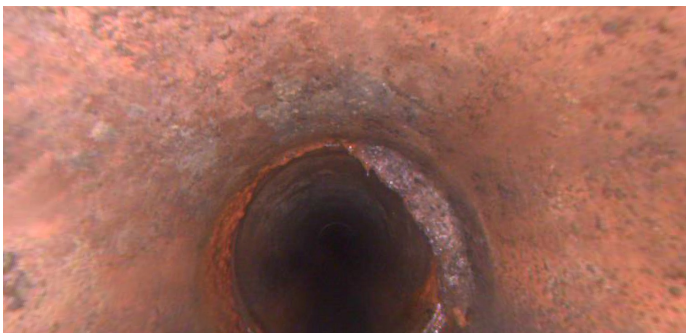
Code: **ID**  
Description: **Infil Dripper**

Distance (ft): **40.1**  
Structural Grade: **0**  
O&M Grade: **3**  
Clock Start/From: **12**  
Clock To:  
1st Value:  
2nd Value:  
Value Percent:  
Continuous Index:  
Within 8" of Joint: **YES**  
Remarks:

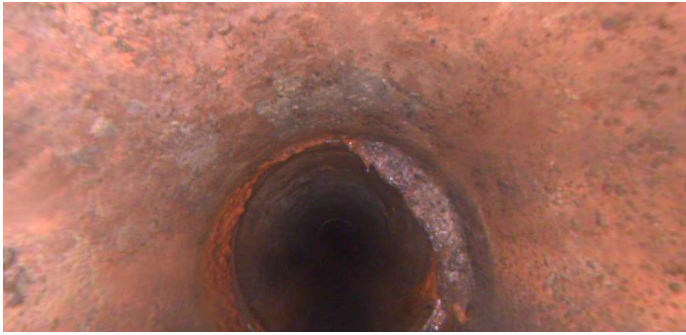
Code: **DAE**  
Description: **Deposits Attached Encrustation**

Distance (ft): **40.1**  
Structural Grade: **0**  
O&M Grade: **2**  
Clock Start/From: **8**  
Clock To: **4**  
1st Value:  
2nd Value:  
Value Percent: **10.000**  
Continuous Index:  
Within 8" of Joint: **YES**  
Remarks:

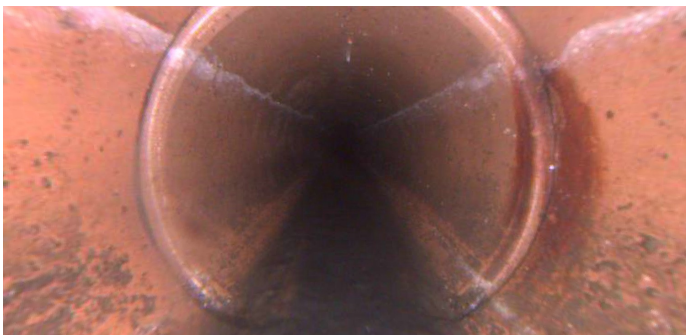
Code: **IS**  
Description: **Infil Stain**

Distance (ft): **51.1**  
Structural Grade: **0**  
O&M Grade: **0**  
Clock Start/From: **2**  
Clock To: **4**  
1st Value:  
2nd Value:  
Value Percent:  
Continuous Index:  
Within 8" of Joint: **YES**  
Remarks:

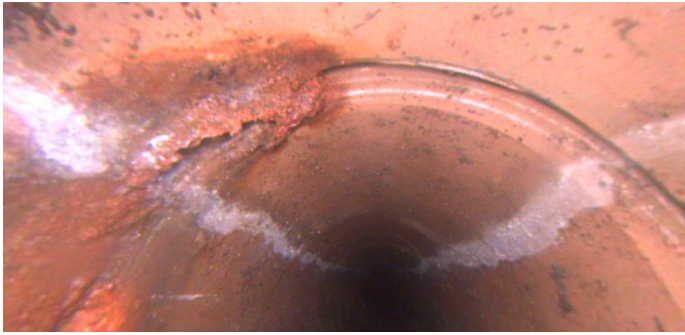
Code: **DAE**  
Description: **Deposits Attached Encrustation**

Distance (ft): **56.5**  
Structural Grade: **0**  
O&M Grade: **2**  
Clock Start/From: **8**  
Clock To: **11**  
1st Value:  
2nd Value:  
Value Percent: **5.000**  
Continuous Index:  
Within 8" of Joint: **YES**  
Remarks:

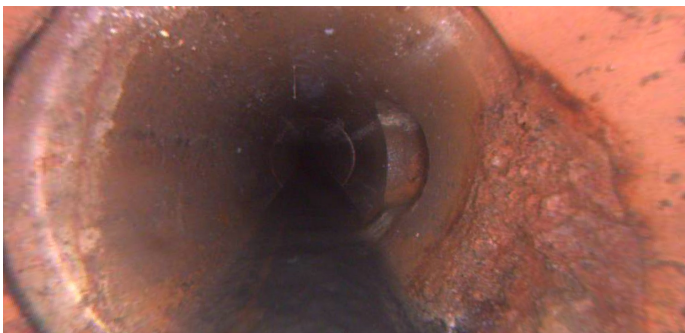
Code: **DAE**  
Description: **Deposits Attached Encrustation**

Distance (ft): **61.7**  
Structural Grade: **0**  
O&M Grade: **2**  
Clock Start/From: **2**  
Clock To: **4**  
1st Value:  
2nd Value:  
Value Percent: **5.000**  
Continuous Index:  
Within 8" of Joint: **YES**  
Remarks:

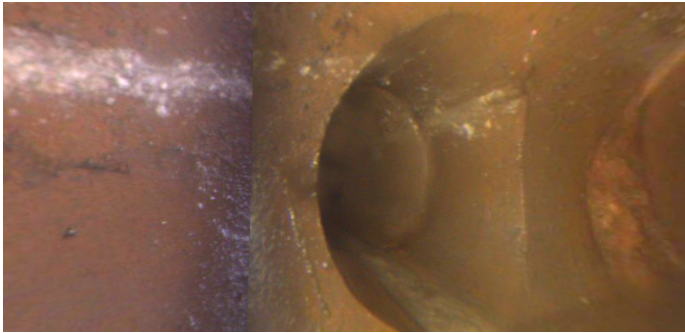
Code: **TF**  
Description: **Tap Factory**

Distance (ft): **63.2**  
Structural Grade: **0**  
O&M Grade: **0**  
Clock Start/From: **3**  
Clock To:  
1st Value: **4.000**  
2nd Value:  
Value Percent:  
Continuous Index:  
Within 8" of Joint:  
Remarks:

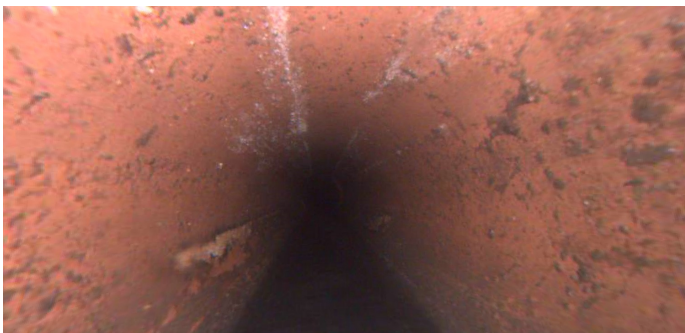
Code: **MSA**  
Description: **Abandoned Survey**

Distance (ft): **69.7**  
Structural Grade: **0**  
O&M Grade: **0**  
Clock Start/From:  
Clock To:  
1st Value:  
2nd Value:  
Value Percent:  
Continuous Index:  
Within 8" of Joint: **NO**  
Remarks: **debris under water**
