Profile/Photo Observation Report

Street:	N COLORADO ST	Flow Control:	Not Controlled
City:	Hobart, IN	Year Renewed:	
Location:	Other	Tape/Media #:	
Purpose:	Not Known	Dia/Height:	10"
Use:	Sanitary	Material:	VCP
Drain Area:	NA	Lining:	
Category:	NA		
Comment:

Location Details:		Direction of Survey:	Downstream
US MH:	M-503-051	DS MH:	M-503-050
		Total Length Surveyed (ft):	117.5

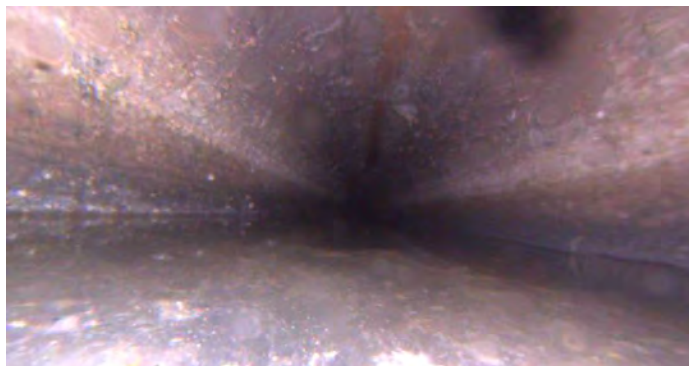
Code: **AMH**
 Description: **Manhole**

Distance (ft): **.0**
 Structural Grade: **0**
 O&M Grade: **0**
 Clock Start/From:
 Clock To:
 1st Value:
 2nd Value:
 Value Percent:
 Continuous Index:
 Within 8" of Joint: **NO**
 Remarks: **M-503-051**

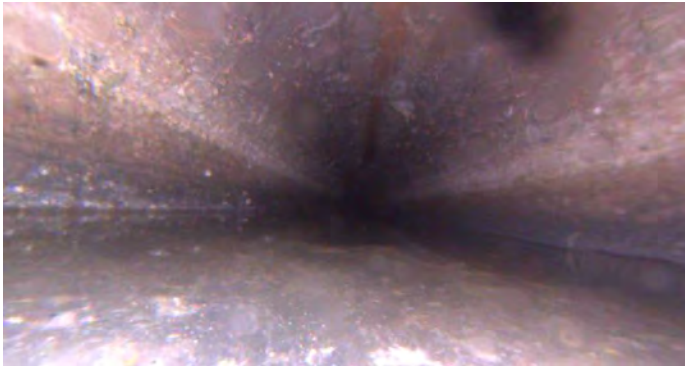
Code:	MWL
Description:	Water Level

Distance (ft):	.0
Structural Grade:	0
O&M Grade:	0
Clock Start/From:	
Clock To:	
1st Value:	
2nd Value:	
Value Percent:	10.000
Continuous Index:	
Within 8" of Joint:	NO
Remarks:

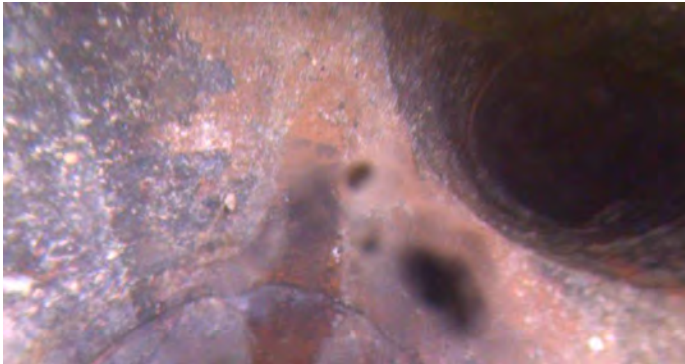
Code:	TF
Description:	Tap Factory

Distance (ft):	15.7
Structural Grade:	0
O&M Grade:	0
Clock Start/From:	2
Clock To:	
1st Value:	4.000
2nd Value:	
Value Percent:	
Continuous Index:	
Within 8" of Joint:	
Remarks:

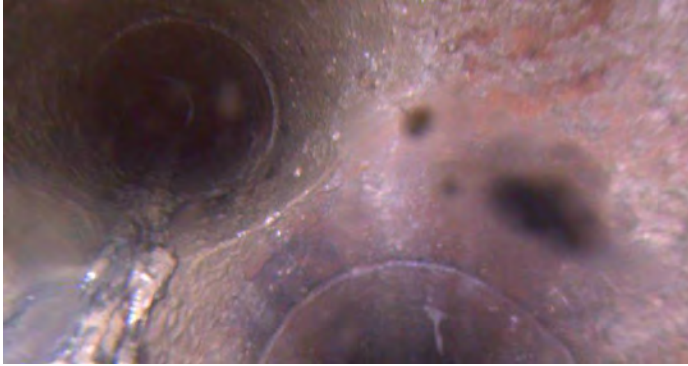
Code: **TF**
Description: **Tap Factory**

Distance (ft): **27.6**
Structural Grade: **0**
O&M Grade: **0**
Clock Start/From: **10**
Clock To:
1st Value: **4.000**
2nd Value:
Value Percent:
Continuous Index:
Within 8" of Joint:
Remarks:

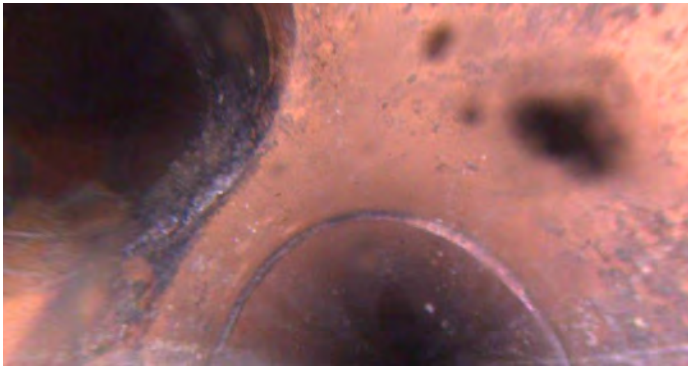
Code: **TF**
Description: **Tap Factory**

Distance (ft): **74.5**
Structural Grade: **0**
O&M Grade: **0**
Clock Start/From: **10**
Clock To:
1st Value: **4.000**
2nd Value:
Value Percent:
Continuous Index:
Within 8" of Joint:
Remarks:

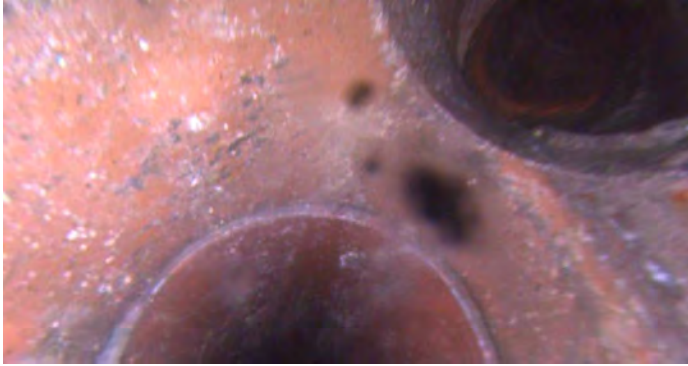
Code: **TF**
Description: **Tap Factory**

Distance (ft): **91.7**
Structural Grade: **0**
O&M Grade: **0**
Clock Start/From: **2**
Clock To:
1st Value: **4.000**
2nd Value:
Value Percent:
Continuous Index:
Within 8" of Joint:
Remarks:

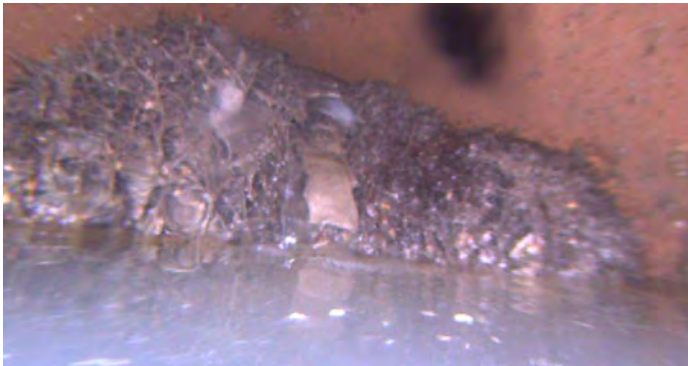
Code: **RBB**
Description: **Roots Ball Barrel**

Distance (ft): **116.7**
Structural Grade: **0**
O&M Grade: **5**
Clock Start/From: **9**
Clock To: **4**
1st Value:
2nd Value:
Value Percent: **70.000**
Continuous Index:
Within 8" of Joint: **NO**
Remarks:
