Profile/Photo Observation Report

Street:	N GUYER ST	Flow Control:	Not Controlled
City:	Hobart, IN	Year Renewed:	
Location:	Other	Tape/Media #:	
Purpose:	Not Known	Dia/Height:	10"
Use:	Sanitary	Material:	VCP
Drain Area:	NA	Lining:	
Category:	NA		
Comment:

Location Details:		Direction of Survey:	Downstream
US MH:	M-503-053	DS MH:	M-503-054
		Total Length Surveyed (ft):	85.8

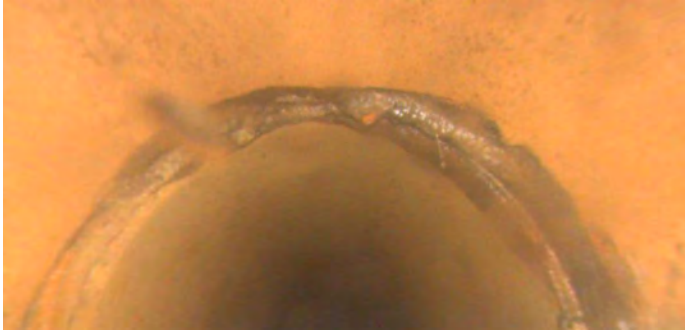
Code: ID
Description: Infil Dripper

Distance (ft): 45.2
Structural Grade: 0
O&M Grade: 3
Clock Start/From: 12
Clock To:
1st Value:
2nd Value:
Value Percent:
Continuous Index:
Within 8" of Joint: YES
Remarks:

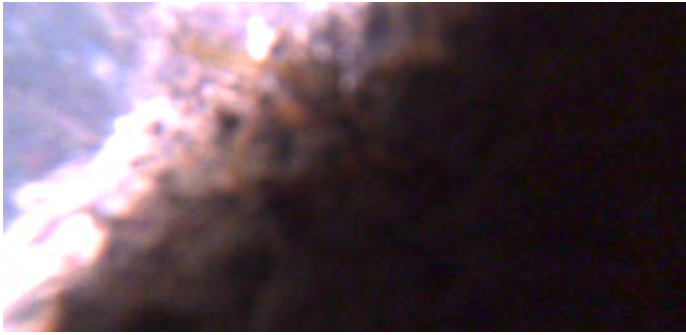
Code: **IW**
Description: **Infil Weeper**

Distance (ft): **85.8**
Structural Grade: **0**
O&M Grade: **2**
Clock Start/From: **8**
Clock To: **4**
1st Value:
2nd Value:
Value Percent:
Continuous Index: **F01**
Within 8" of Joint: **YES**
Remarks:

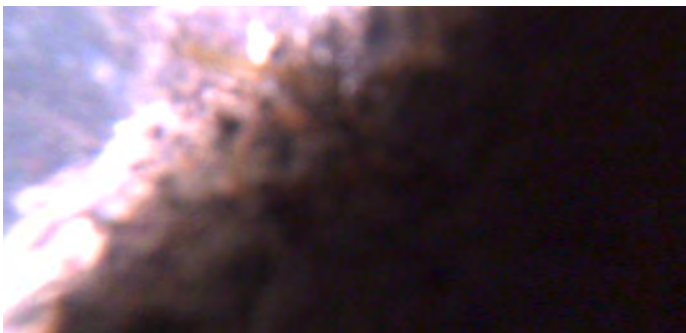
Code: **MSA**
Description: **Abandoned Survey**

Distance (ft): **85.8**
Structural Grade: **0**
O&M Grade: **0**
Clock Start/From:
Clock To:
1st Value:
2nd Value:
Value Percent:
Continuous Index:
Within 8" of Joint: **NO**
Remarks: **MCU**
