Profile/Photo Observation Report

Date:	04/14/2018	Weather:		Coding:	PACP 6.0
Pipe Length (ft):	267.4	Owner:	NA	Pre Clean:	Not Known
P.O.#:		Surveyor:	Jen Costello	PSR:	P-503-054-055
Customer:		Clean Date:	01/01/1900	Shape:	C

Location Details:		Direction of Survey:	Downstream
US MH:	M-503-054	DS MH:	M-503-055
		Total Length Surveyed (ft):	54.8

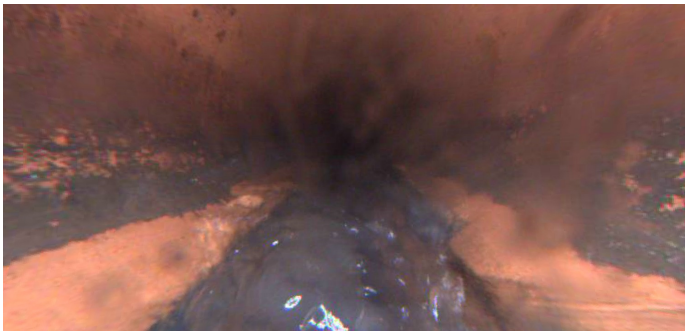
Code: **AMH**
Description: **Manhole**

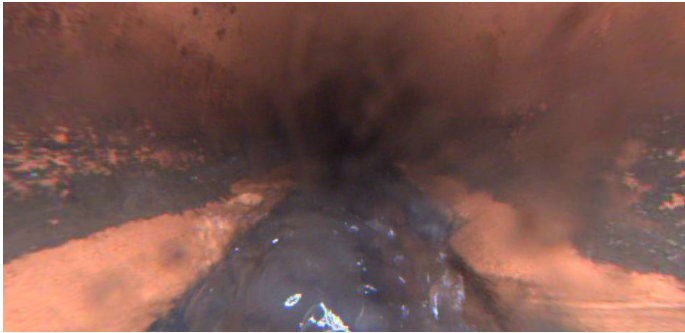
Code:	MWL
Description:	Water Level

Distance (ft):	.0
Structural Grade:	0
O&M Grade:	0
Clock Start/From:	
Clock To:	
1st Value:	
2nd Value:	
Value Percent:	10.000
Continuous Index:	
Within 8" of Joint:	NO
Remarks:

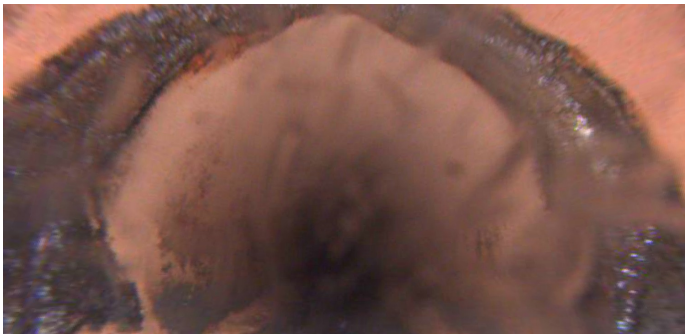
Code:	IW
Description:	Infil Weeper

Distance (ft):	3.3
Structural Grade:	0
O&M Grade:	2
Clock Start/From:	8
Clock To:	4
1st Value:	
2nd Value:	
Value Percent:	
Continuous Index:	
Within 8" of Joint:	YES
Remarks:

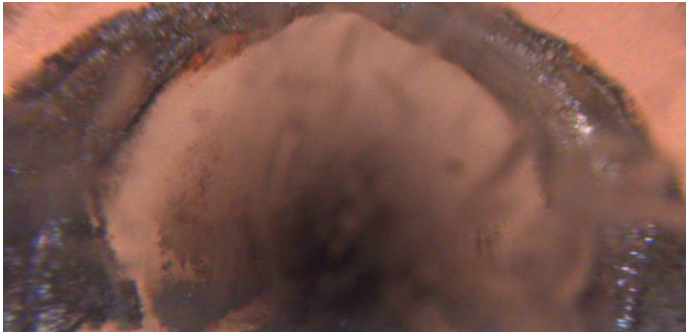
Code: **DAE**
Description: **Deposits Attached Encrustation**

Distance (ft): **3.3**
Structural Grade: **0**
O&M Grade: **2**
Clock Start/From: **8**
Clock To: **4**
1st Value:
2nd Value:
Value Percent: **5.000**
Continuous Index:
Within 8" of Joint: **YES**
Remarks:

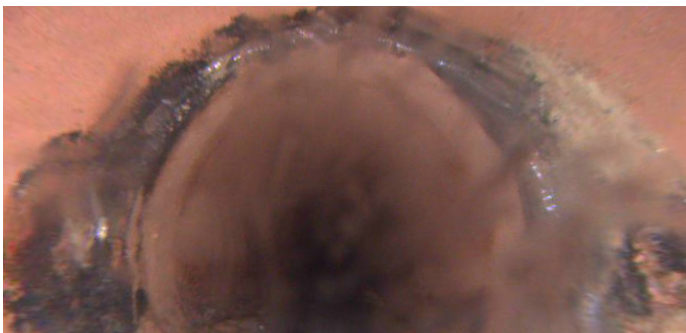
Code: **IW**
Description: **Infil Weeper**

Distance (ft): **18.2**
Structural Grade: **0**
O&M Grade: **2**
Clock Start/From: **8**
Clock To: **4**
1st Value:
2nd Value:
Value Percent:
Continuous Index: **S01**
Within 8" of Joint: **YES**
Remarks:

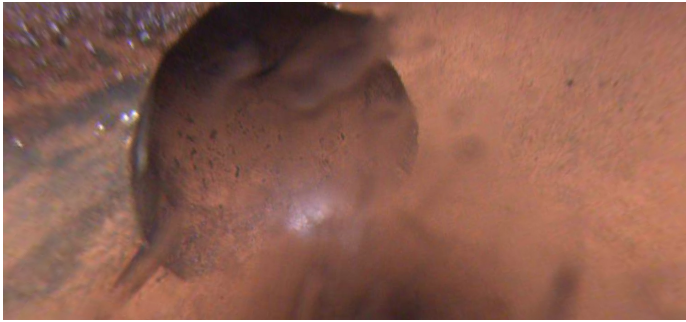
Code: **TFA**
Description: **Tap Factory Active**

Distance (ft): **34.2**
Structural Grade: **0**
O&M Grade: **0**
Clock Start/From: **11**
Clock To:
1st Value: **4.000**
2nd Value:
Value Percent:
Continuous Index:
Within 8" of Joint:
Remarks:

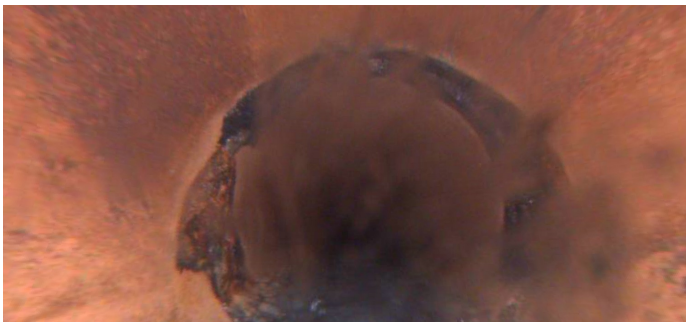
Code: **DAE**
Description: **Deposits Attached Encrustation**

Distance (ft): **35.3**
Structural Grade: **0**
O&M Grade: **2**
Clock Start/From: **8**
Clock To: **4**
1st Value:
2nd Value:
Value Percent: **5.000**
Continuous Index:
Within 8" of Joint: **YES**
Remarks:

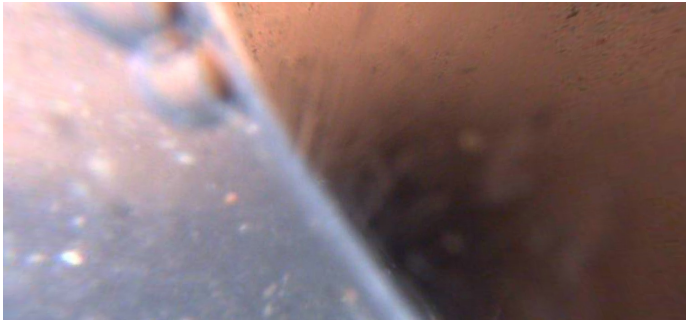
Code: **MWL**
Description: **Water Level**

Distance (ft): **54.8**
Structural Grade: **0**
O&M Grade: **0**
Clock Start/From:
Clock To:
1st Value:
2nd Value:
Value Percent: **40.000**
Continuous Index:
Within 8" of Joint: **NO**
Remarks:

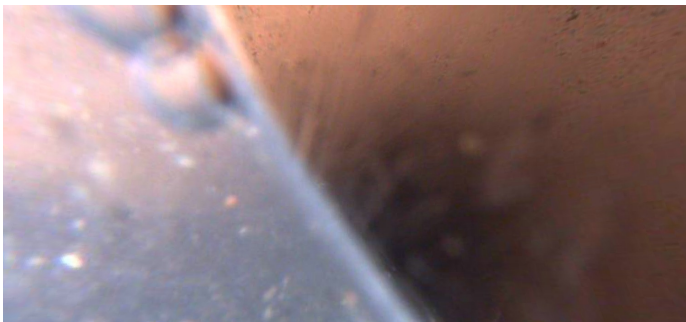
Code: **MSA**
Description: **Abandoned Survey**

Distance (ft): **54.8**
Structural Grade: **0**
O&M Grade: **0**
Clock Start/From:
Clock To:
1st Value:
2nd Value:
Value Percent:
Continuous Index:
Within 8" of Joint: **NO**
Remarks: **overturned**

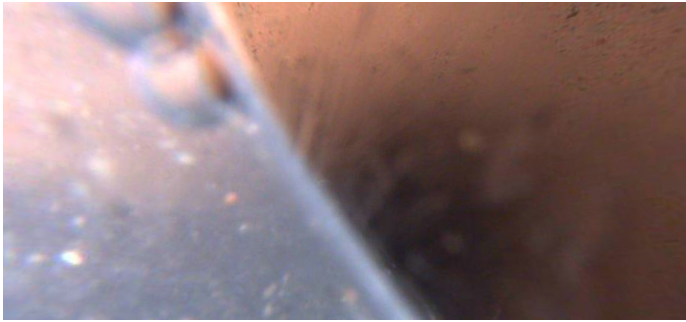
Code:	IW
Description:	Infil Weeper
Distance (ft):	54.8
Structural Grade:	0
O&M Grade:	2
Clock Start/From:	8
Clock To:	4
1st Value:	
2nd Value:	
Value Percent:	
Continuous Index:	F01
Within 8" of Joint:	YES
Remarks:
