Profile/Photo Observation Report

Date:	09/17/2021	Weather:		Coding:	PACP 7.0
Pipe Length (ft):	251.1	Owner:	City of Hobart	Pre Clean:	Heavy Cleaning
P.O.#:	YES502259	Surveyor:	S. Bucklin	PSR:	P-503-055-056
Customer:	City of Hobart	Clean Date:	08/24/2021	Shape:	C

Street:	North Guyer Street	Flow Control:	Not Controlled
City:	Hobart, IN	Year Renewed:	
Location:	Alley	Tape/Media #:	
Purpose:	Routine Assessment	Dia/Height:	10"
Use:	Sanitary Sewage Pipe	Material:	VCP
Drain Area:		Lining:	None
Category:	NA		
Comment:			
Location Details:		Direction of Survey:	Downstream
US MH:	M-503-055	DS MH:	M-503-056
		Total Length Surveyed (ft):	251.1

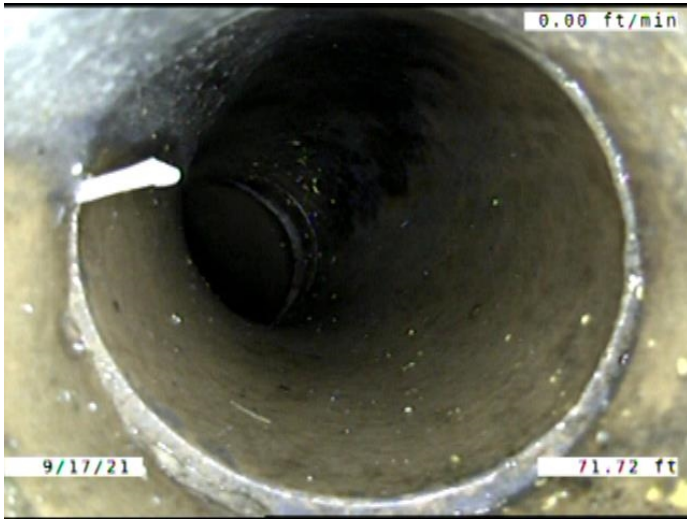
Code: **TF**
Description: **Tap Factory**

Distance (ft): **71.7**
Structural Grade: **0**
O&M Grade: **0**
Clock Start/From: **11**
Clock To:
1st Value: **4.000**
2nd Value:
Value Percent:
Continuous Index:
Within 8" of Joint: **YES**
Remarks:

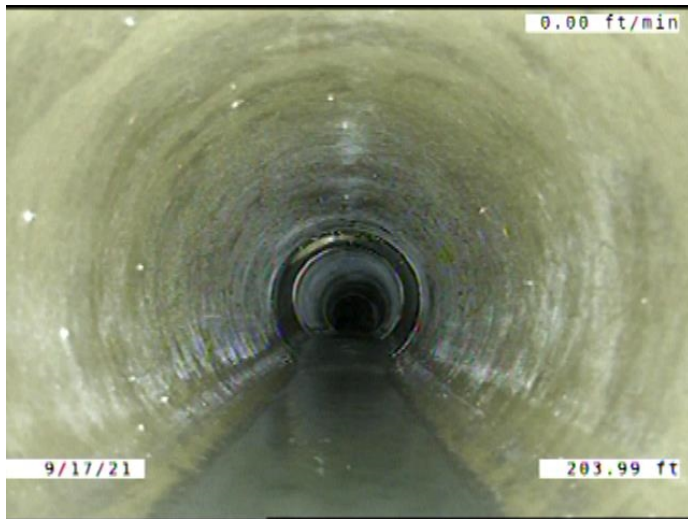
Code: **MWL**
 Description: **Miscellaneous Water Level**

Distance (ft): **204.0**
 Structural Grade: **0**
 O&M Grade: **0**
 Clock Start/From:
 Clock To:
 1st Value:
 2nd Value:
 Value Percent: **5.000**
 Continuous Index:
 Within 8" of Joint: **NO**
 Remarks:

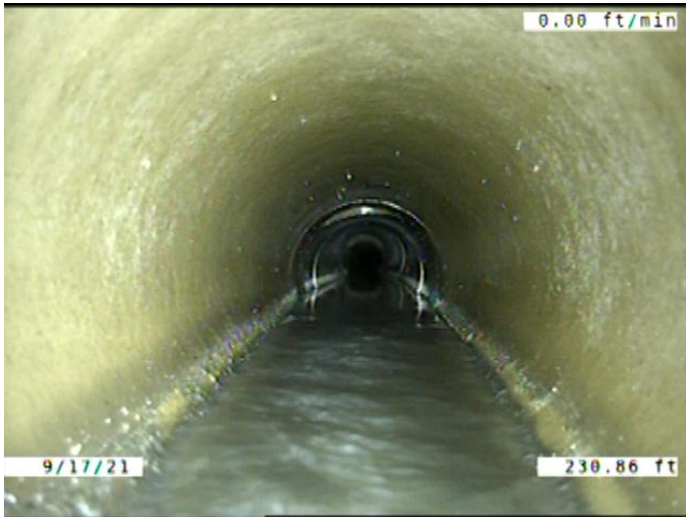
Code: **MWLS**
Description: **Miscellaneous Water Level Sag**

Distance (ft): **230.9**
Structural Grade: **2**
O&M Grade: **0**
Clock Start/From:
Clock To:
1st Value:
2nd Value:
Value Percent: **10.000**
Continuous Index: **S04**
Within 8" of Joint: **NO**
Remarks:

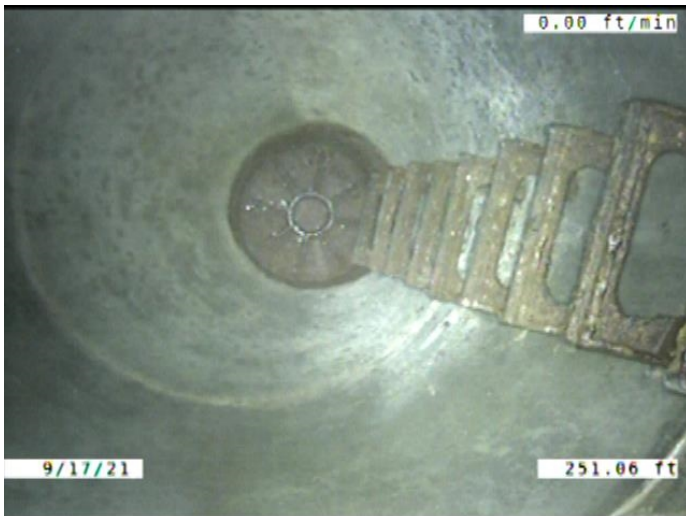
Code: **AMH**
 Description: **Manhole**

Distance (ft): **251.1**
 Structural Grade: **0**
 O&M Grade: **0**
 Clock Start/From:
 Clock To:
 1st Value:
 2nd Value:
 Value Percent:
 Continuous Index:
 Within 8" of Joint: **NO**
 Remarks: **M-503-056**
