Profile/Photo Observation Report

Date:	04/13/2018	Weather:		Coding:	PACP 6.0
Pipe Length (ft):	239.4	Owner:	NA	Pre Clean:	Not Known
P.O.#:		Surveyor:	Jen Costello	PSR:	P-503-056-057
Customer:		Clean Date:	01/01/1900	Shape:	C

Street:	N COLORADO ST	Flow Control:	Not Controlled
City:	Hobart, IN	Year Renewed:	
Location:	Other	Tape/Media #:	
Purpose:	Not Known	Dia/Height:	10"
Use:	Sanitary	Material:	VCP
Drain Area:	NA	Lining:	
Category:	NA		
Comment:

Location Details:		Direction of Survey:	Downstream
US MH:	M-503-056	DS MH:	M-503-057
		Total Length Surveyed (ft):	74.1

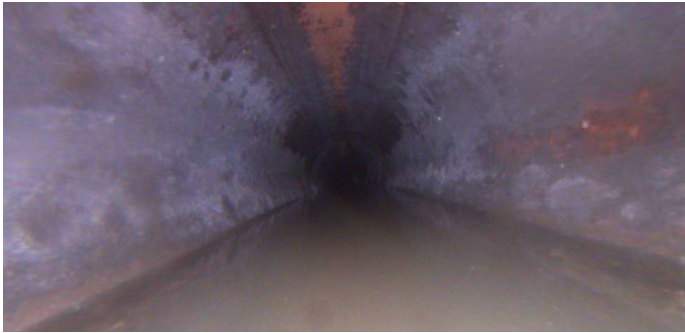
Code:	MWL
Description:	Water Level

Distance (ft):	.0
Structural Grade:	0
O&M Grade:	0
Clock Start/From:	
Clock To:	
1st Value:	
2nd Value:	
Value Percent:	20.000
Continuous Index:	
Within 8" of Joint:	NO
Remarks:

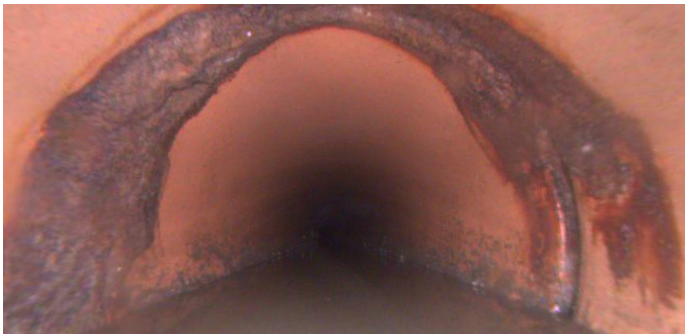
Code:	DAE
Description:	Deposits Attached Encrustation

Distance (ft):	13.8
Structural Grade:	0
O&M Grade:	2
Clock Start/From:	8
Clock To:	4
1st Value:	
2nd Value:	
Value Percent:	5.000
Continuous Index:	
Within 8" of Joint:	YES
Remarks:

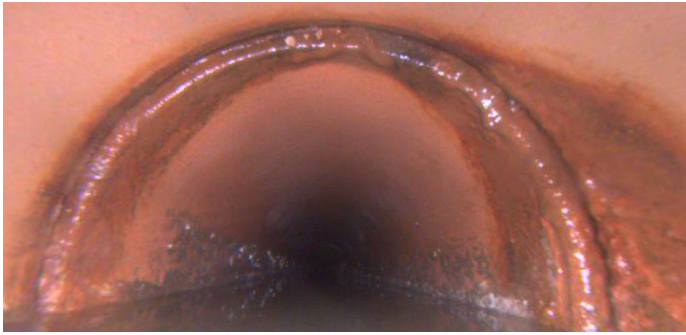
Code: **IW**
Description: **Infil Weeper**

Distance (ft): **19.0**
Structural Grade: **0**
O&M Grade: **2**
Clock Start/From: **8**
Clock To: **4**
1st Value:
2nd Value:
Value Percent:
Continuous Index: **S01**
Within 8" of Joint: **YES**
Remarks:

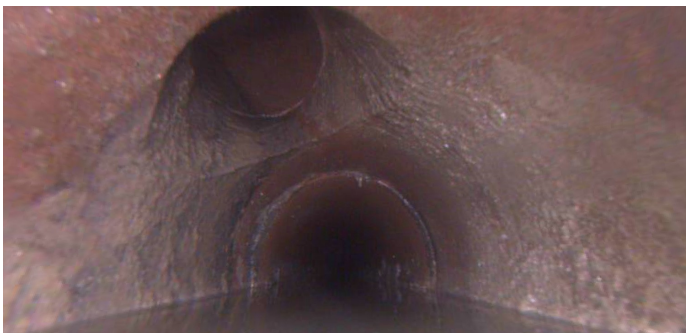
Code: **TF**
Description: **Tap Factory**

Distance (ft): **35.7**
Structural Grade: **0**
O&M Grade: **0**
Clock Start/From: **11**
Clock To:
1st Value: **4.000**
2nd Value:
Value Percent:
Continuous Index:
Within 8" of Joint:
Remarks:

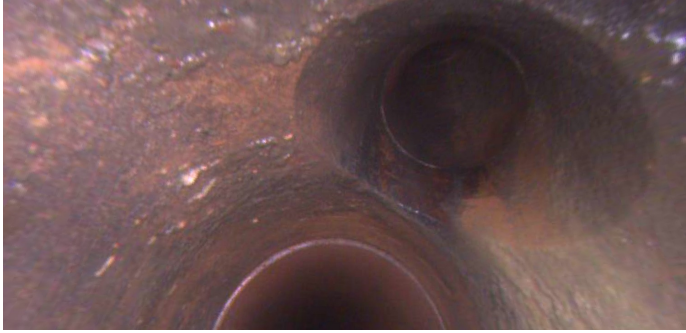
Code: **TF**
Description: **Tap Factory**

Distance (ft): **63.9**
Structural Grade: **0**
O&M Grade: **0**
Clock Start/From: **1**
Clock To:
1st Value: **4.000**
2nd Value:
Value Percent:
Continuous Index:
Within 8" of Joint:
Remarks:

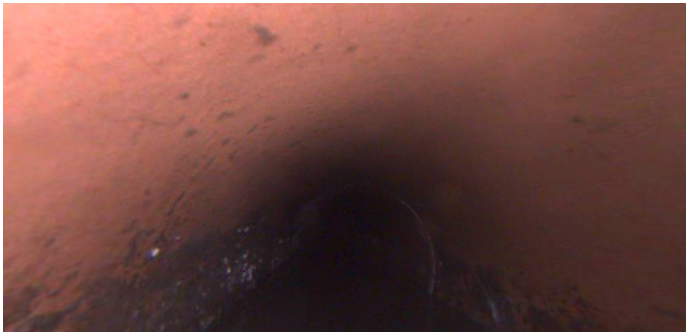
Code: **MSA**
Description: **Abandoned Survey**

Distance (ft): **74.1**
Structural Grade: **0**
O&M Grade: **0**
Clock Start/From:
Clock To:
1st Value:
2nd Value:
Value Percent:
Continuous Index:
Within 8" of Joint: **NO**
Remarks: **debris under water**

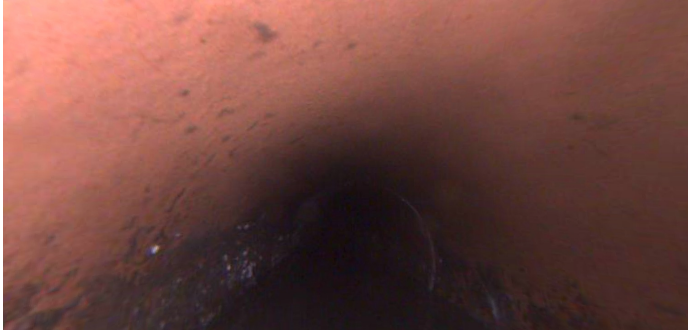
Code:	IW
Description:	Infil Weeper
Distance (ft):	74.1
Structural Grade:	0
O&M Grade:	2
Clock Start/From:	8
Clock To:	4
1st Value:	
2nd Value:	
Value Percent:	
Continuous Index:	F01
Within 8" of Joint:	YES
Remarks:
