Profile/Photo Observation Report

Street:	W 40th ave	Flow Control:	Not Controlled
City:	Hobart, IN	Year Renewed:	
Location:	Other	Tape/Media #:	
Purpose:	Not Known	Dia/Height:	10"
Use:	Sanitary	Material:	VCP
Drain Area:	NA	Lining:	
Category:	NA		
Comment:

Location Details:		Direction of Survey:	Downstream
US MH:	M-503-056	DS MH:	M-503-057
		Total Length Surveyed (ft):	74.1

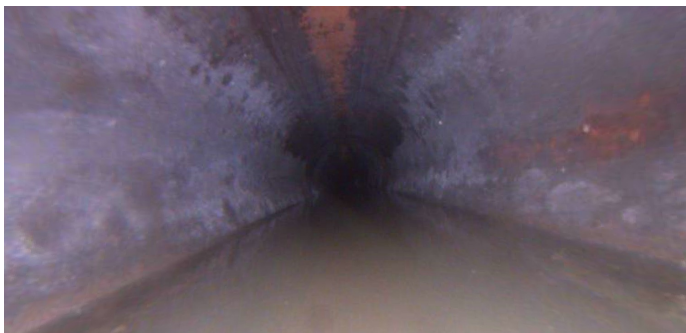
Code: **AMH**
Description: **Manhole**

Distance (ft): **.0**
Structural Grade: **0**
O&M Grade: **0**
Clock Start/From:
Clock To:
1st Value:
2nd Value:
Value Percent:
Continuous Index:
Within 8" of Joint: **NO**
Remarks: **M-503-056**

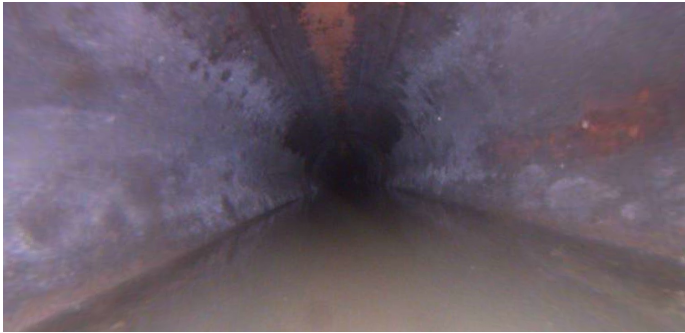
Code:	MWL
Description:	Water Level

Distance (ft):	.0
Structural Grade:	0
O&M Grade:	0
Clock Start/From:	
Clock To:	
1st Value:	
2nd Value:	
Value Percent:	20.000
Continuous Index:	
Within 8" of Joint:	NO
Remarks:

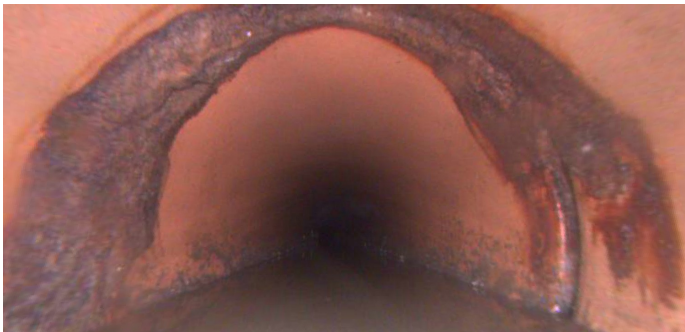
Code:	DAE
Description:	Deposits Attached Encrustation

Distance (ft):	13.8
Structural Grade:	0
O&M Grade:	2
Clock Start/From:	8
Clock To:	4
1st Value:	
2nd Value:	
Value Percent:	5.000
Continuous Index:	
Within 8" of Joint:	YES
Remarks:

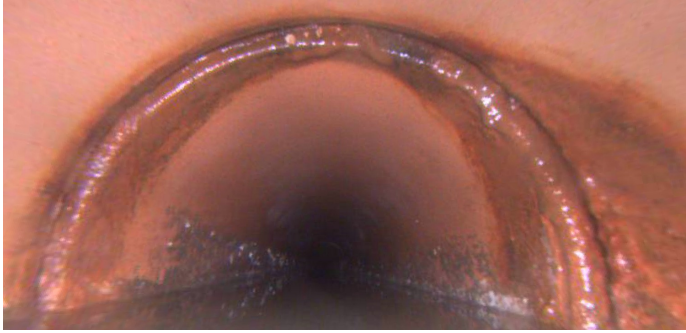
Code: **IW**
Description: **Infil Weeper**

Distance (ft): **19.0**
Structural Grade: **0**
O&M Grade: **2**
Clock Start/From: **8**
Clock To: **4**
1st Value:
2nd Value:
Value Percent:
Continuous Index: **S01**
Within 8" of Joint: **YES**
Remarks:

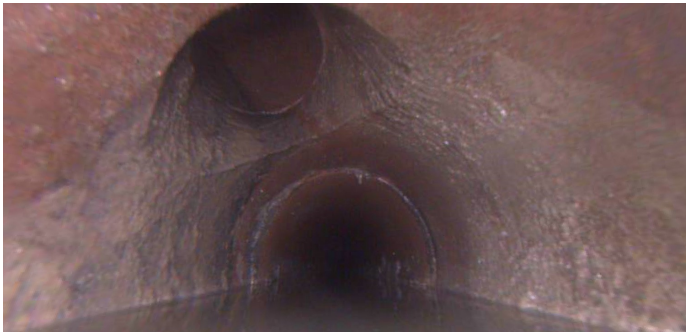
Code: **TF**
Description: **Tap Factory**

Distance (ft): **35.7**
Structural Grade: **0**
O&M Grade: **0**
Clock Start/From: **11**
Clock To:
1st Value: **4.000**
2nd Value:
Value Percent:
Continuous Index:
Within 8" of Joint:
Remarks:

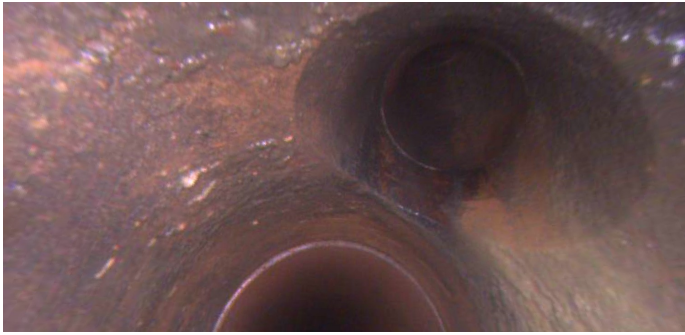
Code: **TF**
Description: **Tap Factory**

Distance (ft): **63.9**
Structural Grade: **0**
O&M Grade: **0**
Clock Start/From: **1**
Clock To:
1st Value: **4.000**
2nd Value:
Value Percent:
Continuous Index:
Within 8" of Joint:
Remarks:

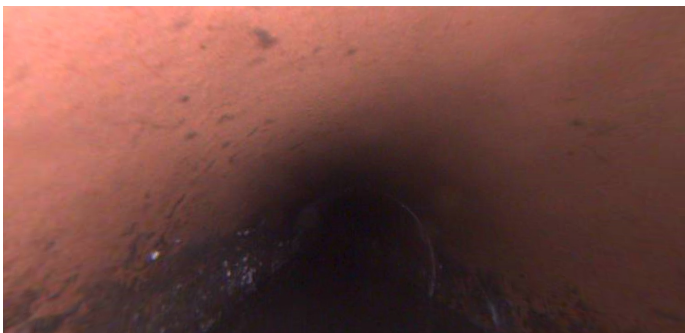
Code: **MSA**
Description: **Abandoned Survey**

Distance (ft): **74.1**
Structural Grade: **0**
O&M Grade: **0**
Clock Start/From:
Clock To:
1st Value:
2nd Value:
Value Percent:
Continuous Index:
Within 8" of Joint: **NO**
Remarks: **debris under water**

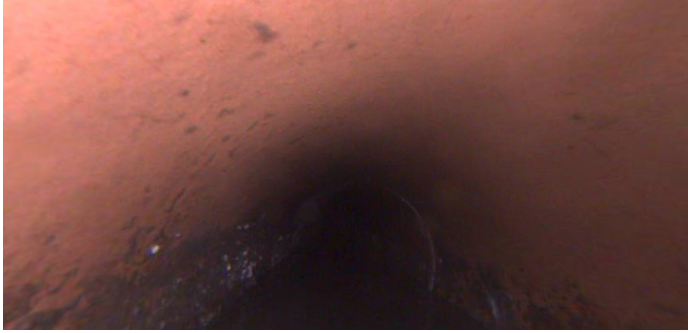
Code:	IW
Description:	Infil Weeper
Distance (ft):	74.1
Structural Grade:	0
O&M Grade:	2
Clock Start/From:	8
Clock To:	4
1st Value:	
2nd Value:	
Value Percent:	
Continuous Index:	F01
Within 8" of Joint:	YES
Remarks:
