## Profile/Photo Observation Report

Date:	<b>09/17/2021</b>	Weather:		Coding:	<b>PACP 7.0</b>
Pipe Length (ft):	<b>289.7</b>	Owner:	<b>City of Hobart</b>	Pre Clean:	<b>Light Cleaning</b>
P.O.#:	<b>YES502259</b>	Surveyor:	<b>S. Bucklin</b>	PSR:	<b>P-503-058-057</b>
Customer:	<b>City of Hobart</b>	Clean Date:	<b>08/24/2021</b>	Shape:	<b>C</b>

Street:	<b>North Colorado Street</b>	Flow Control:	<b>Not Controlled</b>
City:	<b>Hobart, IN</b>	Year Renewed:	
Location:	<b>Alley</b>	Tape/Media #:	
Purpose:	<b>Routine Assessment</b>	Dia/Height:	<b>10"</b>
Use:	<b>Sanitary Sewage Pipe</b>	Material:	<b>VCP</b>
Drain Area:		Lining:	<b>None</b>
Category:	<b>NA</b>		
Comment:

Location Details:		Direction of Survey:	<b>Downstream</b>
US MH:	<b>M-503-057</b>	DS MH:	<b>M-503-058</b>
		Total Length Surveyed (ft):	<b>289.7</b>

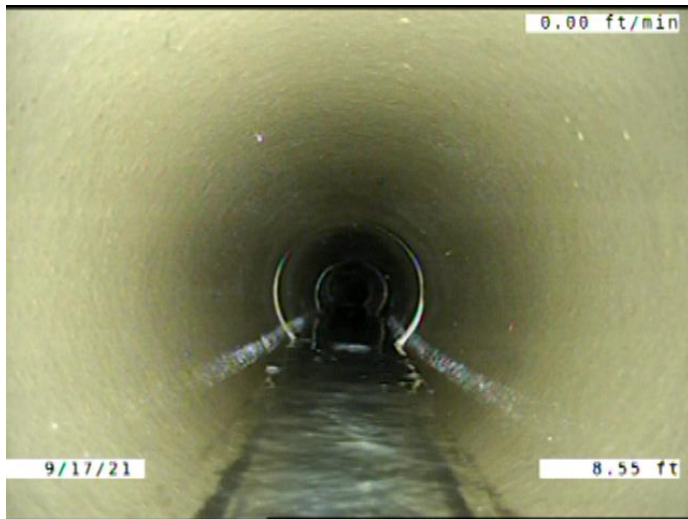
Code: **LD**  
 Description: **Line Down**

Distance (ft): **8.5**  
 Structural Grade: **0**  
 O&M Grade: **1**  
 Clock Start/From:  
 Clock To:  
 1st Value:  
 2nd Value:  
 Value Percent: **5.000**  
 Continuous Index:  
 Within 8" of Joint: **NO**  
 Remarks:

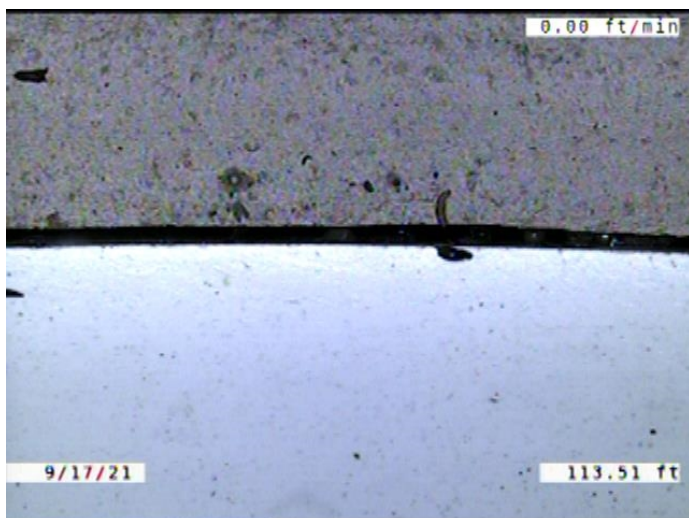
Code: **MMC**  
 Description: **Miscellaneous Material Change**

Distance (ft): **113.5**  
 Structural Grade: **0**  
 O&M Grade: **0**  
 Clock Start/From:  
 Clock To:  
 1st Value:  
 2nd Value:  
 Value Percent:  
 Continuous Index:  
 Within 8" of Joint: **NO**  
 Remarks: **VCP TO PVC**

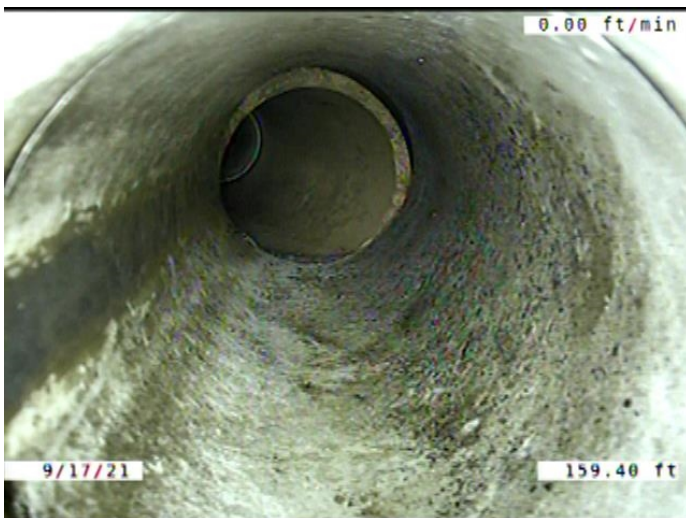
Code: **TF**  
Description: **Tap Factory**

Distance (ft): **159.4**  
Structural Grade: **0**  
O&M Grade: **0**  
Clock Start/From: **10**  
Clock To:  
1st Value: **4.000**  
2nd Value:  
Value Percent:  
Continuous Index:  
Within 8" of Joint: **YES**  
Remarks:

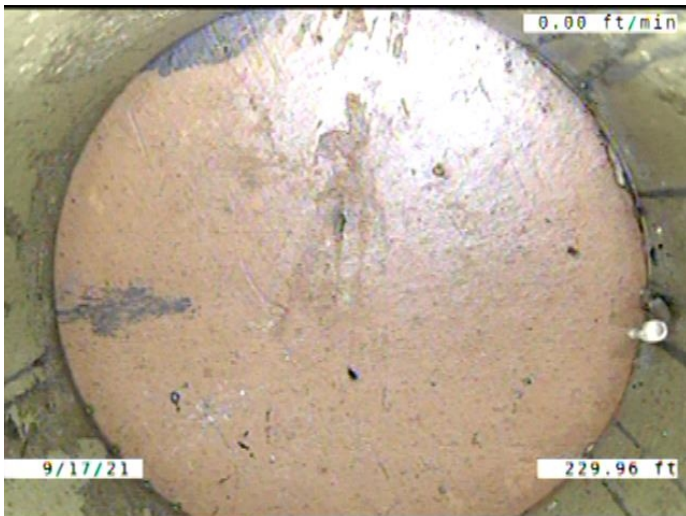
Code: **TFC**  
Description: **Tap Factory Capped**

Distance (ft): **230.0**  
Structural Grade: **0**  
O&M Grade: **0**  
Clock Start/From: **1**  
Clock To:  
1st Value: **4.000**  
2nd Value:  
Value Percent:  
Continuous Index:  
Within 8" of Joint: **YES**  
Remarks:

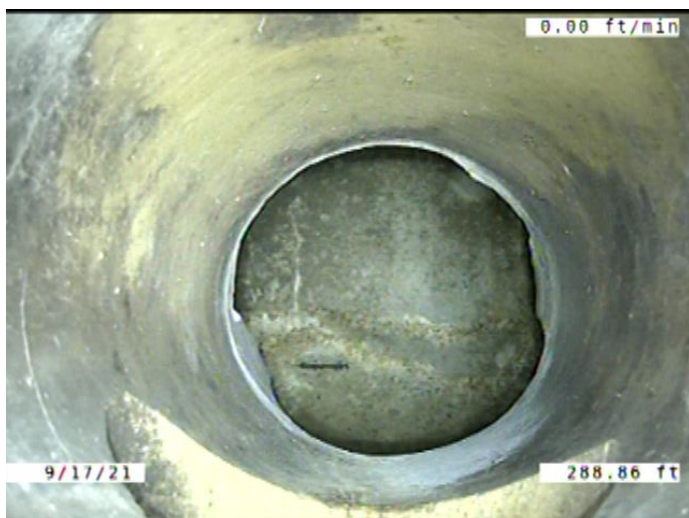
Code: **DSF**  
 Description: **Deposits Settled Fine**

Distance (ft): **288.9**  
 Structural Grade: **0**  
 O&M Grade: **2**  
 Clock Start/From: **5**  
 Clock To: **7**  
 1st Value:  
 2nd Value:  
 Value Percent: **5.000**  
 Continuous Index: **F02**  
 Within 8" of Joint: **YES**  
 Remarks:

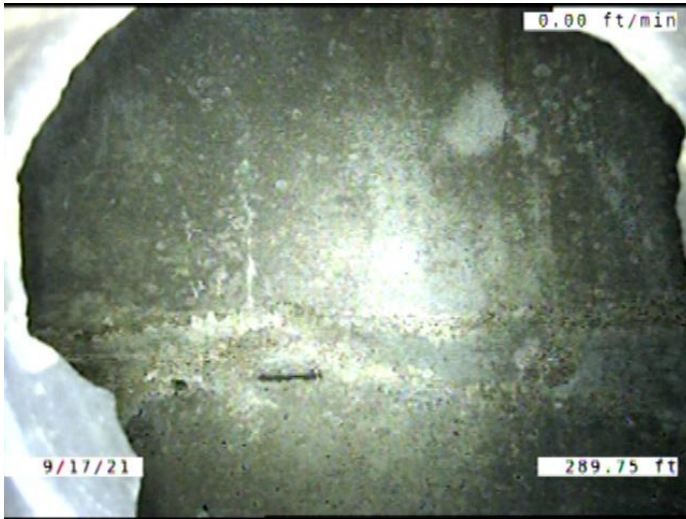
Code:	<b>AMH</b>
Description:	<b>Manhole</b>
Distance (ft):	<b>289.7</b>
Structural Grade:	<b>0</b>
O&M Grade:	<b>0</b>
Clock Start/From:	
Clock To:	
1st Value:	
2nd Value:	
Value Percent:	
Continuous Index:	
Within 8" of Joint:	<b>NO</b>
Remarks:	<b>M-503-058</b>
