Profile/Photo Observation Report

Street:	W 40th ave	Flow Control:	Not Controlled
City:	Hobart, IN	Year Renewed:	
Location:	Other	Tape/Media #:	
Purpose:	Not Known	Dia/Height:	10"
Use:	Sanitary	Material:	VCP
Drain Area:	NA	Lining:	
Category:	NA		
Comment:

Location Details:		Direction of Survey:	Downstream
US MH:	M-503-057	DS MH:	M-503-074
		Total Length Surveyed (ft):	12.6

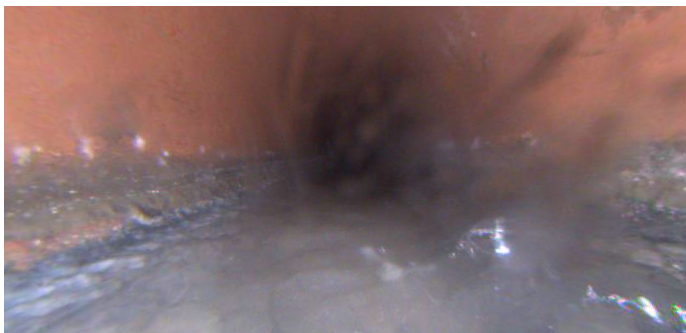
Code: **AMH**
Description: **Manhole**

Distance (ft): **.0**
Structural Grade: **0**
O&M Grade: **0**
Clock Start/From:
Clock To:
1st Value:
2nd Value:
Value Percent:
Continuous Index:
Within 8" of Joint: **NO**
Remarks: **M-503-057**

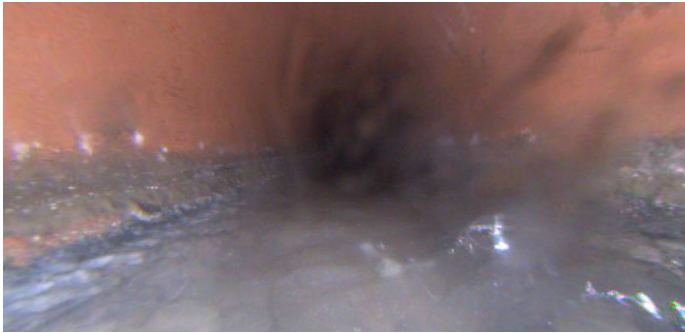
Code:	MWL
Description:	Water Level

Distance (ft):	.0
Structural Grade:	0
O&M Grade:	0
Clock Start/From:	
Clock To:	
1st Value:	
2nd Value:	
Value Percent:	20.000
Continuous Index:	
Within 8" of Joint:	NO
Remarks:

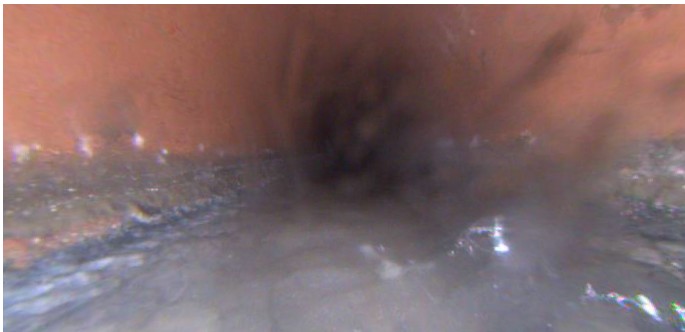
Code:	DAGS
Description:	Deposits Attached Grease

Distance (ft):	.0
Structural Grade:	0
O&M Grade:	2
Clock Start/From:	8
Clock To:	4
1st Value:	
2nd Value:	
Value Percent:	5.000
Continuous Index:	S01
Within 8" of Joint:	NO
Remarks:

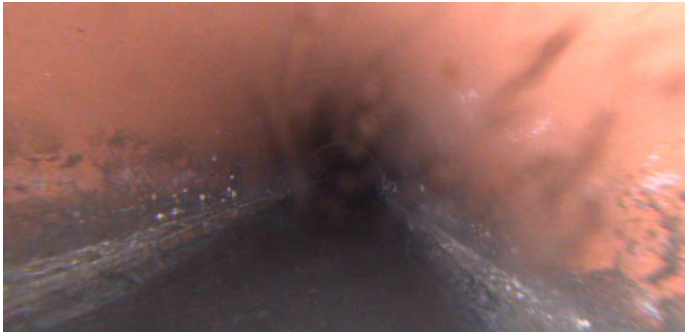
Code: **MSA**
Description: **Abandoned Survey**

Distance (ft): **12.6**
Structural Grade: **0**
O&M Grade: **0**
Clock Start/From:
Clock To:
1st Value:
2nd Value:
Value Percent:
Continuous Index:
Within 8" of Joint: **NO**
Remarks: **unknown**

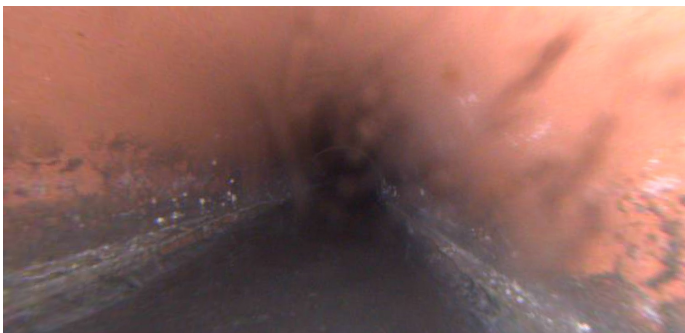
Code: **DAGS**
Description: **Deposits Attached Grease**

Distance (ft): **12.6**
Structural Grade: **0**
O&M Grade: **2**
Clock Start/From: **8**
Clock To: **4**
1st Value:
2nd Value:
Value Percent: **5.000**
Continuous Index: **F01**
Within 8" of Joint: **NO**
Remarks:
