Profile/Photo Observation Report

Street:	ALLEY BETWEEN W 38TH PL & W 38	Flow Control:	Not Controlled
City:	Hobart, IN	Year Renewed:	
Location:	Other	Tape/Media #:	
Purpose:	Not Known	Dia/Height:	10"
Use:	Sanitary	Material:	VCP
Drain Area:	NA	Lining:	
Category:	NA		
Comment:

Location Details:		Direction of Survey:	Downstream
US MH:	M-503-058	DS MH:	M-503-059
		Total Length Surveyed (ft):	12.0

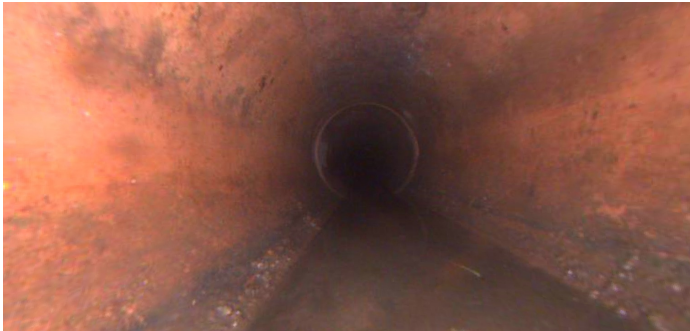
AMH

Manhole

.0

M-503-058

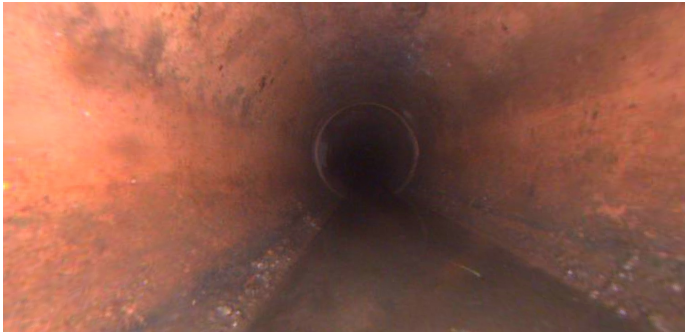
Code:	MWL
Description:	Water Level

Distance (ft):	.0
Structural Grade:	0
O&M Grade:	0
Clock Start/From:	
Clock To:	
1st Value:	
2nd Value:	
Value Percent:	5.000
Continuous Index:	
Within 8" of Joint:	NO
Remarks:

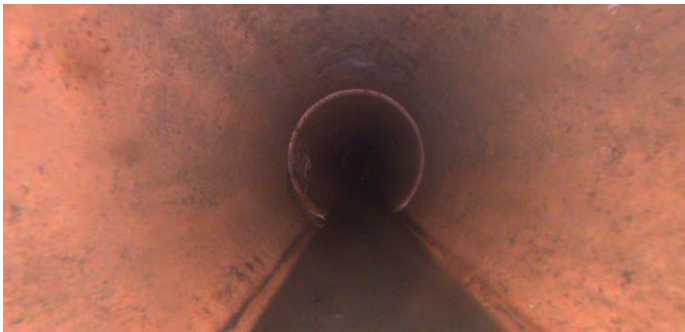
Code:	MSA
Description:	Abandoned Survey

Distance (ft):	12.0
Structural Grade:	0
O&M Grade:	0
Clock Start/From:	
Clock To:	
1st Value:	
2nd Value:	
Value Percent:	
Continuous Index:	
Within 8" of Joint:	NO
Remarks:	unknown
