Profile/Photo Observation Report

Street:	W 40th ave	Flow Control:	Not Controlled
City:	Hobart, IN	Year Renewed:	
Location:	Other	Tape/Media #:	
Purpose:	Not Known	Dia/Height:	10"
Use:	Sanitary	Material:	VCP
Drain Area:	NA	Lining:	
Category:	NA		
Comment:

Location Details:		Direction of Survey:	Upstream
US MH:	M-503-058	DS MH:	M-503-059
		Total Length Surveyed (ft):	2.2

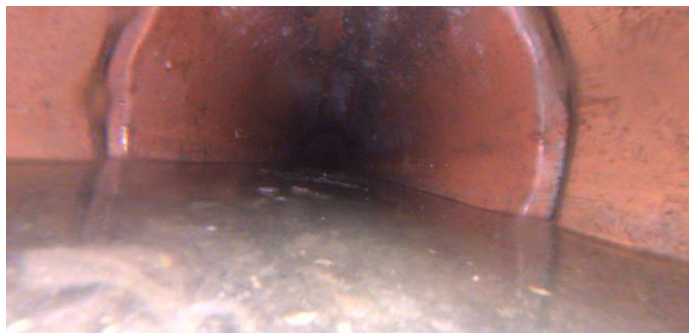
Code: **AMH**
Description: **Manhole**

Distance (ft): **.0**
Structural Grade: **0**
O&M Grade: **0**
Clock Start/From:
Clock To:
1st Value:
2nd Value:
Value Percent:
Continuous Index:
Within 8" of Joint: **NO**
Remarks: **M-503-058**

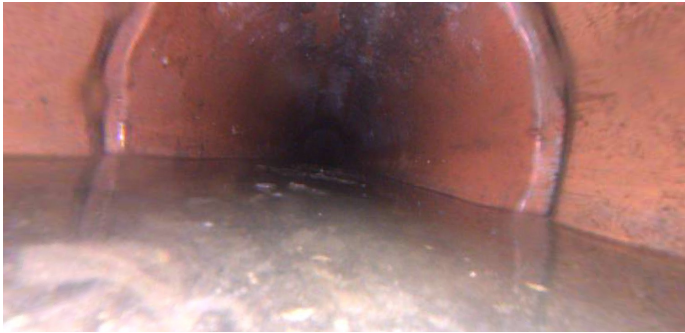
Code:	MWL
Description:	Water Level

Distance (ft):	.0
Structural Grade:	0
O&M Grade:	0
Clock Start/From:	
Clock To:	
1st Value:	
2nd Value:	
Value Percent:	30.000
Continuous Index:	
Within 8" of Joint:	NO
Remarks:

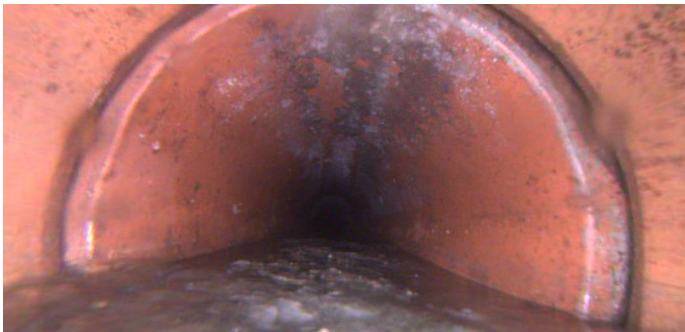
Code:	MSA
Description:	Abandoned Survey

Distance (ft):	2.2
Structural Grade:	0
O&M Grade:	0
Clock Start/From:	
Clock To:	
1st Value:	
2nd Value:	
Value Percent:	
Continuous Index:	
Within 8" of Joint:	NO
Remarks:	debris under water
