Profile/Photo Observation Report

Date:	04/13/2018	Weather:		Coding:	PACP 6.0
Pipe Length (ft):	265.2	Owner:	NA	Pre Clean:	Not Known
P.O.#:		Surveyor:	Jen Costello	PSR:	P-503-060-061
Customer:		Clean Date:	01/01/1900	Shape:	C

Street:	N VIRGINIA ST	Flow Control:	Not Controlled
City:	Hobart, IN	Year Renewed:	
Location:	Other	Tape/Media #:	
Purpose:	Not Known	Dia/Height:	10"
Use:	Sanitary	Material:	PVC
Drain Area:	NA	Lining:	
Category:	NA		
Comment:			
Location Details:		Direction of Survey:	Downstream
US MH:	M-503-061	DS MH:	M-503-060
		Total Length Surveyed (ft):	263.5

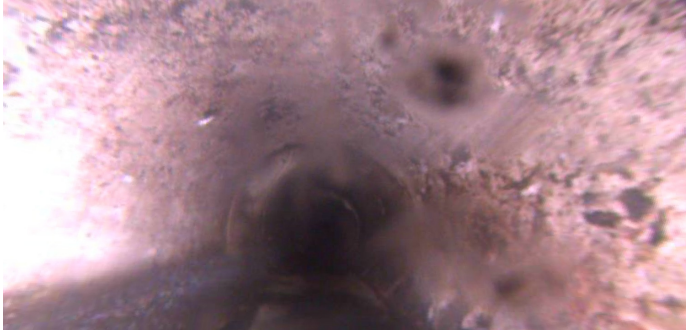
Code: **AMH**
Description: **Manhole**

Distance (ft): **.0**
Structural Grade: **0**
O&M Grade: **0**
Clock Start/From:
Clock To:
1st Value:
2nd Value:
Value Percent:
Continuous Index:
Within 8" of Joint: **NO**
Remarks: **M-503-061**

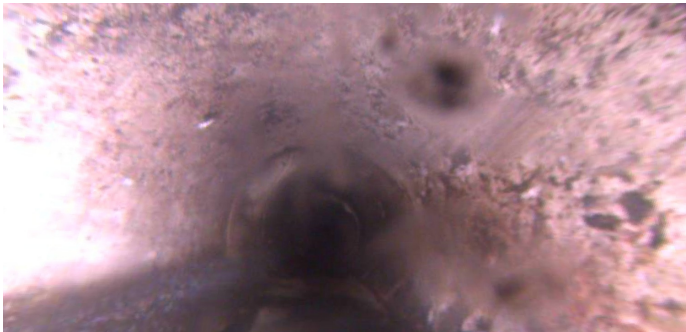
Code: **MWL**
Description: **Water Level**

Distance (ft): **.0**
Structural Grade: **0**
O&M Grade: **0**
Clock Start/From:
Clock To:
1st Value:
2nd Value:
Value Percent: **5.000**
Continuous Index:
Within 8" of Joint: **NO**
Remarks:

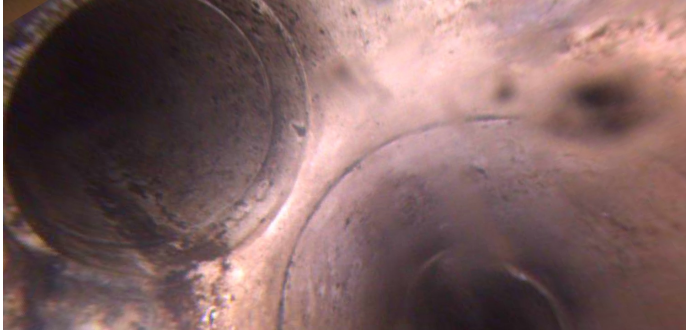
Code: **TF**
Description: **Tap Factory**

Distance (ft): **2.6**
Structural Grade: **0**
O&M Grade: **0**
Clock Start/From: **10**
Clock To:
1st Value: **4.000**
2nd Value:
Value Percent:
Continuous Index:
Within 8" of Joint:
Remarks:

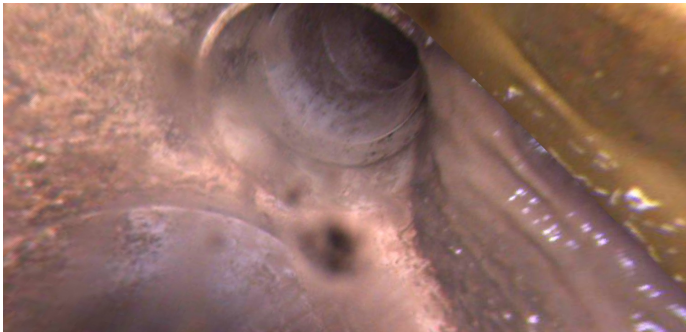
Code: **TFA**
Description: **Tap Factory Active**

Distance (ft): **4.4**
Structural Grade: **0**
O&M Grade: **0**
Clock Start/From: **1**
Clock To:
1st Value: **4.000**
2nd Value:
Value Percent:
Continuous Index:
Within 8" of Joint:
Remarks: **dags**

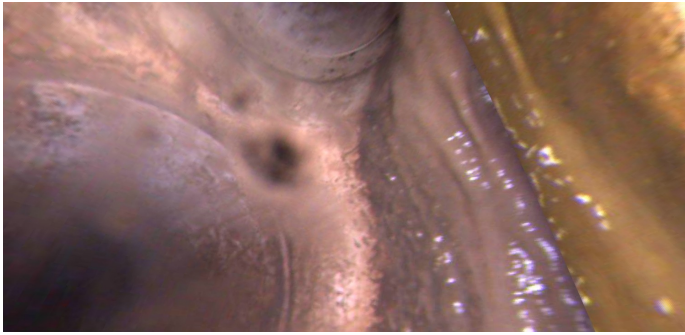
Code: **DAGS**
Description: **Deposits Attached Grease**

Distance (ft): **4.4**
Structural Grade: **0**
O&M Grade: **2**
Clock Start/From: **1**
Clock To: **4**
1st Value:
2nd Value:
Value Percent: **5.000**
Continuous Index:
Within 8" of Joint: **NO**
Remarks:

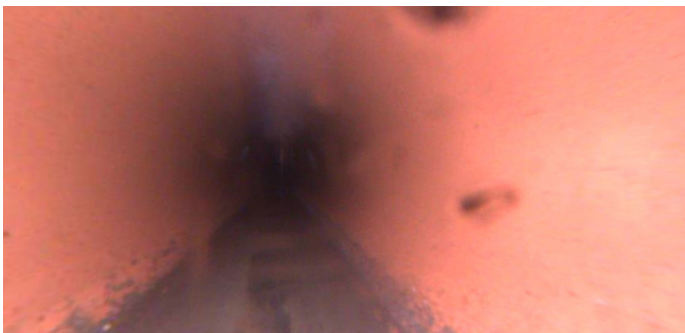
Code: **MMC**
Description: **Material Change**

Distance (ft): **8.5**
Structural Grade: **0**
O&M Grade: **0**
Clock Start/From:
Clock To:
1st Value:
2nd Value:
Value Percent:
Continuous Index:
Within 8" of Joint: **NO**
Remarks: **VCP**

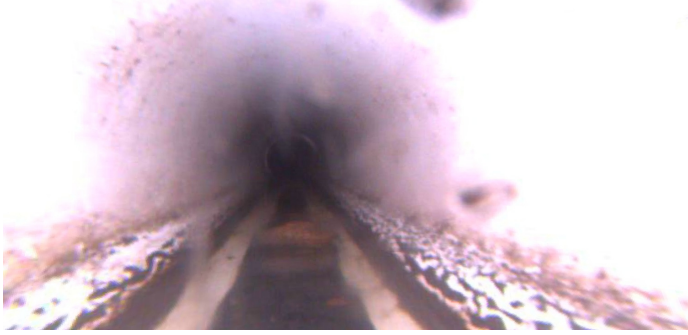
Code: **MMC**
Description: **Material Change**

Distance (ft): **25.8**
Structural Grade: **0**
O&M Grade: **0**
Clock Start/From:
Clock To:
1st Value:
2nd Value:
Value Percent:
Continuous Index:
Within 8" of Joint: **NO**
Remarks: **pvc**

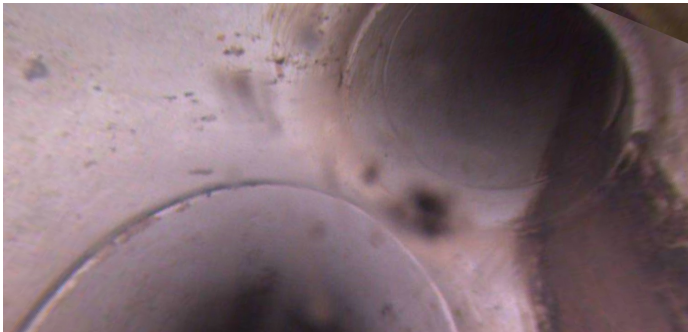
Code: **TF**
Description: **Tap Factory**

Distance (ft): **30.0**
Structural Grade: **0**
O&M Grade: **0**
Clock Start/From: **1**
Clock To:
1st Value: **4.000**
2nd Value:
Value Percent:
Continuous Index:
Within 8" of Joint:
Remarks:

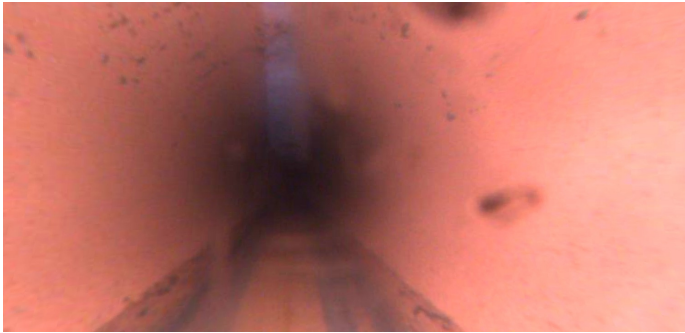
Code: **MMC**
Description: **Material Change**

Distance (ft): **35.6**
Structural Grade: **0**
O&M Grade: **0**
Clock Start/From:
Clock To:
1st Value:
2nd Value:
Value Percent:
Continuous Index:
Within 8" of Joint: **NO**
Remarks: **VCP**

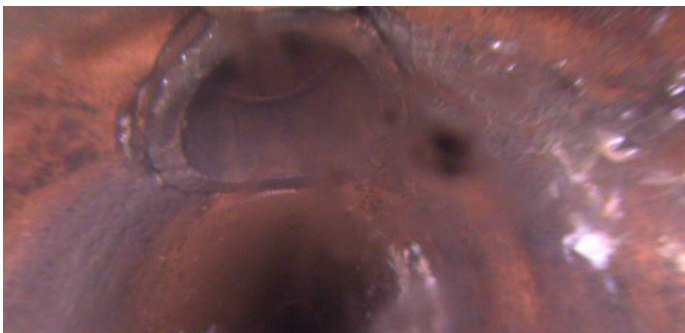
Code: **TB**
Description: **Tap Break-in**

Distance (ft): **66.4**
Structural Grade: **0**
O&M Grade: **0**
Clock Start/From: **12**
Clock To:
1st Value: **4.000**
2nd Value:
Value Percent:
Continuous Index:
Within 8" of Joint:
Remarks:

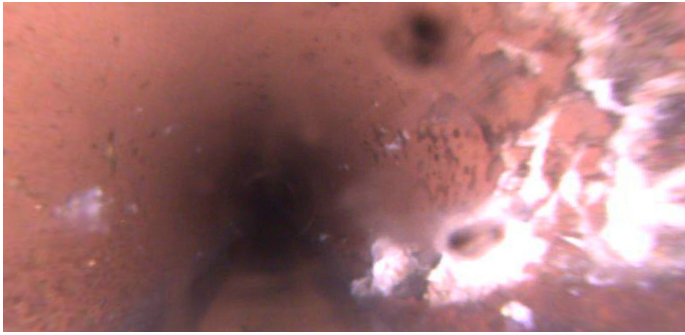
Code: **DAGS**
Description: **Deposits Attached Grease**

Distance (ft): **67.2**
Structural Grade: **0**
O&M Grade: **2**
Clock Start/From: **2**
Clock To: **4**
1st Value:
2nd Value:
Value Percent: **5.000**
Continuous Index:
Within 8" of Joint: **NO**
Remarks:

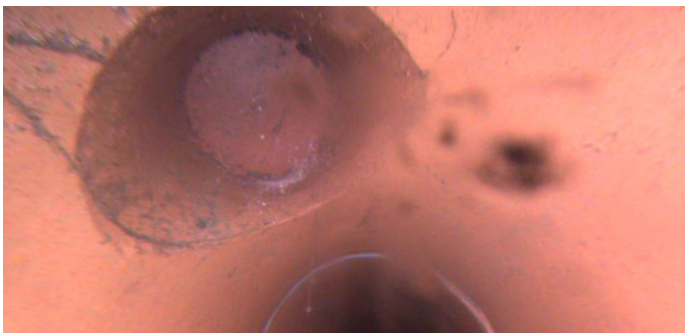
Code: **TFC**
Description: **Tap Factory Capped**

Distance (ft): **70.8**
Structural Grade: **0**
O&M Grade: **0**
Clock Start/From: **11**
Clock To:
1st Value: **4.000**
2nd Value:
Value Percent:
Continuous Index:
Within 8" of Joint:
Remarks:

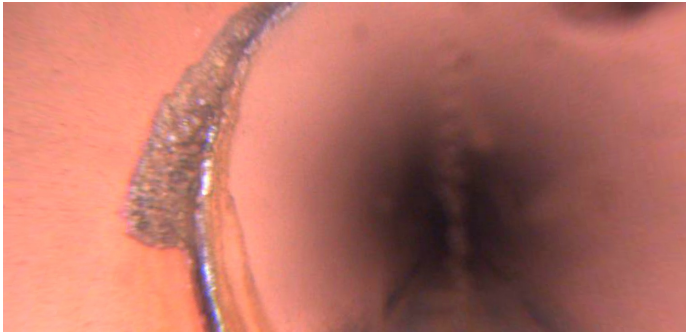
Code: **IW**
Description: **Infil Weeper**

Distance (ft): **91.2**
Structural Grade: **0**
O&M Grade: **2**
Clock Start/From: **8**
Clock To: **11**
1st Value:
2nd Value:
Value Percent:
Continuous Index:
Within 8" of Joint: **YES**
Remarks:

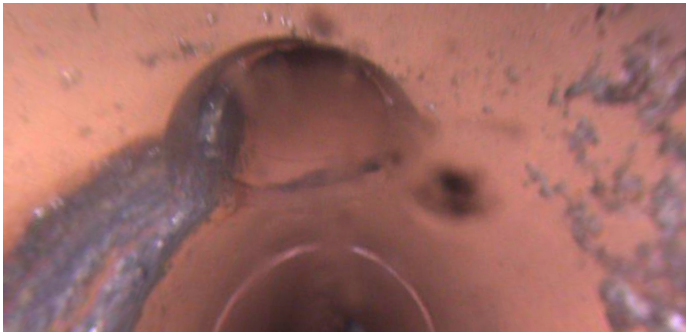
Code: **TBA**
Description: **Tap Break-in Active**

Distance (ft): **97.3**
Structural Grade: **0**
O&M Grade: **0**
Clock Start/From: **12**
Clock To:
1st Value: **4.000**
2nd Value:
Value Percent:
Continuous Index:
Within 8" of Joint:
Remarks:

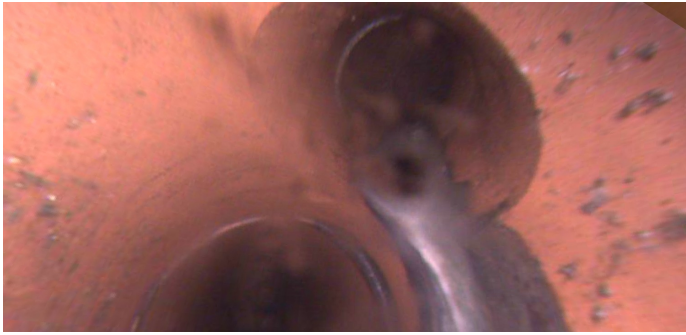
Code: **TFA**
Description: **Tap Factory Active**

Distance (ft): **99.4**
Structural Grade: **0**
O&M Grade: **0**
Clock Start/From: **1**
Clock To:
1st Value: **4.000**
2nd Value:
Value Percent:
Continuous Index:
Within 8" of Joint:
Remarks:

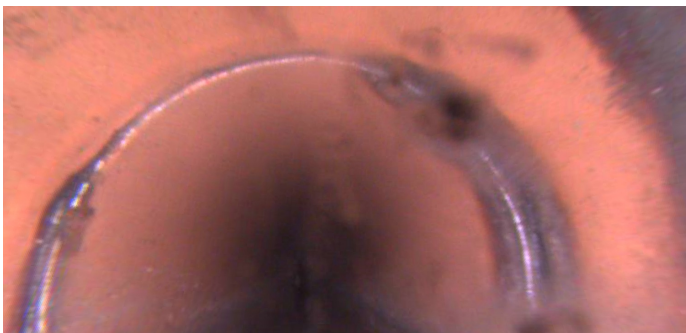
Code: **IW**
Description: **Infil Weeper**

Distance (ft): **99.9**
Structural Grade: **0**
O&M Grade: **2**
Clock Start/From: **8**
Clock To: **4**
1st Value:
2nd Value:
Value Percent:
Continuous Index:
Within 8" of Joint: **YES**
Remarks:

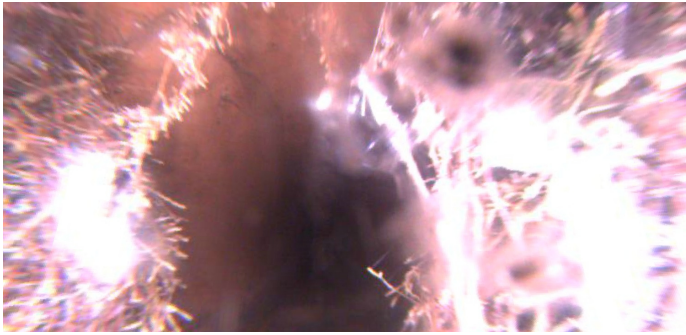
Code: **RMJ**
Description: **Roots Medium Joint**

Distance (ft): **105.2**
Structural Grade: **0**
O&M Grade: **3**
Clock Start/From: **8**
Clock To: **4**
1st Value:
2nd Value:
Value Percent: **30.000**
Continuous Index:
Within 8" of Joint: **YES**
Remarks:

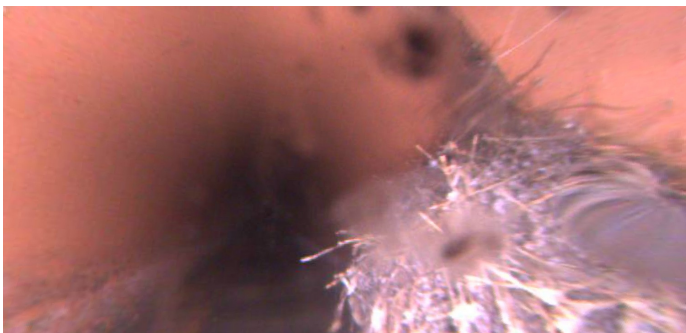
Code: **RMJ**
Description: **Roots Medium Joint**

Distance (ft): **110.1**
Structural Grade: **0**
O&M Grade: **3**
Clock Start/From: **2**
Clock To: **5**
1st Value:
2nd Value:
Value Percent: **20.000**
Continuous Index:
Within 8" of Joint: **YES**
Remarks:

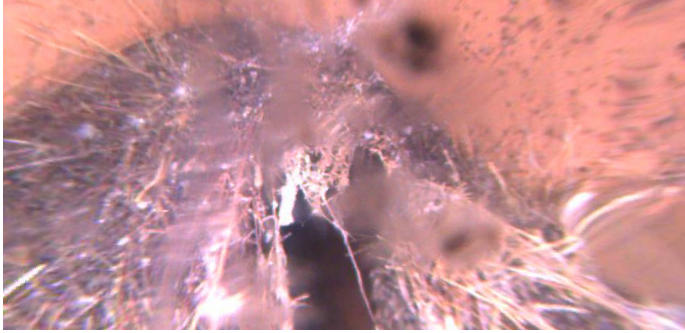
Code: **RBJ**
Description: **Roots Ball Joint**

Distance (ft): **115.0**
Structural Grade: **0**
O&M Grade: **4**
Clock Start/From: **12**
Clock To: **12**
1st Value:
2nd Value:
Value Percent: **90.000**
Continuous Index:
Within 8" of Joint: **YES**
Remarks:

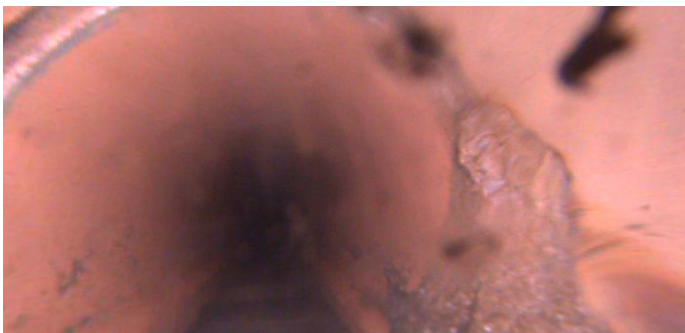
Code: **DAE**
Description: **Deposits Attached Encrustation**

Distance (ft): **124.9**
Structural Grade: **0**
O&M Grade: **2**
Clock Start/From: **2**
Clock To: **4**
1st Value:
2nd Value:
Value Percent: **5.000**
Continuous Index:
Within 8" of Joint: **YES**
Remarks:

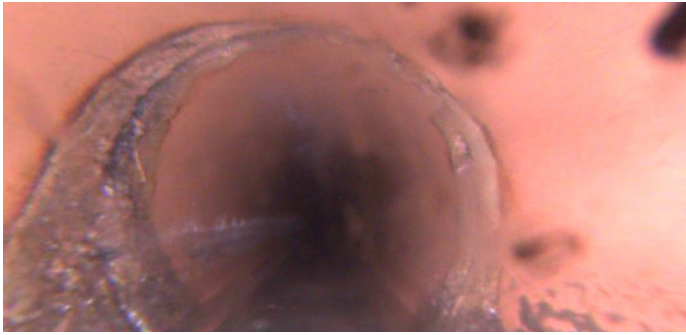
Code: **DAE**
Description: **Deposits Attached Encrustation**

Distance (ft): **129.7**
Structural Grade: **0**
O&M Grade: **2**
Clock Start/From: **8**
Clock To: **4**
1st Value:
2nd Value:
Value Percent: **5.000**
Continuous Index:
Within 8" of Joint: **YES**
Remarks:

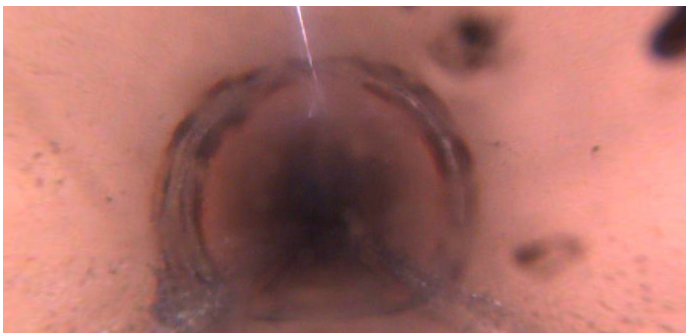
Code: **IW**
Description: **Infil Weeper**

Distance (ft): **134.5**
Structural Grade: **0**
O&M Grade: **2**
Clock Start/From: **8**
Clock To: **4**
1st Value:
2nd Value:
Value Percent:
Continuous Index:
Within 8" of Joint: **YES**
Remarks:

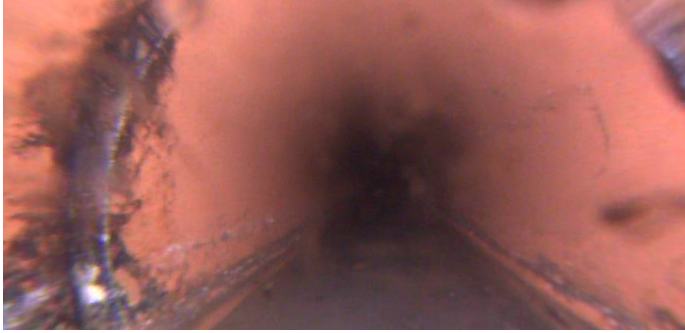
Code: **IW**
Description: **Infil Weeper**

Distance (ft): **144.9**
Structural Grade: **0**
O&M Grade: **2**
Clock Start/From: **8**
Clock To: **4**
1st Value:
2nd Value:
Value Percent:
Continuous Index:
Within 8" of Joint: **YES**
Remarks:

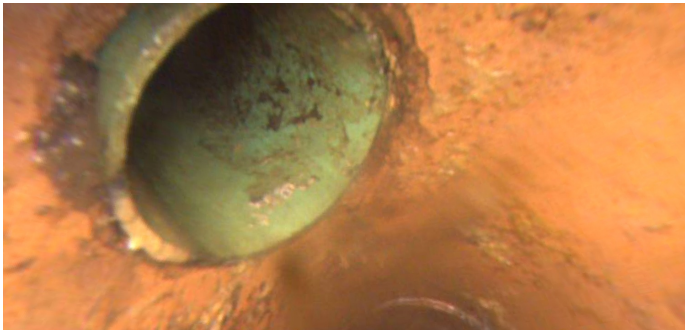
Code: **TBI**
Description: **Tap Break-in Intruding**

Distance (ft): **163.4**
Structural Grade: **0**
O&M Grade: **2**
Clock Start/From: **1**
Clock To:
1st Value: **4.000**
2nd Value: **1.000**
Value Percent:
Continuous Index:
Within 8" of Joint:
Remarks:

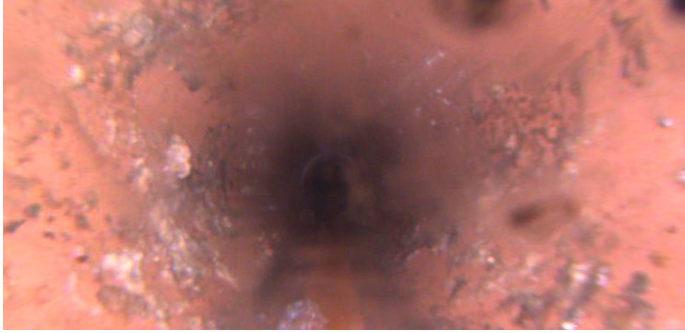
Code: **DAGS**
Description: **Deposits Attached Grease**

Distance (ft): **163.4**
Structural Grade: **0**
O&M Grade: **2**
Clock Start/From: **8**
Clock To: **4**
1st Value:
2nd Value:
Value Percent: **5.000**
Continuous Index:
Within 8" of Joint: **NO**
Remarks:

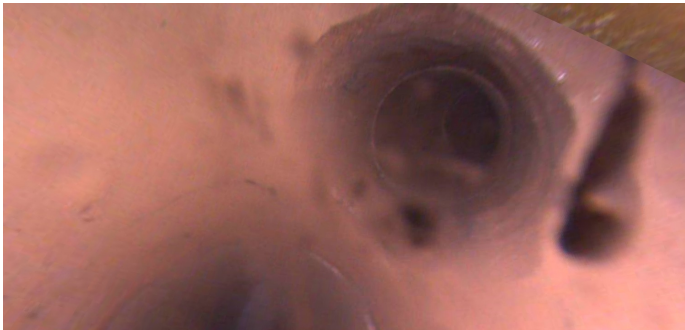
Code: **TF**
Description: **Tap Factory**

Distance (ft): **168.1**
Structural Grade: **0**
O&M Grade: **0**
Clock Start/From: **1**
Clock To:
1st Value: **4.000**
2nd Value:
Value Percent:
Continuous Index:
Within 8" of Joint:
Remarks:

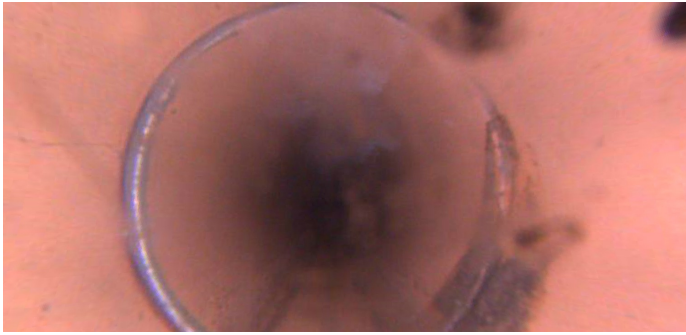
Code: **IW**
Description: **Infil Weeper**

Distance (ft): **183.3**
Structural Grade: **0**
O&M Grade: **2**
Clock Start/From: **2**
Clock To: **4**
1st Value:
2nd Value:
Value Percent:
Continuous Index:
Within 8" of Joint: **YES**
Remarks:

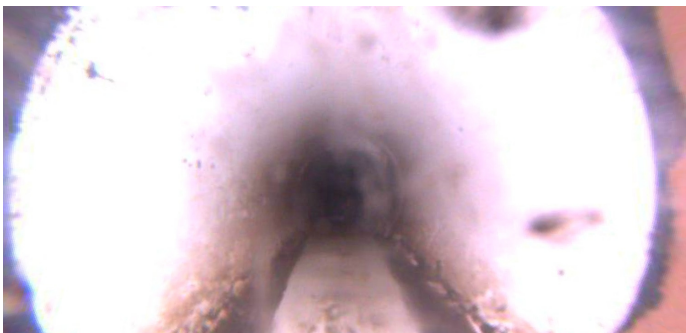
Code: **MMC**
Description: **Material Change**

Distance (ft): **208.3**
Structural Grade: **0**
O&M Grade: **0**
Clock Start/From:
Clock To:
1st Value:
2nd Value:
Value Percent:
Continuous Index:
Within 8" of Joint: **NO**
Remarks: **pvc**

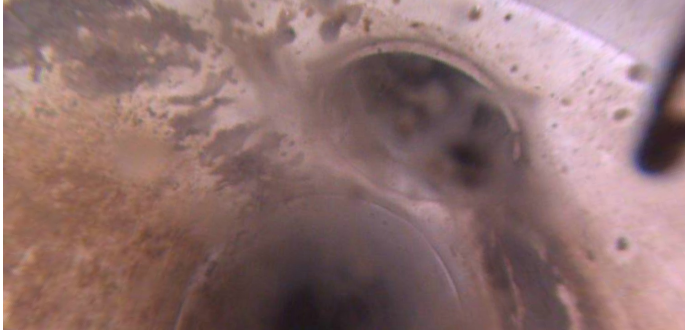
Code: **TF**
Description: **Tap Factory**

Distance (ft): **209.9**
Structural Grade: **0**
O&M Grade: **0**
Clock Start/From: **1**
Clock To:
1st Value: **4.000**
2nd Value:
Value Percent:
Continuous Index:
Within 8" of Joint:
Remarks:

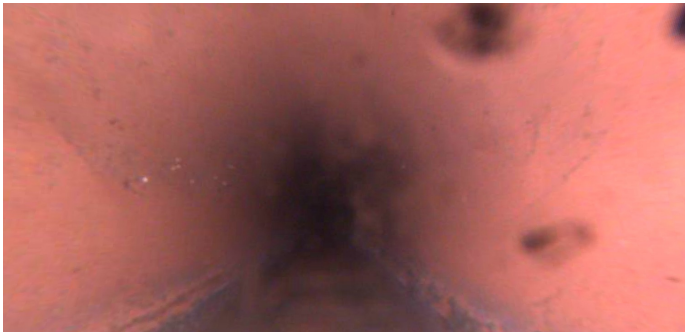
Code: **MMC**
Description: **Material Change**

Distance (ft): **212.5**
Structural Grade: **0**
O&M Grade: **0**
Clock Start/From:
Clock To:
1st Value:
2nd Value:
Value Percent:
Continuous Index:
Within 8" of Joint: **NO**
Remarks: **VCP**

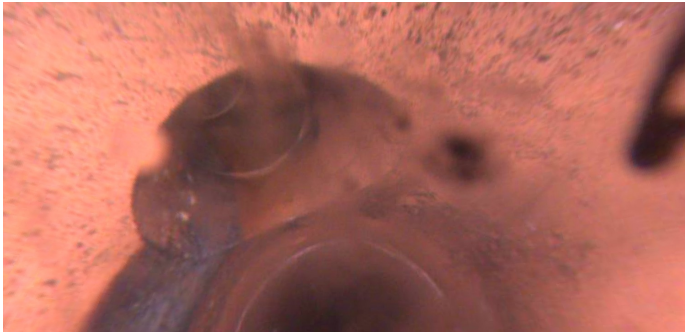
Code: **TF**
Description: **Tap Factory**

Distance (ft): **216.5**
Structural Grade: **0**
O&M Grade: **0**
Clock Start/From: **11**
Clock To:
1st Value: **4.000**
2nd Value:
Value Percent:
Continuous Index:
Within 8" of Joint:
Remarks:

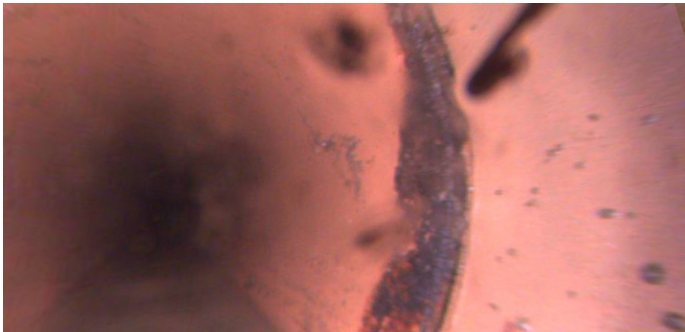
Code: **IW**
Description: **Infil Weeper**

Distance (ft): **227.2**
Structural Grade: **0**
O&M Grade: **2**
Clock Start/From: **8**
Clock To: **4**
1st Value:
2nd Value:
Value Percent:
Continuous Index: **S01**
Within 8" of Joint: **YES**
Remarks:

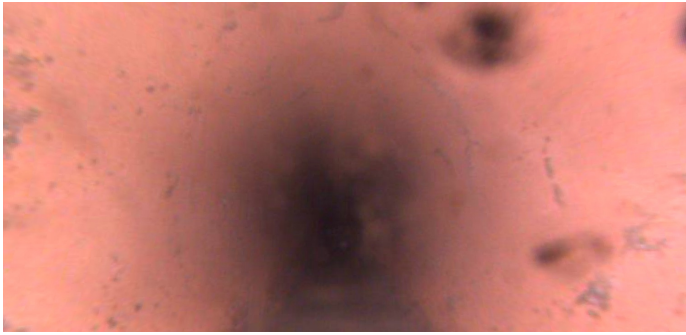
Code: **IW**
Description: **Infil Weeper**

Distance (ft): **247.5**
Structural Grade: **0**
O&M Grade: **2**
Clock Start/From: **8**
Clock To: **4**
1st Value:
2nd Value:
Value Percent:
Continuous Index: **F01**
Within 8" of Joint: **YES**
Remarks:

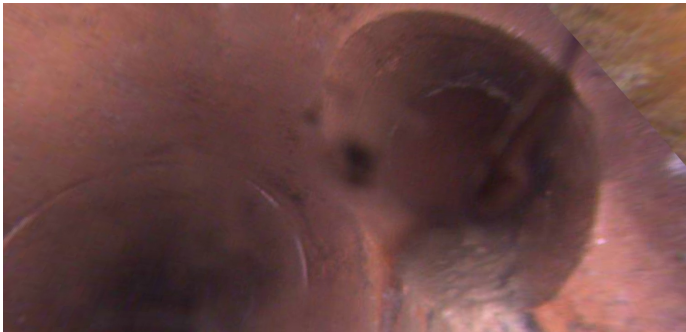
Code: **TF**
Description: **Tap Factory**

Distance (ft): **258.3**
Structural Grade: **0**
O&M Grade: **0**
Clock Start/From: **2**
Clock To:
1st Value: **4.000**
2nd Value:
Value Percent:
Continuous Index:
Within 8" of Joint:
Remarks:
