Profile/Photo Observation Report

Street:	W 40th ave	Flow Control:	Not Controlled
City:	Hobart, IN	Year Renewed:	
Location:	Other	Tape/Media #:	
Purpose:	Not Known	Dia/Height:	10"
Use:	Sanitary	Material:	PVC
Drain Area:	NA	Lining:	
Category:	NA		
Comment:

Location Details:		Direction of Survey:	Downstream
US MH:	M-503-061	DS MH:	M-503-060
		Total Length Surveyed (ft):	263.5

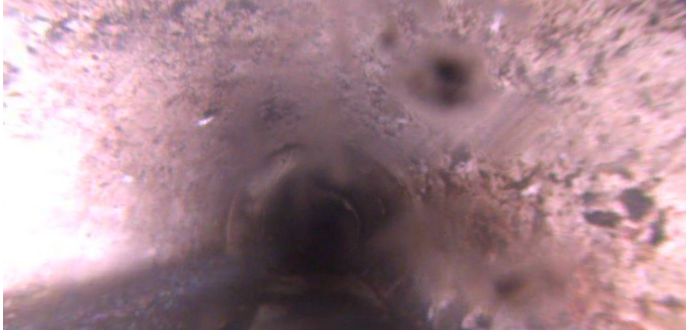
Code: **AMH**
Description: **Manhole**

Distance (ft): **.0**
Structural Grade: **0**
O&M Grade: **0**
Clock Start/From:
Clock To:
1st Value:
2nd Value:
Value Percent:
Continuous Index:
Within 8" of Joint: **NO**
Remarks: **M-503-061**

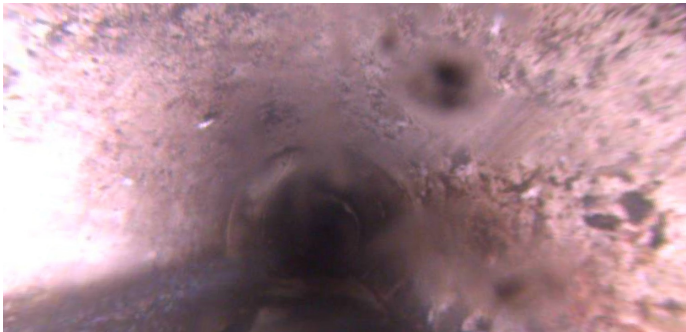
Code: **MWL**
Description: **Water Level**

Distance (ft): **.0**
Structural Grade: **0**
O&M Grade: **0**
Clock Start/From:
Clock To:
1st Value:
2nd Value:
Value Percent: **5.000**
Continuous Index:
Within 8" of Joint: **NO**
Remarks:

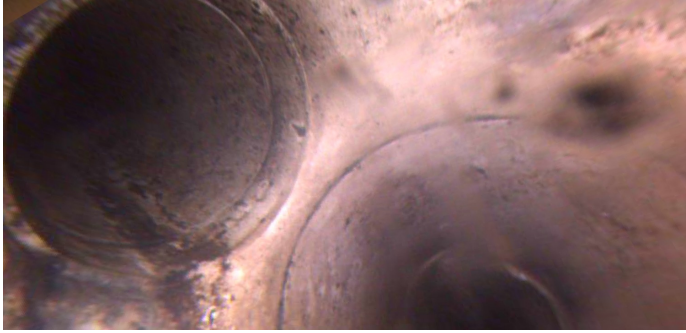
Code: **TF**
Description: **Tap Factory**

Distance (ft): **2.6**
Structural Grade: **0**
O&M Grade: **0**
Clock Start/From: **10**
Clock To:
1st Value: **4.000**
2nd Value:
Value Percent:
Continuous Index:
Within 8" of Joint:
Remarks:

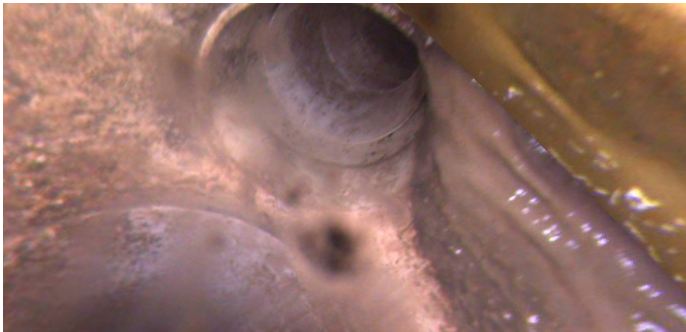
Code: **TFA**
Description: **Tap Factory Active**

Distance (ft): **4.4**
Structural Grade: **0**
O&M Grade: **0**
Clock Start/From: **1**
Clock To:
1st Value: **4.000**
2nd Value:
Value Percent:
Continuous Index:
Within 8" of Joint:
Remarks: **dags**

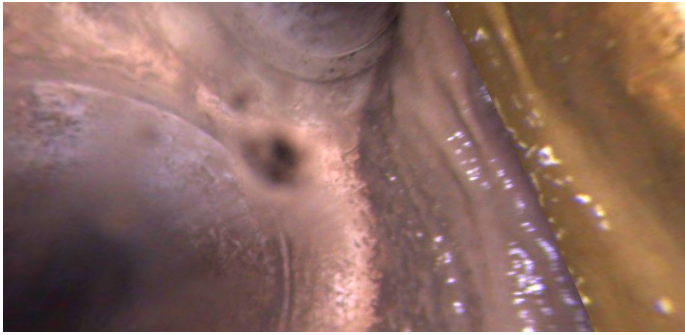
Code: **DAGS**
Description: **Deposits Attached Grease**

Distance (ft): **4.4**
Structural Grade: **0**
O&M Grade: **2**
Clock Start/From: **1**
Clock To: **4**
1st Value:
2nd Value:
Value Percent: **5.000**
Continuous Index:
Within 8" of Joint: **NO**
Remarks:

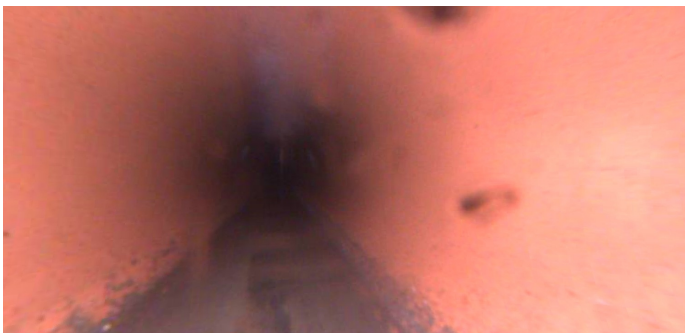
Code: **MMC**
Description: **Material Change**

Distance (ft): **8.5**
Structural Grade: **0**
O&M Grade: **0**
Clock Start/From:
Clock To:
1st Value:
2nd Value:
Value Percent:
Continuous Index:
Within 8" of Joint: **NO**
Remarks: **VCP**

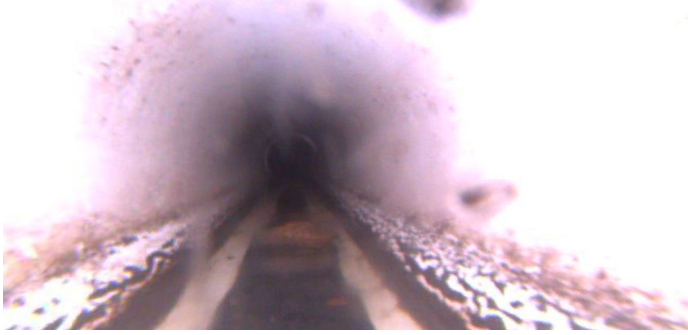
Code: **MMC**
Description: **Material Change**

Distance (ft): **25.8**
Structural Grade: **0**
O&M Grade: **0**
Clock Start/From:
Clock To:
1st Value:
2nd Value:
Value Percent:
Continuous Index:
Within 8" of Joint: **NO**
Remarks: **pvc**

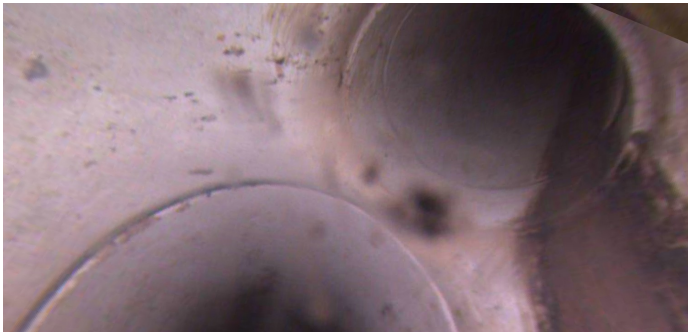
Code: **TF**
Description: **Tap Factory**

Distance (ft): **30.0**
Structural Grade: **0**
O&M Grade: **0**
Clock Start/From: **1**
Clock To:
1st Value: **4.000**
2nd Value:
Value Percent:
Continuous Index:
Within 8" of Joint:
Remarks:

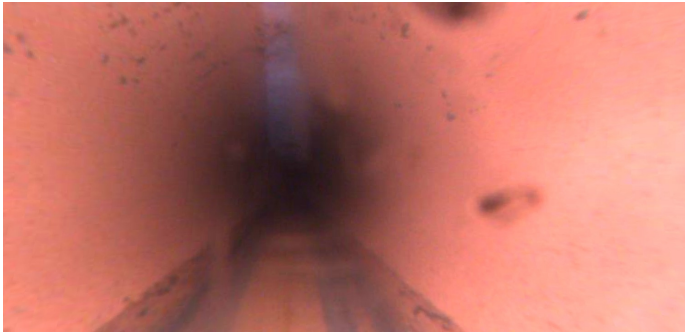
Code: **MMC**
Description: **Material Change**

Distance (ft): **35.6**
Structural Grade: **0**
O&M Grade: **0**
Clock Start/From:
Clock To:
1st Value:
2nd Value:
Value Percent:
Continuous Index:
Within 8" of Joint: **NO**
Remarks: **VCP**

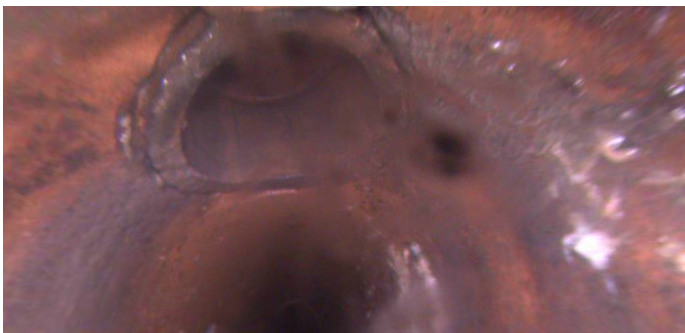
Code: **TB**
Description: **Tap Break-in**

Distance (ft): **66.4**
Structural Grade: **0**
O&M Grade: **0**
Clock Start/From: **12**
Clock To:
1st Value: **4.000**
2nd Value:
Value Percent:
Continuous Index:
Within 8" of Joint:
Remarks:

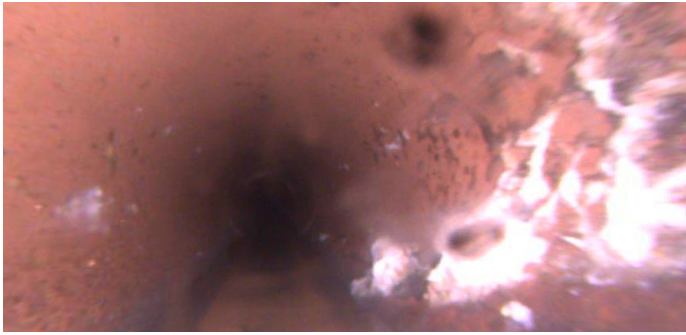
Code: **DAGS**
Description: **Deposits Attached Grease**

Distance (ft): **67.2**
Structural Grade: **0**
O&M Grade: **2**
Clock Start/From: **2**
Clock To: **4**
1st Value:
2nd Value:
Value Percent: **5.000**
Continuous Index:
Within 8" of Joint: **NO**
Remarks:

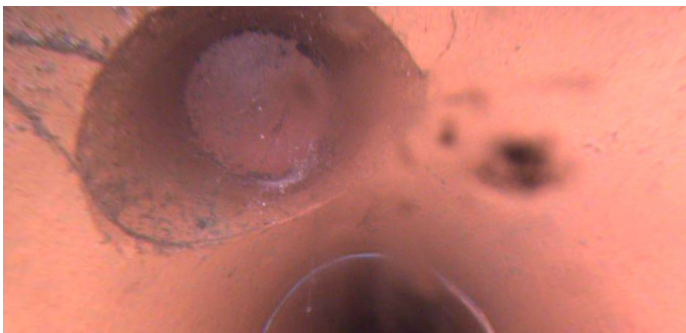
Code: **TFC**
Description: **Tap Factory Capped**

Distance (ft): **70.8**
Structural Grade: **0**
O&M Grade: **0**
Clock Start/From: **11**
Clock To:
1st Value: **4.000**
2nd Value:
Value Percent:
Continuous Index:
Within 8" of Joint:
Remarks:

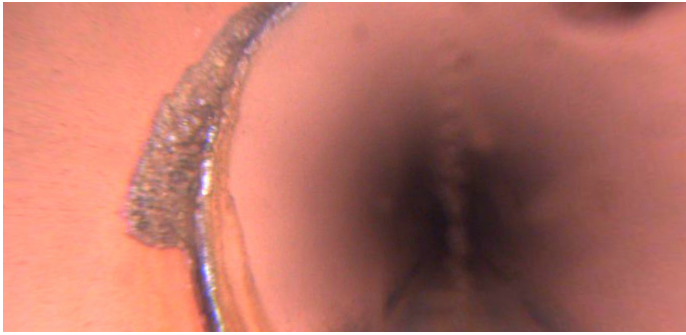
Code: **IW**
Description: **Infil Weeper**

Distance (ft): **91.2**
Structural Grade: **0**
O&M Grade: **2**
Clock Start/From: **8**
Clock To: **11**
1st Value:
2nd Value:
Value Percent:
Continuous Index:
Within 8" of Joint: **YES**
Remarks:

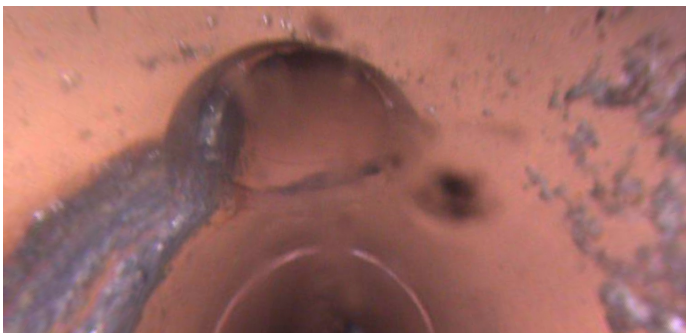
Code: **TBA**
Description: **Tap Break-in Active**

Distance (ft): **97.3**
Structural Grade: **0**
O&M Grade: **0**
Clock Start/From: **12**
Clock To:
1st Value: **4.000**
2nd Value:
Value Percent:
Continuous Index:
Within 8" of Joint:
Remarks:

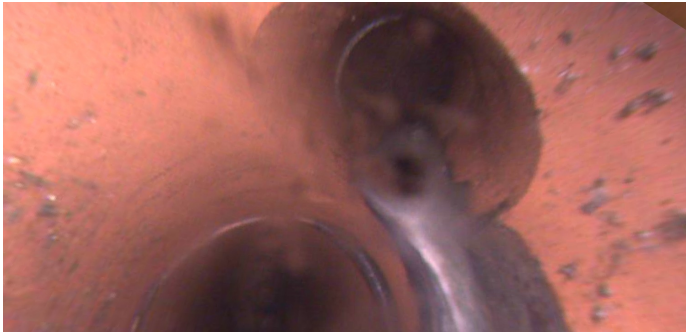
Code: **TFA**
Description: **Tap Factory Active**

Distance (ft): **99.4**
Structural Grade: **0**
O&M Grade: **0**
Clock Start/From: **1**
Clock To:
1st Value: **4.000**
2nd Value:
Value Percent:
Continuous Index:
Within 8" of Joint:
Remarks:

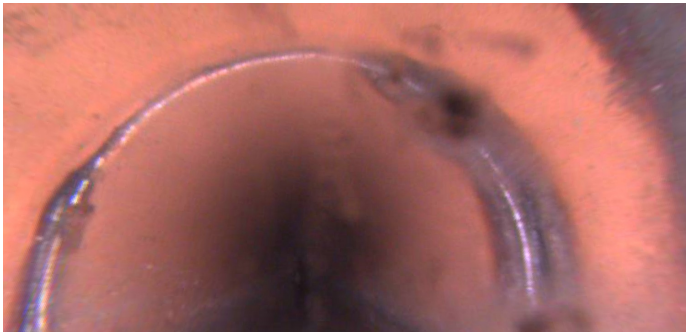
Code: **IW**
Description: **Infil Weeper**

Distance (ft): **99.9**
Structural Grade: **0**
O&M Grade: **2**
Clock Start/From: **8**
Clock To: **4**
1st Value:
2nd Value:
Value Percent:
Continuous Index:
Within 8" of Joint: **YES**
Remarks:

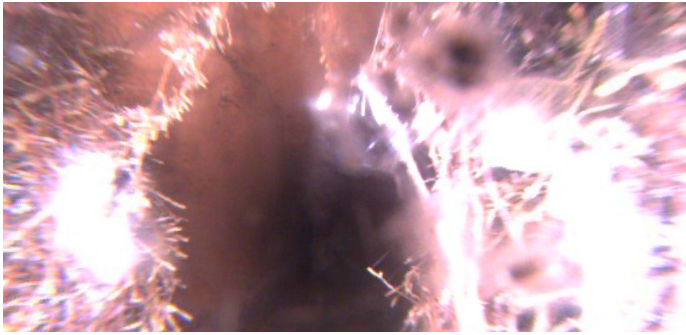
Code: **RMJ**
Description: **Roots Medium Joint**

Distance (ft): **105.2**
Structural Grade: **0**
O&M Grade: **3**
Clock Start/From: **8**
Clock To: **4**
1st Value:
2nd Value:
Value Percent: **30.000**
Continuous Index:
Within 8" of Joint: **YES**
Remarks:

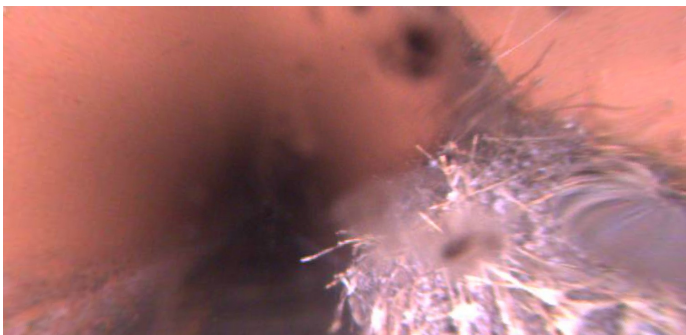
Code: **RMJ**
Description: **Roots Medium Joint**

Distance (ft): **110.1**
Structural Grade: **0**
O&M Grade: **3**
Clock Start/From: **2**
Clock To: **5**
1st Value:
2nd Value:
Value Percent: **20.000**
Continuous Index:
Within 8" of Joint: **YES**
Remarks:

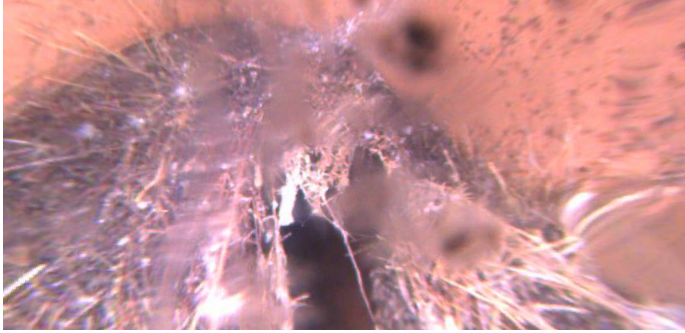
Code: **RBJ**
Description: **Roots Ball Joint**

Distance (ft): **115.0**
Structural Grade: **0**
O&M Grade: **4**
Clock Start/From: **12**
Clock To: **12**
1st Value:
2nd Value:
Value Percent: **90.000**
Continuous Index:
Within 8" of Joint: **YES**
Remarks:

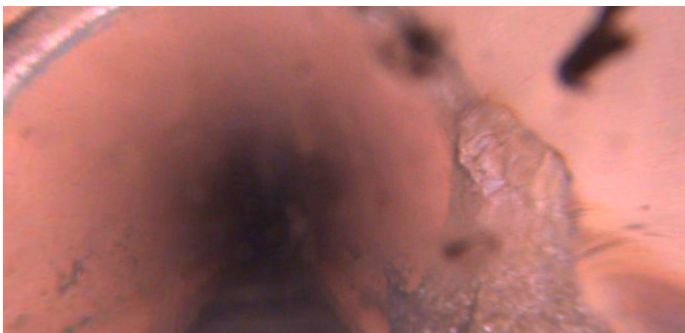
Code: **DAE**
Description: **Deposits Attached Encrustation**

Distance (ft): **124.9**
Structural Grade: **0**
O&M Grade: **2**
Clock Start/From: **2**
Clock To: **4**
1st Value:
2nd Value:
Value Percent: **5.000**
Continuous Index:
Within 8" of Joint: **YES**
Remarks:

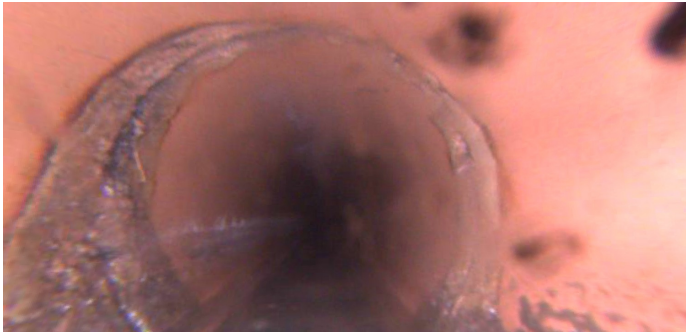
Code: **DAE**
Description: **Deposits Attached Encrustation**

Distance (ft): **129.7**
Structural Grade: **0**
O&M Grade: **2**
Clock Start/From: **8**
Clock To: **4**
1st Value:
2nd Value:
Value Percent: **5.000**
Continuous Index:
Within 8" of Joint: **YES**
Remarks:

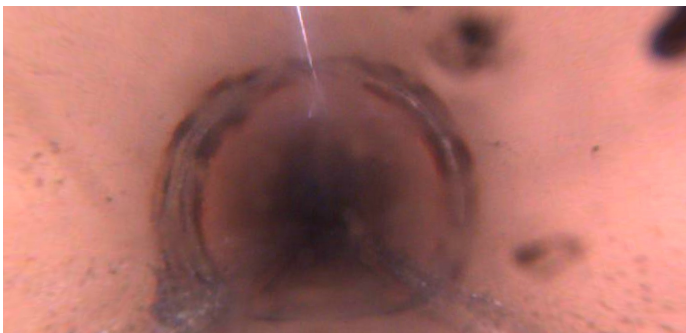
Code: **IW**
Description: **Infil Weeper**

Distance (ft): **134.5**
Structural Grade: **0**
O&M Grade: **2**
Clock Start/From: **8**
Clock To: **4**
1st Value:
2nd Value:
Value Percent:
Continuous Index:
Within 8" of Joint: **YES**
Remarks:

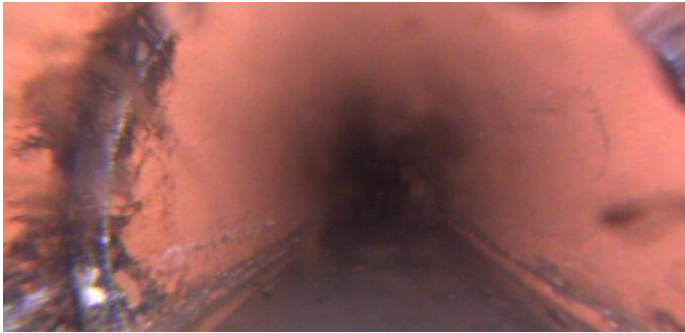
Code: **IW**
Description: **Infil Weeper**

Distance (ft): **144.9**
Structural Grade: **0**
O&M Grade: **2**
Clock Start/From: **8**
Clock To: **4**
1st Value:
2nd Value:
Value Percent:
Continuous Index:
Within 8" of Joint: **YES**
Remarks:

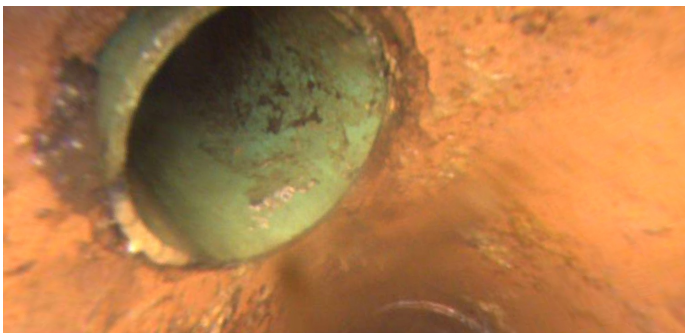
Code: **TBI**
Description: **Tap Break-in Intruding**

Distance (ft): **163.4**
Structural Grade: **0**
O&M Grade: **2**
Clock Start/From: **1**
Clock To:
1st Value: **4.000**
2nd Value: **1.000**
Value Percent:
Continuous Index:
Within 8" of Joint:
Remarks:

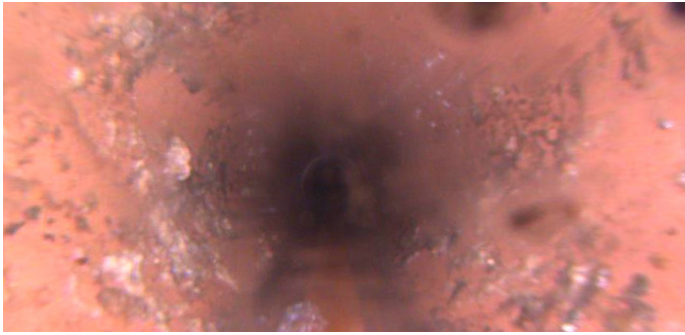
Code: **DAGS**
Description: **Deposits Attached Grease**

Distance (ft): **163.4**
Structural Grade: **0**
O&M Grade: **2**
Clock Start/From: **8**
Clock To: **4**
1st Value:
2nd Value:
Value Percent: **5.000**
Continuous Index:
Within 8" of Joint: **NO**
Remarks:

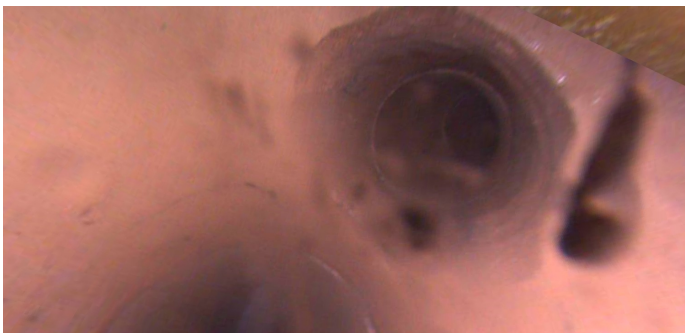
Code: **TF**
Description: **Tap Factory**

Distance (ft): **168.1**
Structural Grade: **0**
O&M Grade: **0**
Clock Start/From: **1**
Clock To:
1st Value: **4.000**
2nd Value:
Value Percent:
Continuous Index:
Within 8" of Joint:
Remarks:

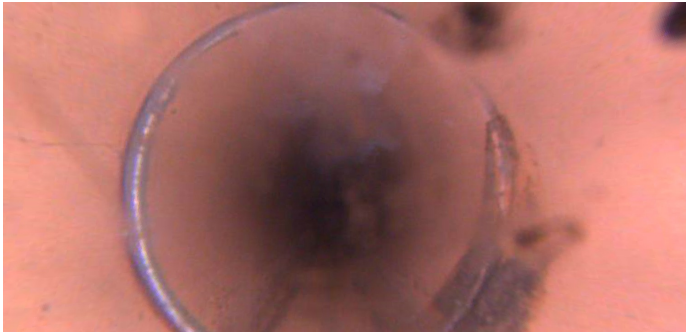
Code: **IW**
Description: **Infil Weeper**

Distance (ft): **183.3**
Structural Grade: **0**
O&M Grade: **2**
Clock Start/From: **2**
Clock To: **4**
1st Value:
2nd Value:
Value Percent:
Continuous Index:
Within 8" of Joint: **YES**
Remarks:

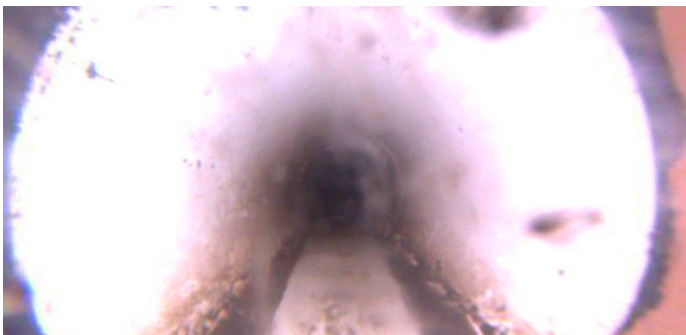
Code: **MMC**
Description: **Material Change**

Distance (ft): **208.3**
Structural Grade: **0**
O&M Grade: **0**
Clock Start/From:
Clock To:
1st Value:
2nd Value:
Value Percent:
Continuous Index:
Within 8" of Joint: **NO**
Remarks: **pvc**

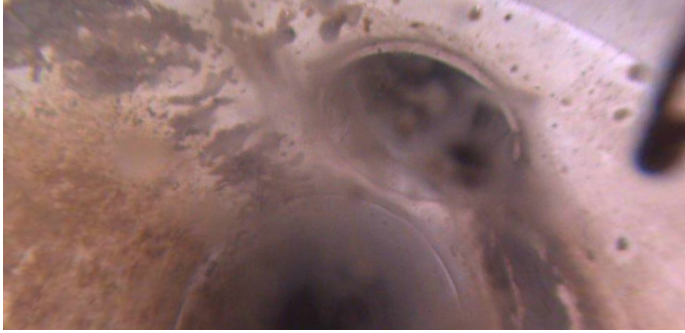
Code: **TF**
Description: **Tap Factory**

Distance (ft): **209.9**
Structural Grade: **0**
O&M Grade: **0**
Clock Start/From: **1**
Clock To:
1st Value: **4.000**
2nd Value:
Value Percent:
Continuous Index:
Within 8" of Joint:
Remarks:

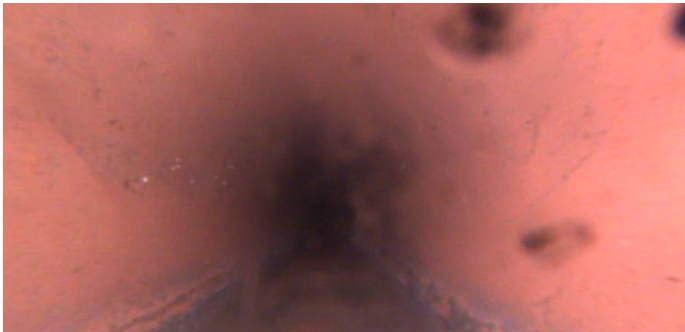
Code: **MMC**
Description: **Material Change**

Distance (ft): **212.5**
Structural Grade: **0**
O&M Grade: **0**
Clock Start/From:
Clock To:
1st Value:
2nd Value:
Value Percent:
Continuous Index:
Within 8" of Joint: **NO**
Remarks: **VCP**

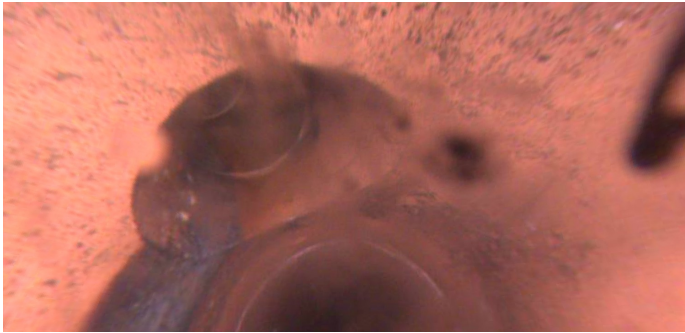
Code: **TF**
Description: **Tap Factory**

Distance (ft): **216.5**
Structural Grade: **0**
O&M Grade: **0**
Clock Start/From: **11**
Clock To:
1st Value: **4.000**
2nd Value:
Value Percent:
Continuous Index:
Within 8" of Joint:
Remarks:

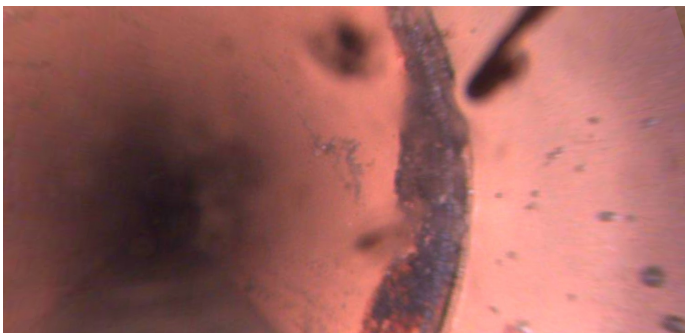
Code: **IW**
Description: **Infil Weeper**

Distance (ft): **227.2**
Structural Grade: **0**
O&M Grade: **2**
Clock Start/From: **8**
Clock To: **4**
1st Value:
2nd Value:
Value Percent:
Continuous Index: **S01**
Within 8" of Joint: **YES**
Remarks:

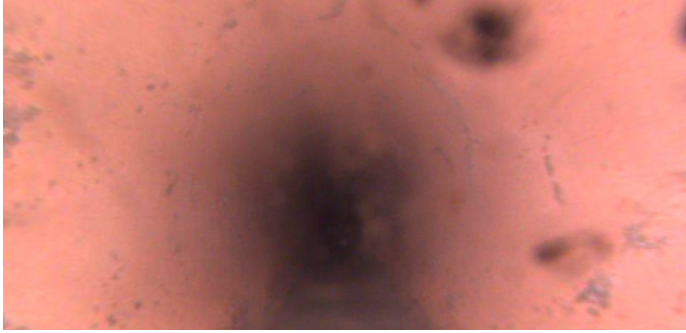
Code: **IW**
Description: **Infil Weeper**

Distance (ft): **247.5**
Structural Grade: **0**
O&M Grade: **2**
Clock Start/From: **8**
Clock To: **4**
1st Value:
2nd Value:
Value Percent:
Continuous Index: **F01**
Within 8" of Joint: **YES**
Remarks:

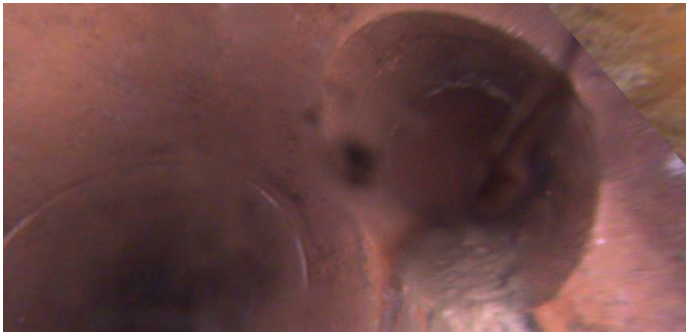
Code: **TF**
Description: **Tap Factory**

Distance (ft): **258.3**
Structural Grade: **0**
O&M Grade: **0**
Clock Start/From: **2**
Clock To:
1st Value: **4.000**
2nd Value:
Value Percent:
Continuous Index:
Within 8" of Joint:
Remarks:
