Profile/Photo Observation Report

Date:	04/14/2018	Weather:		Coding:	PACP 6.0
Pipe Length (ft):	267.4	Owner:	NA	Pre Clean:	Not Known
P.O.#:		Surveyor:	Jen Costello	PSR:	P-503-061-062
Customer:		Clean Date:	01/01/1900	Shape:	C

Street:	ALLEY BETWEEN W 38TH PL & W 38	Flow Control:	Not Controlled
City:	Hobart, IN	Year Renewed:	
Location:	Other	Tape/Media #:	
Purpose:	Not Known	Dia/Height:	10"
Use:	Sanitary	Material:	VCP
Drain Area:	NA	Lining:	
Category:	NA		
Comment:

Location Details:		Direction of Survey:	Upstream
US MH:	M-503-062	DS MH:	M-503-061
		Total Length Surveyed (ft):	197.0

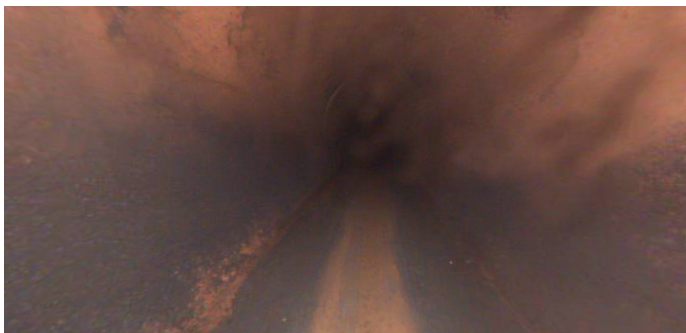
Code: **AMH**
Description: **Manhole**

Distance (ft): **.0**
Structural Grade: **0**
O&M Grade: **0**
Clock Start/From:
Clock To:
1st Value:
2nd Value:
Value Percent:
Continuous Index:
Within 8" of Joint: **NO**
Remarks: **M-503-062**

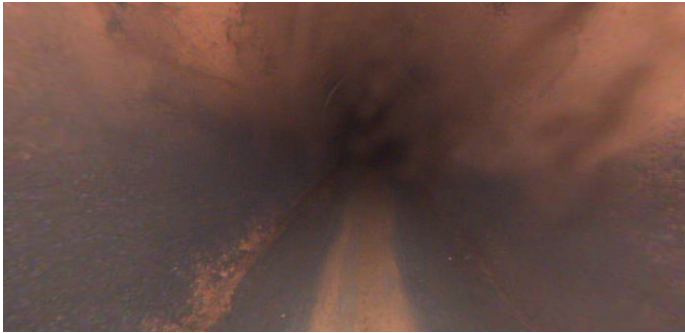
Code:	MWL
Description:	Water Level

Distance (ft):	.0
Structural Grade:	0
O&M Grade:	0
Clock Start/From:	
Clock To:	
1st Value:	
2nd Value:	
Value Percent:	5.000
Continuous Index:	
Within 8" of Joint:	NO
Remarks:

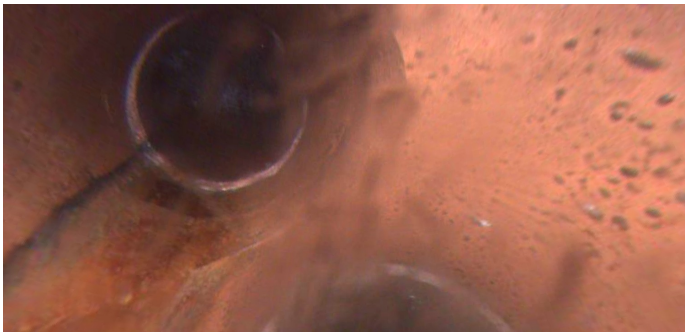
Code:	TFA
Description:	Tap Factory Active

Distance (ft):	34.2
Structural Grade:	0
O&M Grade:	0
Clock Start/From:	11
Clock To:	
1st Value:	4.000
2nd Value:	
Value Percent:	
Continuous Index:	
Within 8" of Joint:	
Remarks:

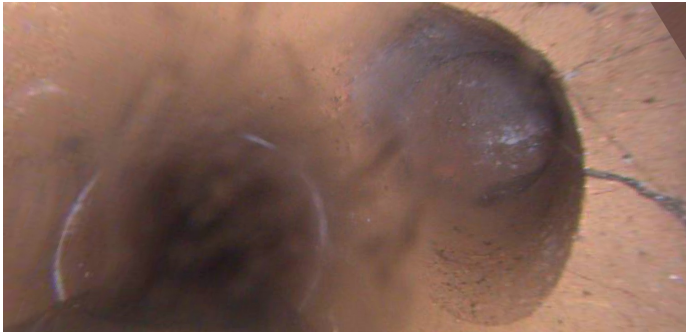
Code: **FM**
Description: **Fracture Multiple**

Distance (ft): **36.0**
Structural Grade: **4**
O&M Grade: **0**
Clock Start/From: **1**
Clock To: **3**
1st Value:
2nd Value:
Value Percent:
Continuous Index:
Within 8" of Joint:
Remarks:

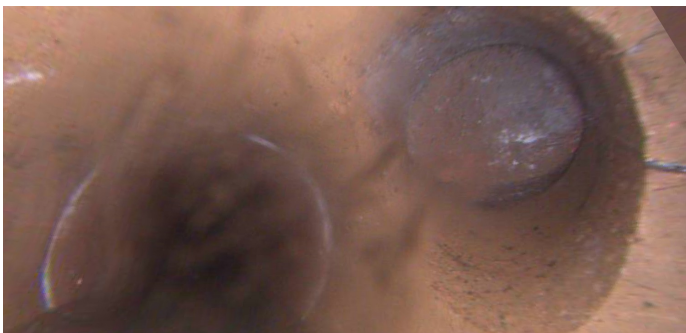
Code: **TFC**
Description: **Tap Factory Capped**

Distance (ft): **36.1**
Structural Grade: **0**
O&M Grade: **0**
Clock Start/From: **2**
Clock To:
1st Value: **4.000**
2nd Value:
Value Percent:
Continuous Index:
Within 8" of Joint:
Remarks:

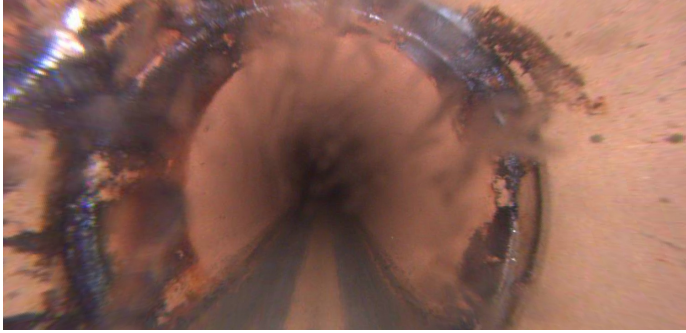
Code: **IW**
Description: **Infil Weeper**

Distance (ft): **57.0**
Structural Grade: **0**
O&M Grade: **2**
Clock Start/From: **8**
Clock To: **4**
1st Value:
2nd Value:
Value Percent:
Continuous Index:
Within 8" of Joint: **YES**
Remarks:

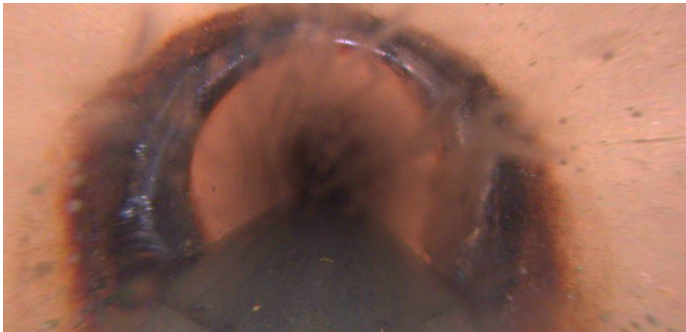
Code: **IW**
Description: **Infil Weeper**

Distance (ft): **62.0**
Structural Grade: **0**
O&M Grade: **2**
Clock Start/From: **8**
Clock To: **4**
1st Value:
2nd Value:
Value Percent:
Continuous Index:
Within 8" of Joint: **YES**
Remarks:

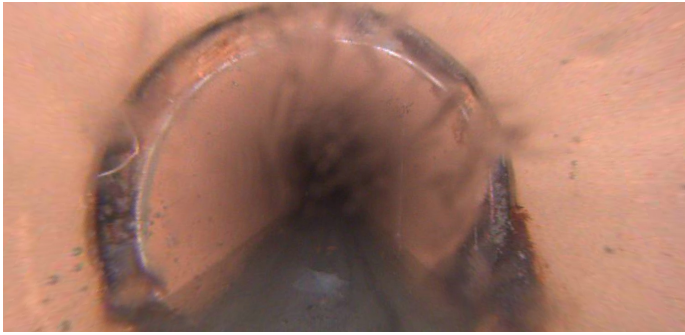
Code: **IW**
Description: **Infil Weeper**

Distance (ft): **67.2**
Structural Grade: **0**
O&M Grade: **2**
Clock Start/From: **8**
Clock To: **4**
1st Value:
2nd Value:
Value Percent:
Continuous Index:
Within 8" of Joint: **YES**
Remarks:

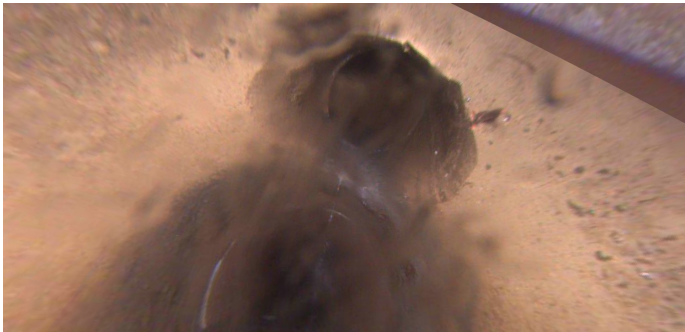
Code: **TFA**
Description: **Tap Factory Active**

Distance (ft): **78.6**
Structural Grade: **0**
O&M Grade: **0**
Clock Start/From: **1**
Clock To:
1st Value: **4.000**
2nd Value:
Value Percent:
Continuous Index:
Within 8" of Joint:
Remarks:

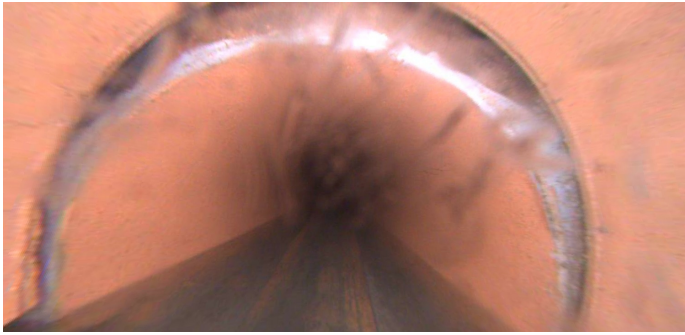
Code: **JOM**
Description: **Joint Offset Medium**

Distance (ft): **99.6**
Structural Grade: **1**
O&M Grade: **0**
Clock Start/From:
Clock To:
1st Value:
2nd Value:
Value Percent:
Continuous Index:
Within 8" of Joint: **NO**
Remarks:

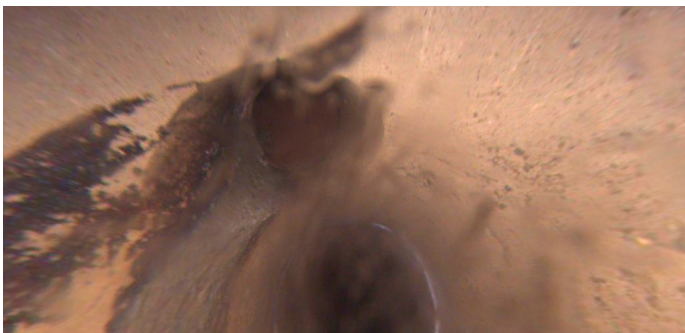
Code: **TF**
Description: **Tap Factory**

Distance (ft): **115.9**
Structural Grade: **0**
O&M Grade: **0**
Clock Start/From: **11**
Clock To:
1st Value: **4.000**
2nd Value:
Value Percent:
Continuous Index:
Within 8" of Joint:
Remarks:

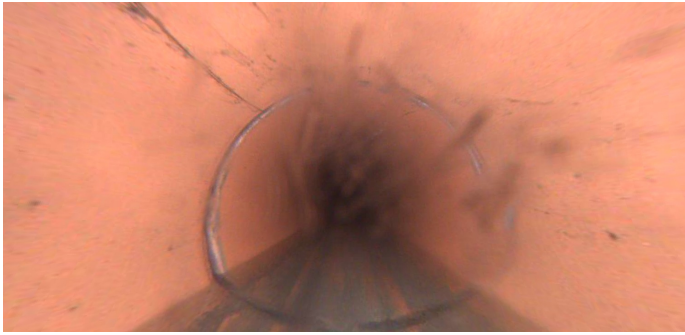
Code: **RFJ**
Description: **Roots Fine Joint**

Distance (ft): **143.8**
Structural Grade: **0**
O&M Grade: **1**
Clock Start/From: **11**
Clock To:
1st Value:
2nd Value:
Value Percent:
Continuous Index:
Within 8" of Joint: **YES**
Remarks:

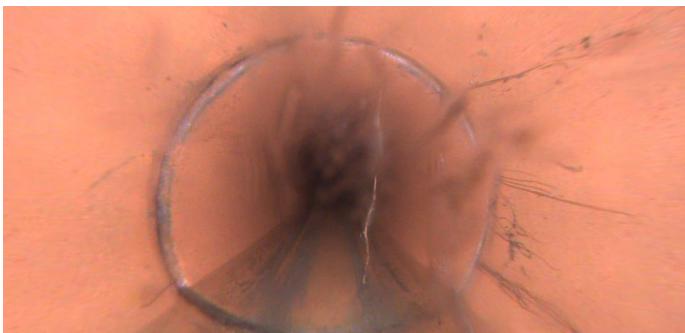
Code: **RFJ**
Description: **Roots Fine Joint**

Distance (ft): **149.0**
Structural Grade: **0**
O&M Grade: **1**
Clock Start/From: **8**
Clock To: **4**
1st Value:
2nd Value:
Value Percent:
Continuous Index:
Within 8" of Joint: **YES**
Remarks:

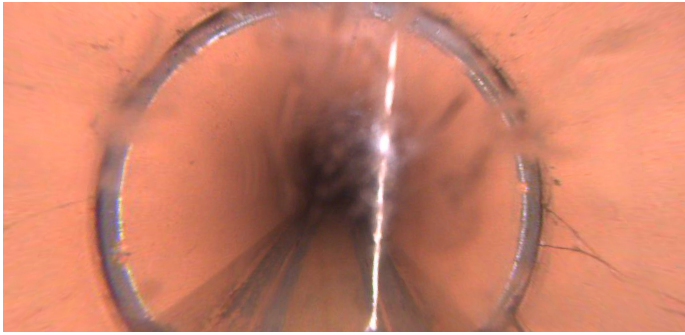
Code: **RFJ**
Description: **Roots Fine Joint**

Distance (ft): **159.2**
Structural Grade: **0**
O&M Grade: **1**
Clock Start/From: **8**
Clock To: **4**
1st Value:
2nd Value:
Value Percent:
Continuous Index:
Within 8" of Joint: **YES**
Remarks:

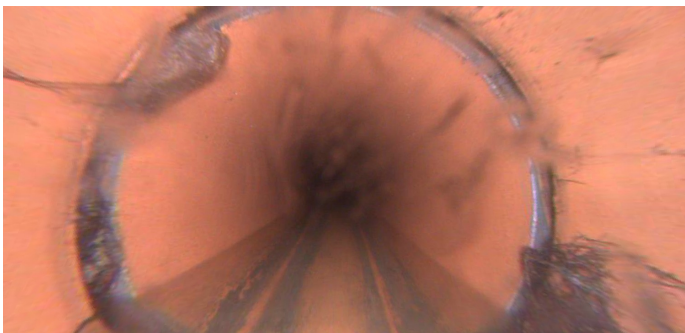
Code: **RFJ**
Description: **Roots Fine Joint**

Distance (ft): **169.3**
Structural Grade: **0**
O&M Grade: **1**
Clock Start/From: **8**
Clock To: **4**
1st Value:
2nd Value:
Value Percent:
Continuous Index:
Within 8" of Joint: **YES**
Remarks:

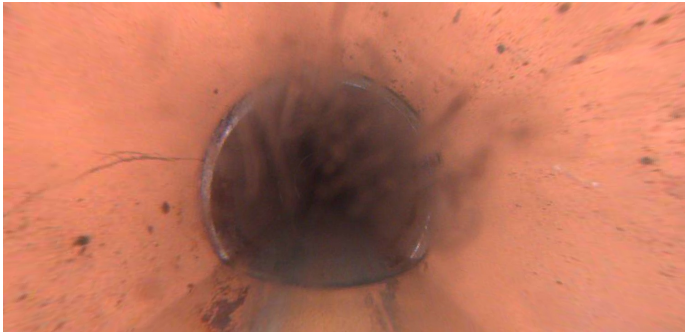
Code: **RFJ**
Description: **Roots Fine Joint**

Distance (ft): **174.0**
Structural Grade: **0**
O&M Grade: **1**
Clock Start/From: **9**
Clock To:
1st Value:
2nd Value:
Value Percent:
Continuous Index:
Within 8" of Joint: **YES**
Remarks:

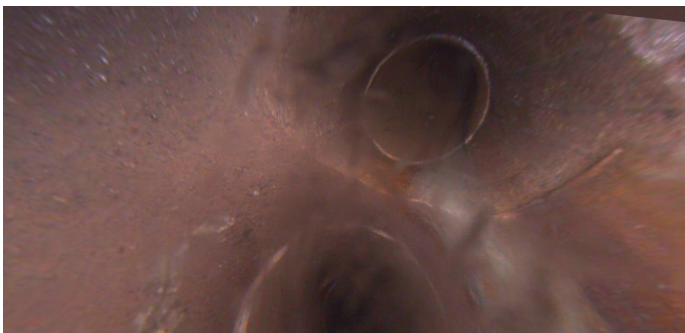
Code: **TF**
Description: **Tap Factory**

Distance (ft): **175.7**
Structural Grade: **0**
O&M Grade: **0**
Clock Start/From: **1**
Clock To:
1st Value: **4.000**
2nd Value:
Value Percent:
Continuous Index:
Within 8" of Joint:
Remarks:

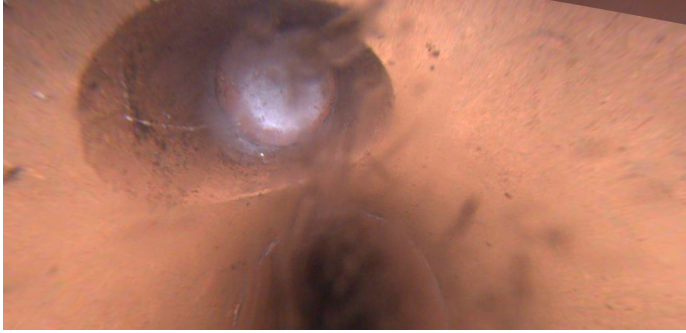
Code: **TFC**
Description: **Tap Factory Capped**

Distance (ft): **177.8**
Structural Grade: **0**
O&M Grade: **0**
Clock Start/From: **11**
Clock To:
1st Value: **4.000**
2nd Value:
Value Percent:
Continuous Index:
Within 8" of Joint:
Remarks:

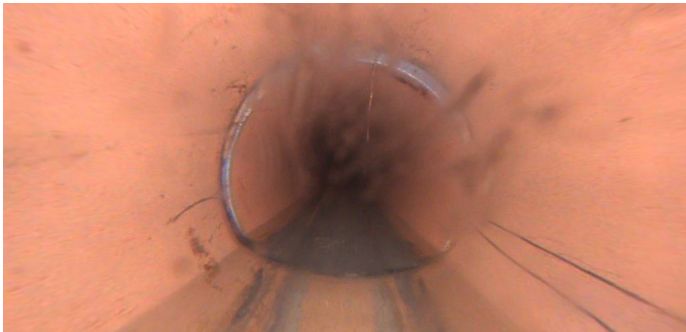
Code: **RFJ**
Description: **Roots Fine Joint**

Distance (ft): **183.2**
Structural Grade: **0**
O&M Grade: **1**
Clock Start/From: **8**
Clock To: **4**
1st Value:
2nd Value:
Value Percent:
Continuous Index: **S01**
Within 8" of Joint: **YES**
Remarks:

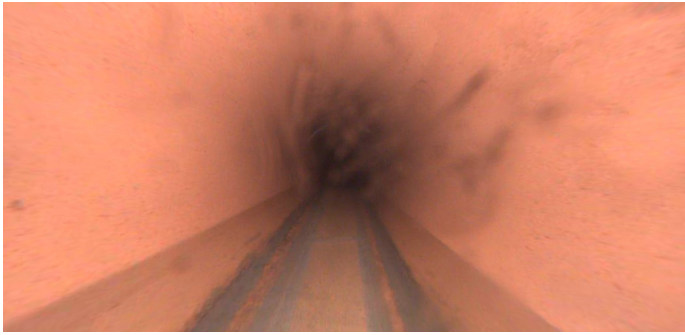
Code: **RFJ**
Description: **Roots Fine Joint**

Distance (ft): **197.0**
Structural Grade: **0**
O&M Grade: **1**
Clock Start/From: **8**
Clock To: **4**
1st Value:
2nd Value:
Value Percent:
Continuous Index: **F01**
Within 8" of Joint: **YES**
Remarks:

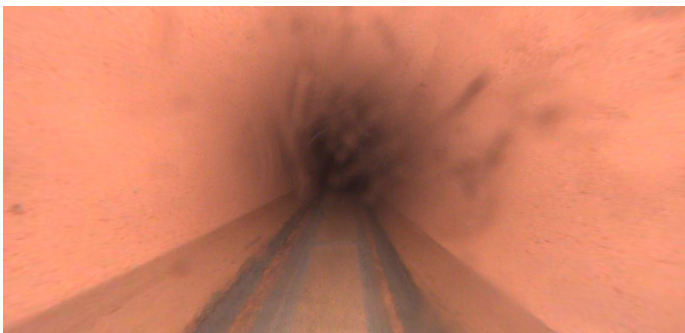
Code: **MSA**
Description: **Abandoned Survey**

Distance (ft): **197.0**
Structural Grade: **0**
O&M Grade: **0**
Clock Start/From:
Clock To:
1st Value:
2nd Value:
Value Percent:
Continuous Index:
Within 8" of Joint: **NO**
Remarks: **UNKNOWN**
