## Profile/Photo Observation Report

Street:	<b>W 40th ave</b>	Flow Control:	<b>Not Controlled</b>
City:	<b>Hobart, IN</b>	Year Renewed:	
Location:	<b>Other</b>	Tape/Media #:	
Purpose:	<b>Not Known</b>	Dia/Height:	<b>12"</b>
Use:	<b>Sanitary</b>	Material:	<b>VCP</b>
Drain Area:	<b>NA</b>	Lining:	
Category:	<b>NA</b>		
Comment:

Location Details:		Direction of Survey:	<b>Downstream</b>
US MH:	<b>M-503-063</b>	DS MH:	<b>M-503-064</b>
		Total Length Surveyed (ft):	<b>141.0</b>

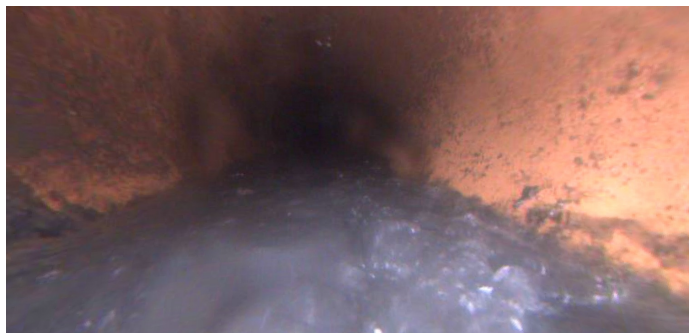
Code: **AMH**  
Description: **Manhole**

Distance (ft): **.0**  
Structural Grade: **0**  
O&M Grade: **0**  
Clock Start/From:  
Clock To:  
1st Value:  
2nd Value:  
Value Percent:  
Continuous Index:  
Within 8" of Joint: **NO**  
Remarks: **M-503-063**

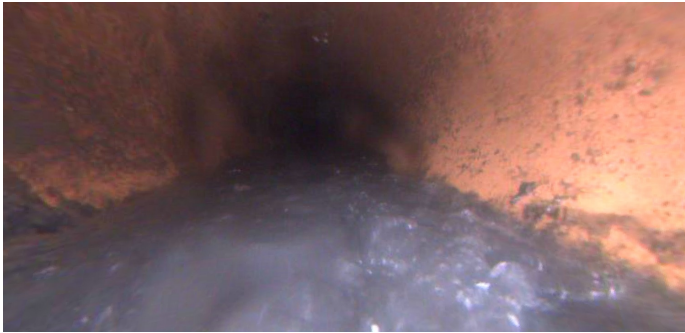
Code:	<b>MWL</b>
Description:	<b>Water Level</b>

Distance (ft):	<b>.0</b>
Structural Grade:	<b>0</b>
O&M Grade:	<b>0</b>
Clock Start/From:	
Clock To:	
1st Value:	
2nd Value:	
Value Percent:	<b>20.000</b>
Continuous Index:	
Within 8" of Joint:	<b>NO</b>
Remarks:

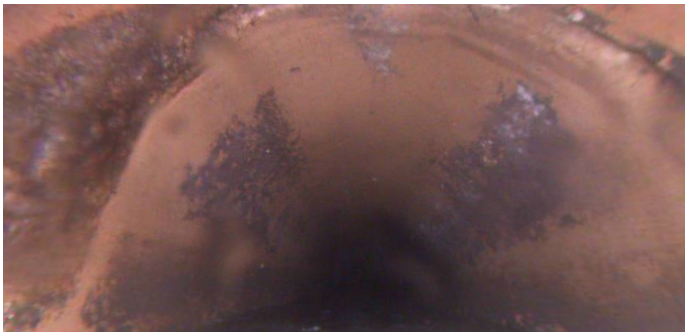
Code:	<b>IW</b>
Description:	<b>Infil Weeper</b>

Distance (ft):	<b>20.5</b>
Structural Grade:	<b>0</b>
O&M Grade:	<b>2</b>
Clock Start/From:	<b>8</b>
Clock To:	<b>12</b>
1st Value:	
2nd Value:	
Value Percent:	
Continuous Index:	
Within 8" of Joint:	<b>YES</b>
Remarks:

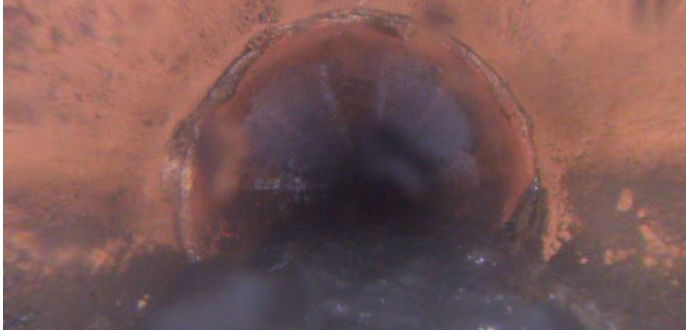
Code: **IW**  
Description: **Infil Weeper**

Distance (ft): **28.3**  
Structural Grade: **0**  
O&M Grade: **2**  
Clock Start/From: **8**  
Clock To: **4**  
1st Value:  
2nd Value:  
Value Percent:  
Continuous Index:  
Within 8" of Joint: **YES**  
Remarks:

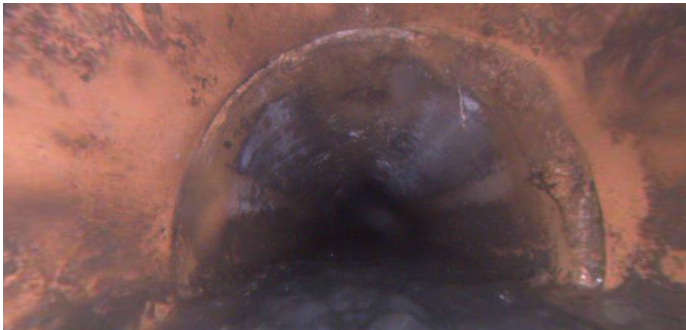
Code: **DAE**  
Description: **Deposits Attached Encrustation**

Distance (ft): **40.7**  
Structural Grade: **0**  
O&M Grade: **2**  
Clock Start/From: **12**  
Clock To: **4**  
1st Value:  
2nd Value:  
Value Percent: **5.000**  
Continuous Index:  
Within 8" of Joint: **YES**  
Remarks:

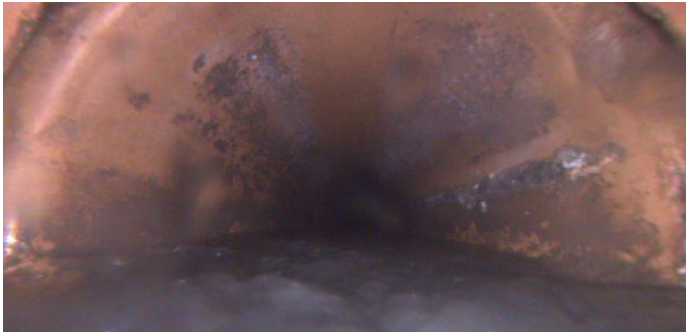
Code: **DAGS**  
Description: **Deposits Attached Grease**

Distance (ft): **45.2**  
Structural Grade: **0**  
O&M Grade: **2**  
Clock Start/From: **8**  
Clock To: **4**  
1st Value:  
2nd Value:  
Value Percent: **5.000**  
Continuous Index: **S01**  
Within 8" of Joint: **NO**  
Remarks:

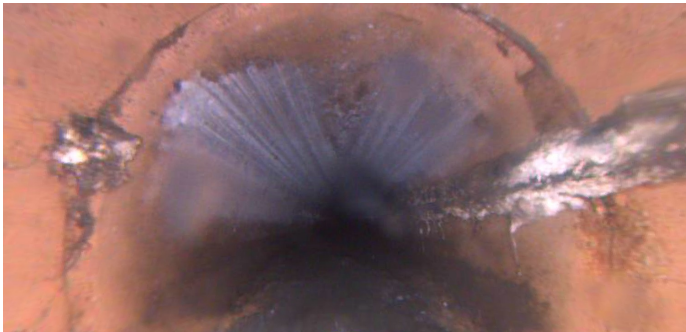
Code: **RFJ**  
Description: **Roots Fine Joint**

Distance (ft): **61.7**  
Structural Grade: **0**  
O&M Grade: **1**  
Clock Start/From: **9**  
Clock To:  
1st Value:  
2nd Value:  
Value Percent:  
Continuous Index:  
Within 8" of Joint: **YES**  
Remarks:

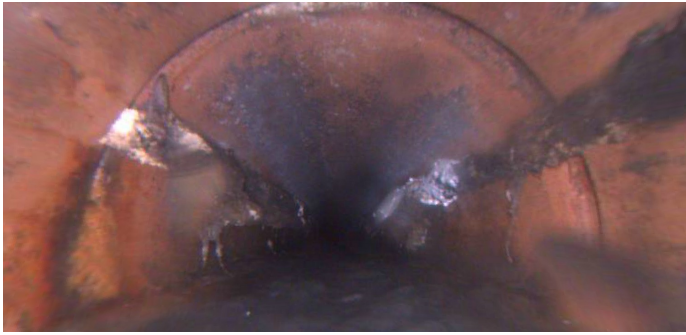
Code: **IW**  
Description: **Infil Weeper**

Distance (ft): **90.4**  
Structural Grade: **0**  
O&M Grade: **2**  
Clock Start/From: **8**  
Clock To: **10**  
1st Value:  
2nd Value:  
Value Percent:  
Continuous Index:  
Within 8" of Joint: **YES**  
Remarks:

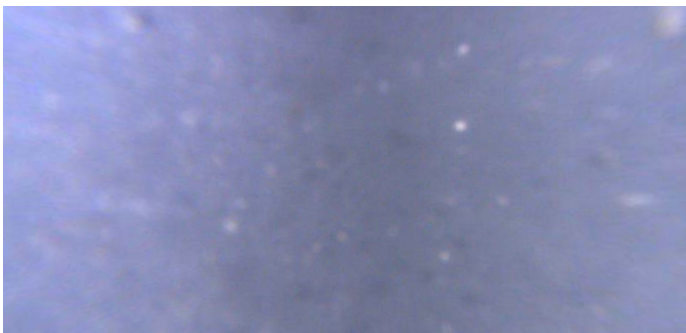
Code: **DAGS**  
Description: **Deposits Attached Grease**

Distance (ft): **123.9**  
Structural Grade: **0**  
O&M Grade: **2**  
Clock Start/From: **8**  
Clock To: **4**  
1st Value:  
2nd Value:  
Value Percent: **5.000**  
Continuous Index: **F01**  
Within 8" of Joint: **NO**  
Remarks:

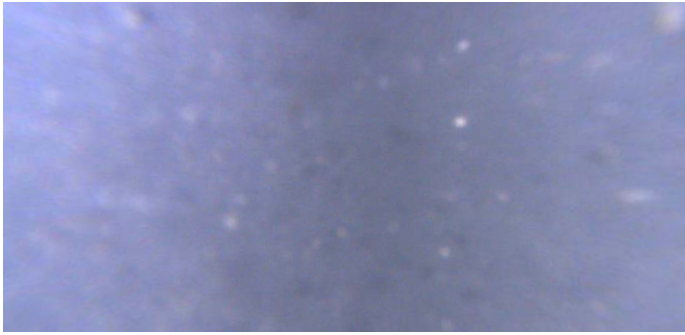
Code: **MWL**  
Description: **Water Level**

Distance (ft): **123.9**  
Structural Grade: **0**  
O&M Grade: **0**  
Clock Start/From:  
Clock To:  
1st Value:  
2nd Value:  
Value Percent: **100.000**  
Continuous Index:  
Within 8" of Joint: **NO**  
Remarks:

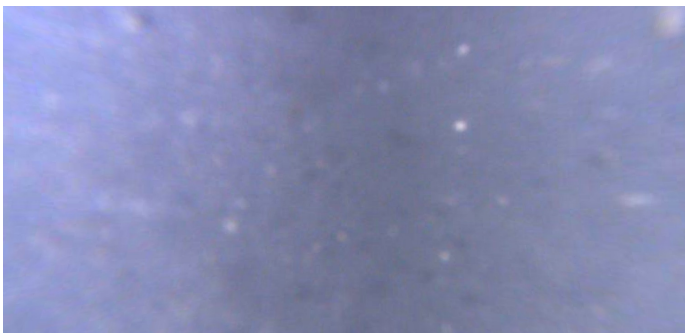
Code: **MCU**  
Description: **Camera Underwater**

Distance (ft): **123.9**  
Structural Grade: **0**  
O&M Grade: **4**  
Clock Start/From:  
Clock To:  
1st Value:  
2nd Value:  
Value Percent:  
Continuous Index: **S02**  
Within 8" of Joint: **NO**  
Remarks:

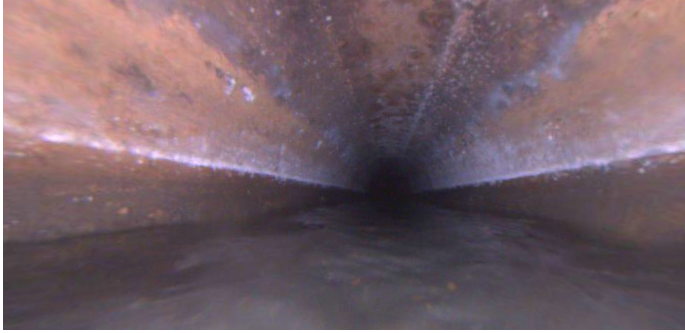
Code: **MCU**  
Description: **Camera Underwater**

Distance (ft): **132.8**  
Structural Grade: **0**  
O&M Grade: **4**  
Clock Start/From:  
Clock To:  
1st Value:  
2nd Value:  
Value Percent:  
Continuous Index: **F02**  
Within 8" of Joint: **NO**  
Remarks:

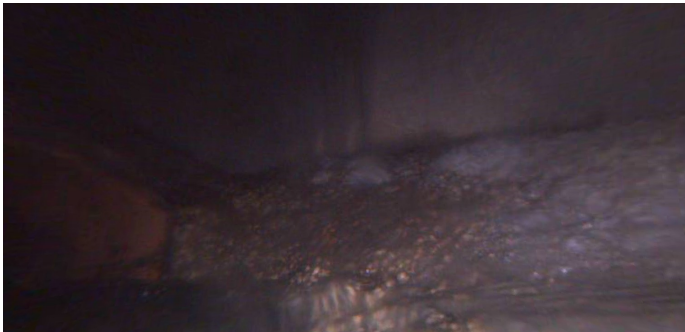
Code: **AMH**  
Description: **Manhole**

Distance (ft): **141.0**  
Structural Grade: **0**  
O&M Grade: **0**  
Clock Start/From:  
Clock To:  
1st Value:  
2nd Value:  
Value Percent:  
Continuous Index:  
Within 8" of Joint: **NO**  
Remarks: **M-503-064**
