Profile/Photo Observation Report

Street:	N WISCONSIN ST	Flow Control:	Not Controlled
City:	Hobart, IN	Year Renewed:	
Location:	Other	Tape/Media #:	
Purpose:	Not Known	Dia/Height:	8"
Use:	Sanitary	Material:	VCP
Drain Area:	NA	Lining:	
Category:	NA		
Comment:

Location Details:		Direction of Survey:	Downstream
US MH:	M-503-068	DS MH:	M-503-069
		Total Length Surveyed (ft):	119.8

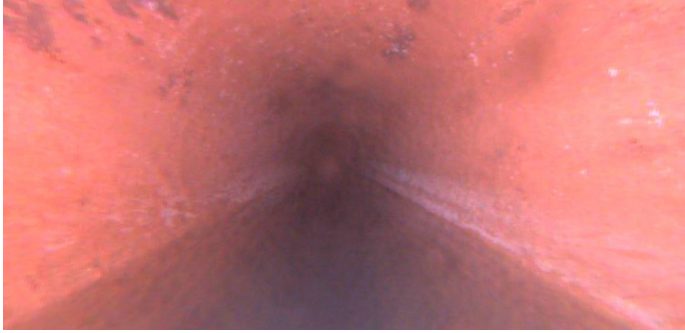
Code: **AMH**
Description: **Manhole**

Distance (ft): **.0**
Structural Grade: **0**
O&M Grade: **0**
Clock Start/From:
Clock To:
1st Value:
2nd Value:
Value Percent:
Continuous Index:
Within 8" of Joint: **NO**
Remarks: **M-503-068**

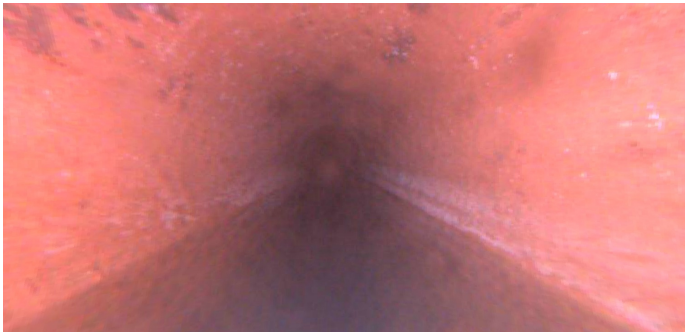
Code: **MWL**
Description: **Water Level**

Distance (ft): **.0**
Structural Grade: **0**
O&M Grade: **0**
Clock Start/From:
Clock To:
1st Value:
2nd Value:
Value Percent: **5.000**
Continuous Index:
Within 8" of Joint: **NO**
Remarks:

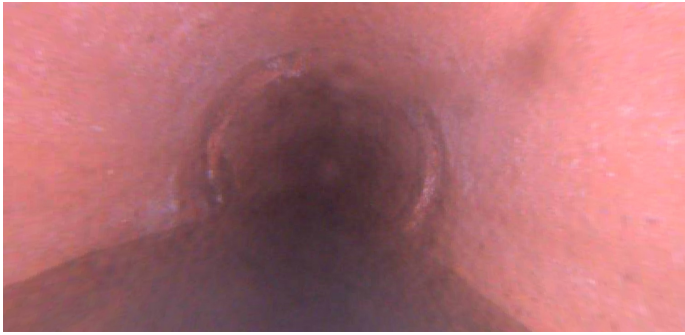
Code: **DAE**
Description: **Deposits Attached Encrustation**

Distance (ft): **7.8**
Structural Grade: **0**
O&M Grade: **2**
Clock Start/From: **7**
Clock To: **5**
1st Value:
2nd Value:
Value Percent: **10.000**
Continuous Index:
Within 8" of Joint: **YES**
Remarks:

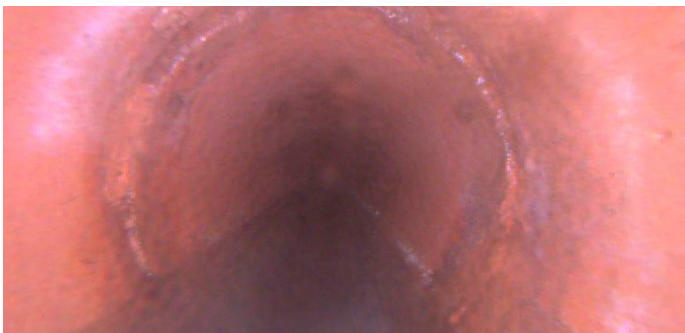
Code: **DAE**
Description: **Deposits Attached Encrustation**

Distance (ft): **13.1**
Structural Grade: **0**
O&M Grade: **2**
Clock Start/From: **7**
Clock To: **5**
1st Value:
2nd Value:
Value Percent: **5.000**
Continuous Index:
Within 8" of Joint: **YES**
Remarks:

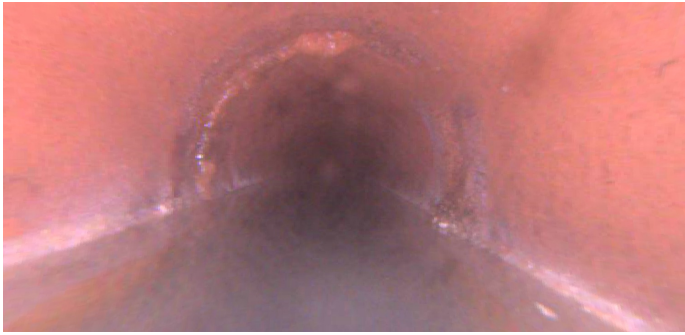
Code: **DAE**
Description: **Deposits Attached Encrustation**

Distance (ft): **22.8**
Structural Grade: **0**
O&M Grade: **2**
Clock Start/From: **7**
Clock To: **5**
1st Value:
2nd Value:
Value Percent: **5.000**
Continuous Index: **S01**
Within 8" of Joint: **YES**
Remarks:

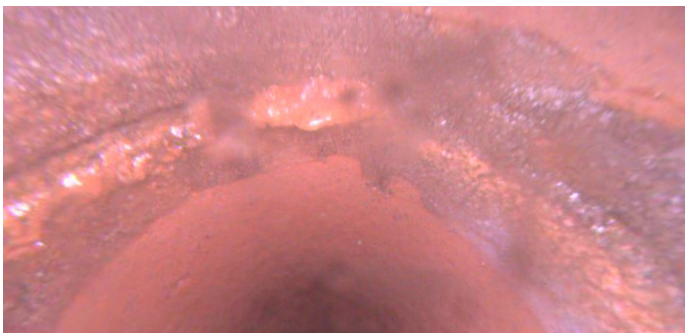
Code: **ID**
Description: **Infil Dripper**

Distance (ft): **23.2**
Structural Grade: **0**
O&M Grade: **3**
Clock Start/From: **12**
Clock To:
1st Value:
2nd Value:
Value Percent:
Continuous Index:
Within 8" of Joint: **YES**
Remarks:

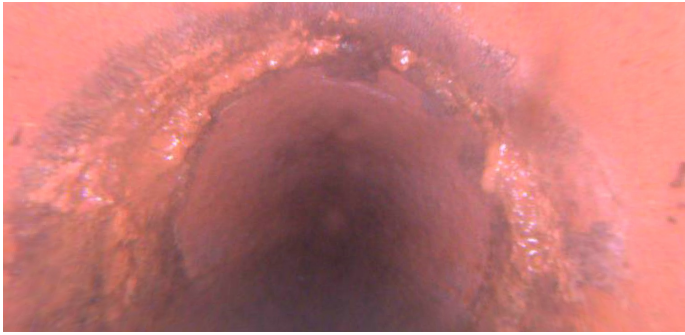
Code: ID
Description: Infil Dripper

Distance (ft): 28.0
Structural Grade: 0
O&M Grade: 3
Clock Start/From: 11
Clock To: 1
1st Value:
2nd Value:
Value Percent:
Continuous Index:
Within 8" of Joint: YES
Remarks:

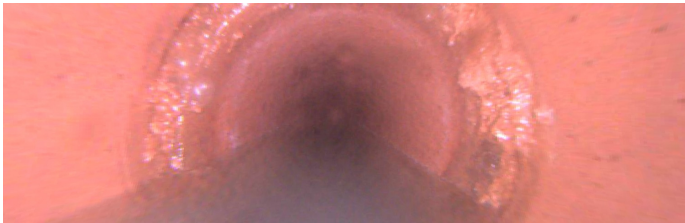
Code: DAE
Description: Deposits Attached Encrustation

Distance (ft): 33.0
Structural Grade: 0
O&M Grade: 2
Clock Start/From: 7
Clock To: 5
1st Value:
2nd Value:
Value Percent: 5.000
Continuous Index: F01
Within 8" of Joint: YES
Remarks:

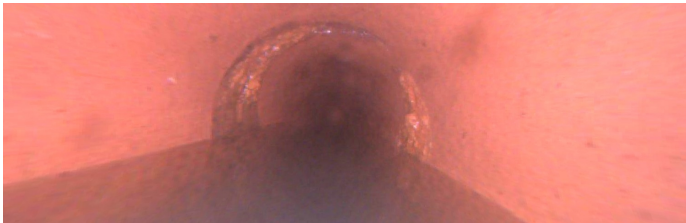
Code: **DAE**
Description: **Deposits Attached Encrustation**

Distance (ft): **47.6**
Structural Grade: **0**
O&M Grade: **2**
Clock Start/From: **7**
Clock To: **5**
1st Value:
2nd Value:
Value Percent: **10.000**
Continuous Index:
Within 8" of Joint: **YES**
Remarks:

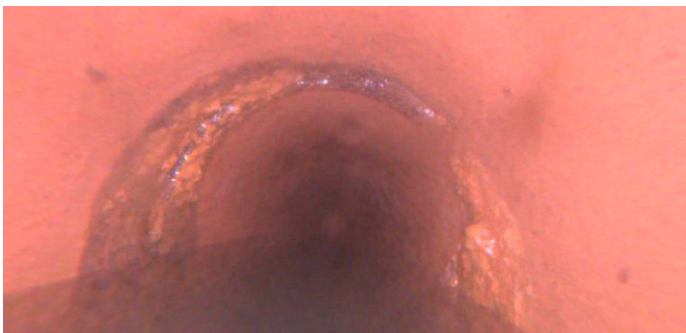
Code: **IW**
Description: **Infil Weeper**

Distance (ft): **47.7**
Structural Grade: **0**
O&M Grade: **2**
Clock Start/From: **8**
Clock To: **4**
1st Value:
2nd Value:
Value Percent:
Continuous Index:
Within 8" of Joint: **YES**
Remarks:

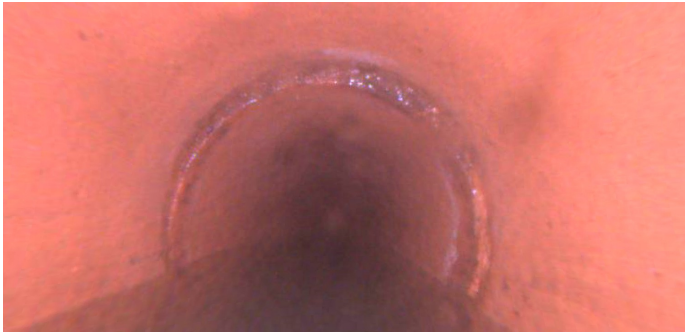
Code: **IW**
Description: **Infil Weeper**

Distance (ft): **52.7**
Structural Grade: **0**
O&M Grade: **2**
Clock Start/From: **8**
Clock To: **4**
1st Value:
2nd Value:
Value Percent:
Continuous Index:
Within 8" of Joint: **YES**
Remarks:

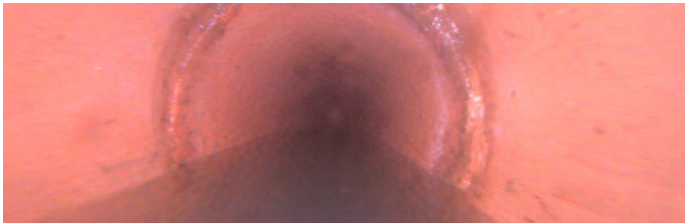
Code: **DAE**
Description: **Deposits Attached Encrustation**

Distance (ft): **52.9**
Structural Grade: **0**
O&M Grade: **2**
Clock Start/From: **8**
Clock To: **4**
1st Value:
2nd Value:
Value Percent: **5.000**
Continuous Index:
Within 8" of Joint: **YES**
Remarks:

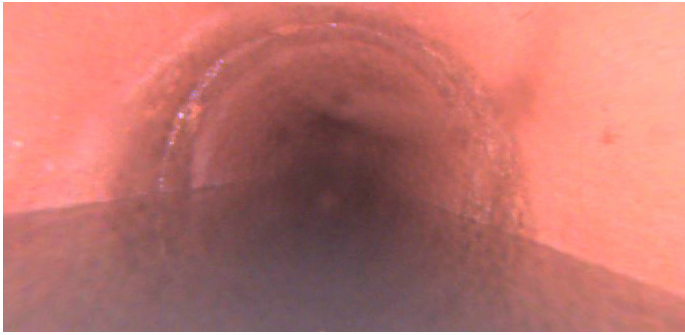
Code: **DAE**
Description: **Deposits Attached Encrustation**

Distance (ft): **64.6**
Structural Grade: **0**
O&M Grade: **2**
Clock Start/From: **8**
Clock To: **4**
1st Value:
2nd Value:
Value Percent: **10.000**
Continuous Index:
Within 8" of Joint: **YES**
Remarks:

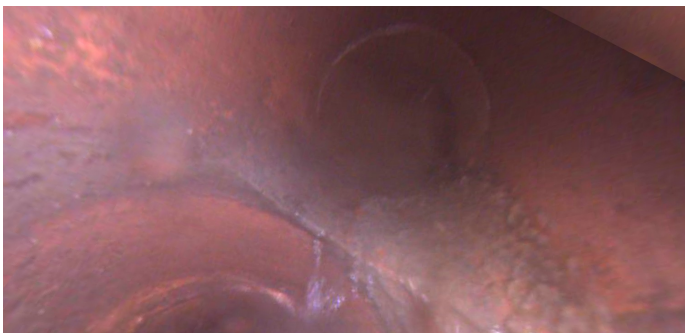
Code: **TFA**
Description: **Tap Factory Active**

Distance (ft): **71.2**
Structural Grade: **0**
O&M Grade: **0**
Clock Start/From: **1**
Clock To:
1st Value: **4.000**
2nd Value:
Value Percent:
Continuous Index:
Within 8" of Joint:
Remarks:

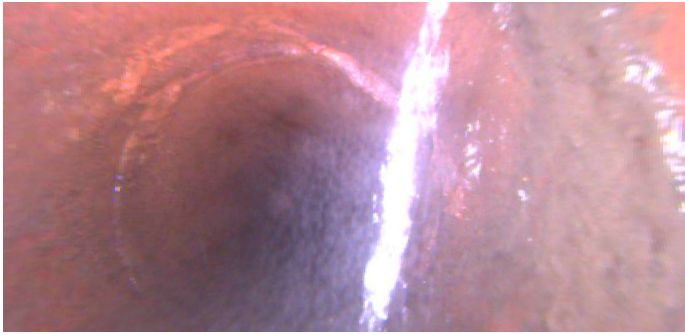
Code: **DAE**
Description: **Deposits Attached Encrustation**

Distance (ft): **71.5**
Structural Grade: **0**
O&M Grade: **2**
Clock Start/From: **10**
Clock To: **4**
1st Value:
2nd Value:
Value Percent: **5.000**
Continuous Index:
Within 8" of Joint: **YES**
Remarks:

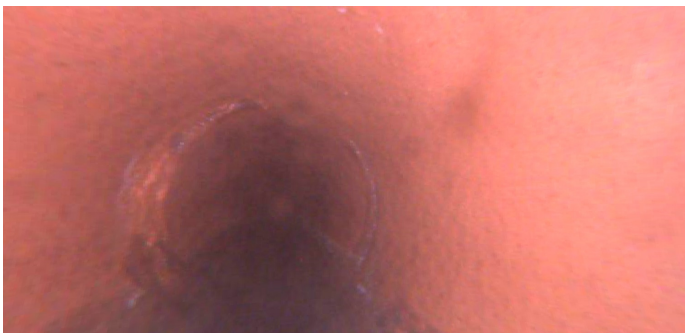
Code: **DAE**
Description: **Deposits Attached Encrustation**

Distance (ft): **76.1**
Structural Grade: **0**
O&M Grade: **2**
Clock Start/From: **7**
Clock To: **12**
1st Value:
2nd Value:
Value Percent: **5.000**
Continuous Index:
Within 8" of Joint: **YES**
Remarks:

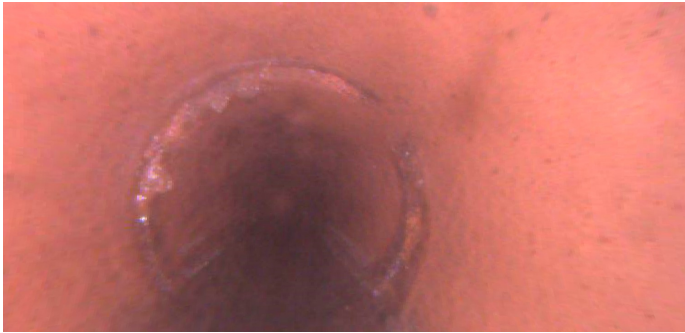
Code: **DAE**
Description: **Deposits Attached Encrustation**

Distance (ft): **81.3**
Structural Grade: **0**
O&M Grade: **2**
Clock Start/From: **7**
Clock To: **5**
1st Value:
2nd Value:
Value Percent: **10.000**
Continuous Index:
Within 8" of Joint: **YES**
Remarks:

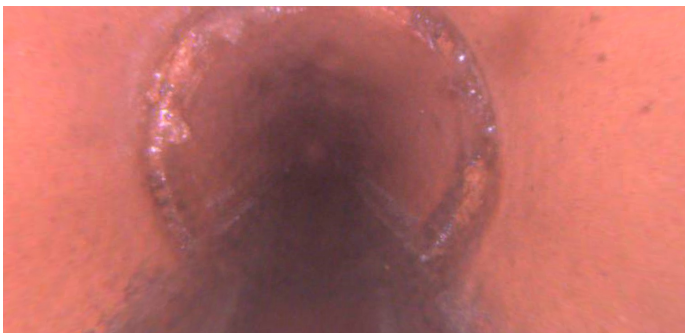
Code: **IW**
Description: **Infil Weeper**

Distance (ft): **81.4**
Structural Grade: **0**
O&M Grade: **2**
Clock Start/From: **8**
Clock To: **4**
1st Value:
2nd Value:
Value Percent:
Continuous Index:
Within 8" of Joint: **YES**
Remarks:

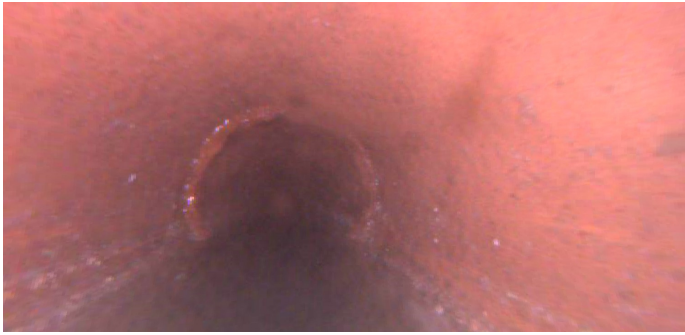
Code:	DAE
Description:	Deposits Attached Encrustation

Distance (ft):	91.0
Structural Grade:	0
O&M Grade:	2
Clock Start/From:	7
Clock To:	5
1st Value:	
2nd Value:	
Value Percent:	5.000
Continuous Index:	
Within 8" of Joint:	YES
Remarks:

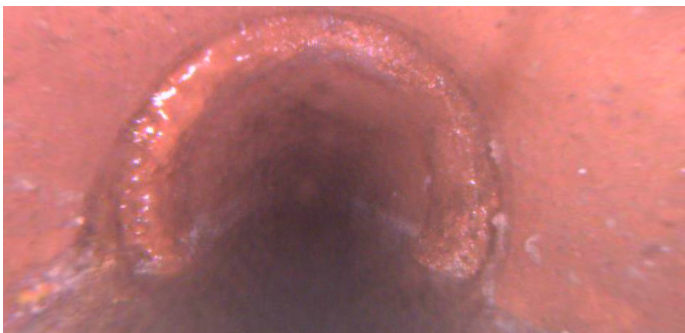
Code:	IW
Description:	Infil Weeper

Distance (ft):	91.5
Structural Grade:	0
O&M Grade:	2
Clock Start/From:	8
Clock To:	4
1st Value:	
2nd Value:	
Value Percent:	
Continuous Index:	
Within 8" of Joint:	YES
Remarks:

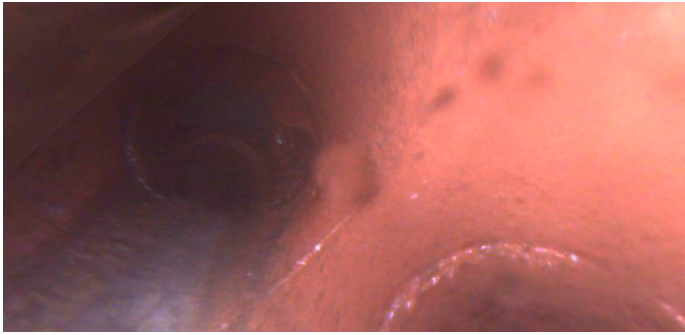
Code: **TF**
Description: **Tap Factory**

Distance (ft): **93.3**
Structural Grade: **0**
O&M Grade: **0**
Clock Start/From: **10**
Clock To:
1st Value: **4.000**
2nd Value:
Value Percent:
Continuous Index:
Within 8" of Joint:
Remarks:

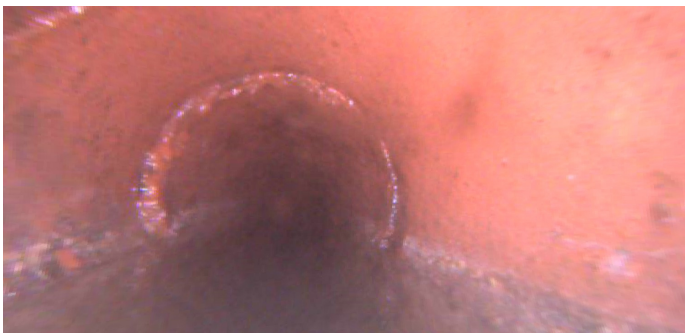
Code: **DAE**
Description: **Deposits Attached Encrustation**

Distance (ft): **93.3**
Structural Grade: **0**
O&M Grade: **2**
Clock Start/From: **7**
Clock To: **5**
1st Value:
2nd Value:
Value Percent: **10.000**
Continuous Index:
Within 8" of Joint: **YES**
Remarks:

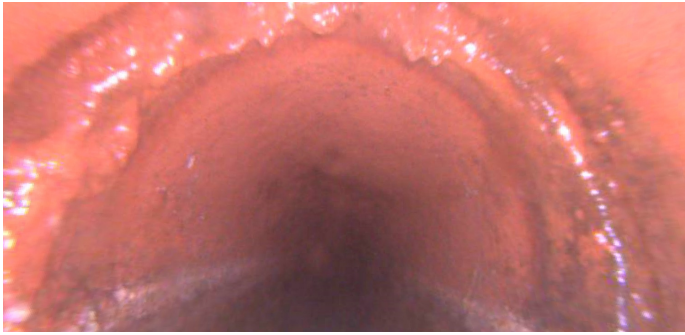
Code: **IW**
Description: **Infil Weeper**

Distance (ft): **93.7**
Structural Grade: **0**
O&M Grade: **2**
Clock Start/From: **8**
Clock To: **4**
1st Value:
2nd Value:
Value Percent:
Continuous Index:
Within 8" of Joint: **YES**
Remarks:

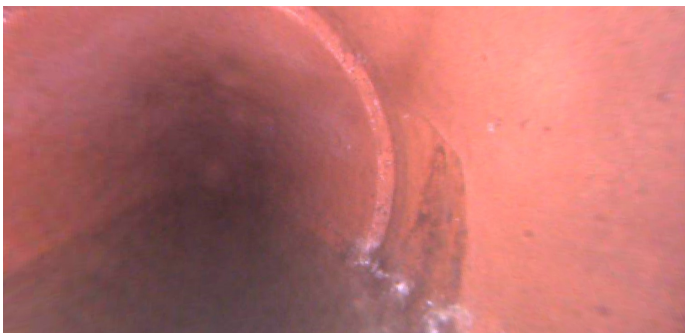
Code: **CC**
Description: **Crack Circumferential**

Distance (ft): **98.5**
Structural Grade: **1**
O&M Grade: **0**
Clock Start/From: **3**
Clock To: **4**
1st Value:
2nd Value:
Value Percent:
Continuous Index:
Within 8" of Joint: **YES**
Remarks:

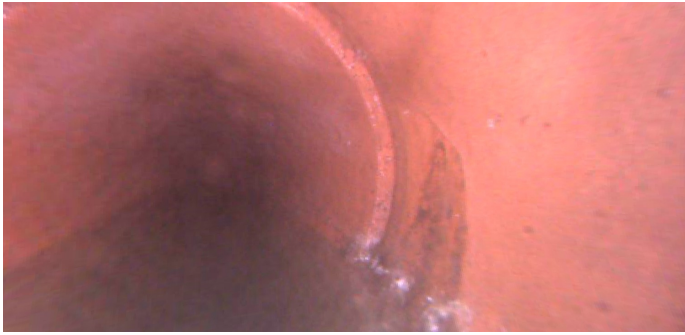
Code: **IS**
Description: **Infil Stain**

Distance (ft): **98.5**
Structural Grade: **0**
O&M Grade: **0**
Clock Start/From: **3**
Clock To: **5**
1st Value:
2nd Value:
Value Percent:
Continuous Index:
Within 8" of Joint: **YES**
Remarks:

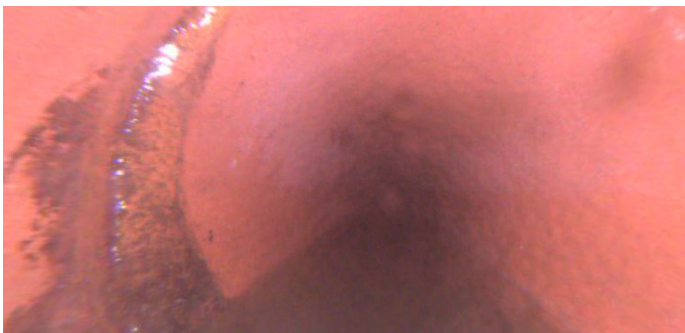
Code: **IW**
Description: **Infil Weeper**

Distance (ft): **103.7**
Structural Grade: **0**
O&M Grade: **2**
Clock Start/From: **8**
Clock To: **12**
1st Value:
2nd Value:
Value Percent:
Continuous Index:
Within 8" of Joint: **YES**
Remarks:

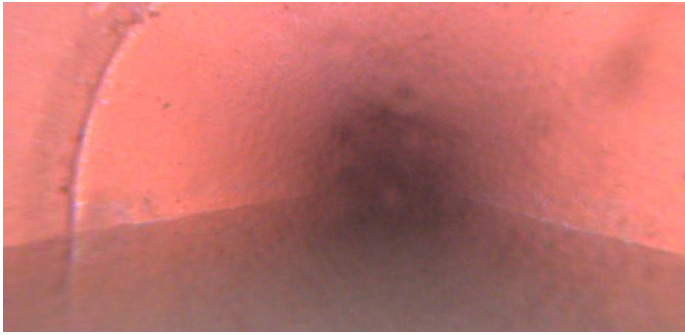
Code: **MWL**
Description: **Water Level**

Distance (ft): **113.8**
Structural Grade: **0**
O&M Grade: **0**
Clock Start/From:
Clock To:
1st Value:
2nd Value:
Value Percent: **40.000**
Continuous Index:
Within 8" of Joint: **NO**
Remarks:

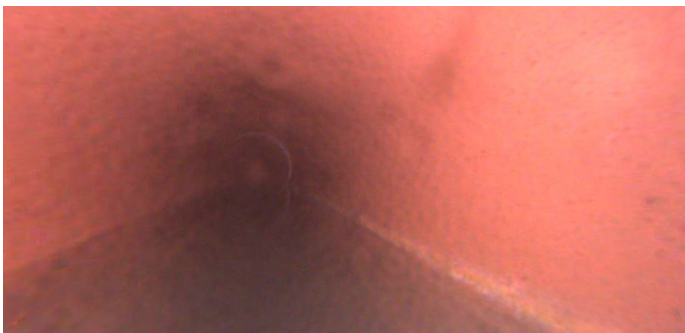
Code: **MSA**
Description: **Abandoned Survey**

Distance (ft): **119.8**
Structural Grade: **0**
O&M Grade: **0**
Clock Start/From:
Clock To:
1st Value:
2nd Value:
Value Percent:
Continuous Index:
Within 8" of Joint: **NO**
Remarks: **CAMERA STOPPED**
