Profile/Photo Observation Report

Date:	04/15/2018	Weather:		Coding:	PACP 6.0
Pipe Length (ft):	175.1	Owner:	NA	Pre Clean:	Not Known
P.O.#:		Surveyor:	Mark Ruby	PSR:	P-503-069-068
Customer:		Clean Date:	01/01/1900	Shape:	C

Location Details:		Direction of Survey:	Downstream
US MH:	M-503-068	DS MH:	M-503-069
		Total Length Surveyed (ft):	179.1

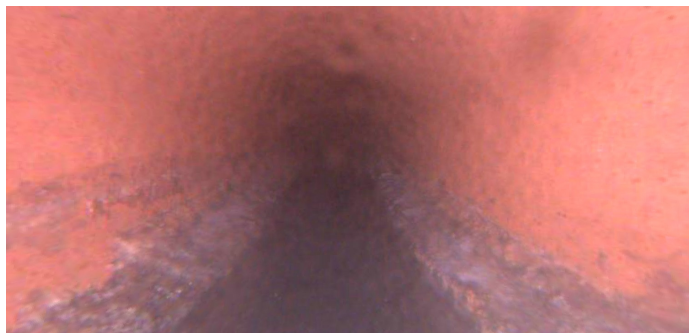
Code: **DAGS**
Description: **Deposits Attached Grease**

Distance (ft): **.0**
Structural Grade: **0**
O&M Grade: **2**
Clock Start/From: **7**
Clock To: **5**
1st Value:
2nd Value:
Value Percent: **10.000**
Continuous Index: **S01**
Within 8" of Joint: **NO**
Remarks:

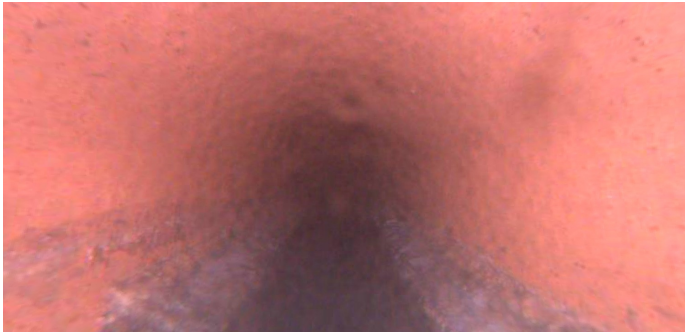
Code:	AMH
Description:	Manhole

Distance (ft):	.0
Structural Grade:	0
O&M Grade:	0
Clock Start/From:	
Clock To:	
1st Value:	
2nd Value:	
Value Percent:	
Continuous Index:	
Within 8" of Joint:	NO
Remarks:	M-503-068

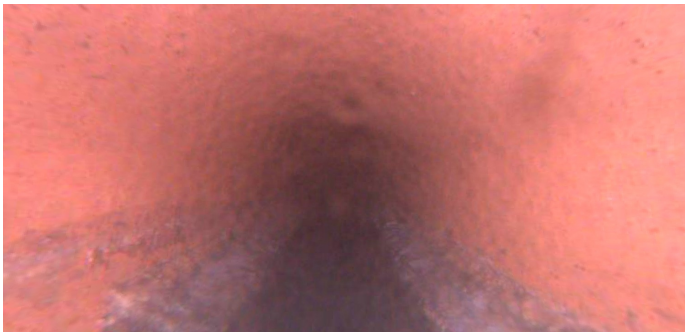
Code:	MWL
Description:	Water Level

Distance (ft):	.0
Structural Grade:	0
O&M Grade:	0
Clock Start/From:	
Clock To:	
1st Value:	
2nd Value:	
Value Percent:	10.000
Continuous Index:	
Within 8" of Joint:	NO
Remarks:

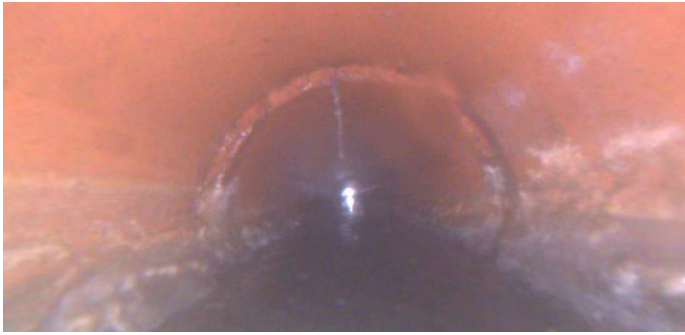
Code: **RFJ**
Description: **Roots Fine Joint**

Distance (ft): **15.8**
Structural Grade: **0**
O&M Grade: **1**
Clock Start/From: **12**
Clock To:
1st Value:
2nd Value:
Value Percent:
Continuous Index:
Within 8" of Joint: **YES**
Remarks:

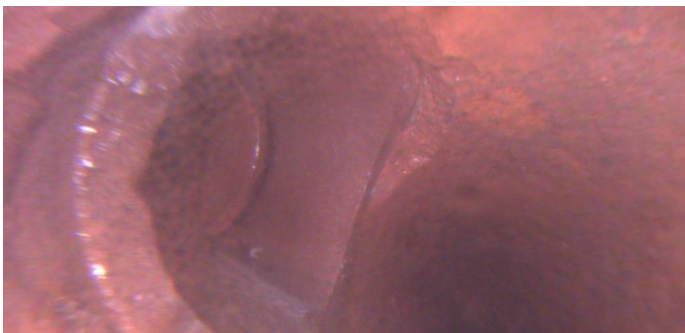
Code: **TB**
Description: **Tap Break-in**

Distance (ft): **46.9**
Structural Grade: **0**
O&M Grade: **0**
Clock Start/From: **10**
Clock To:
1st Value: **4.000**
2nd Value:
Value Percent:
Continuous Index:
Within 8" of Joint:
Remarks:

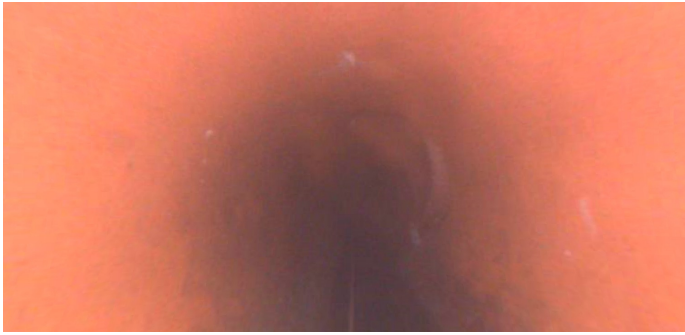
Code: **DAGS**
Description: **Deposits Attached Grease**

Distance (ft): **48.5**
Structural Grade: **0**
O&M Grade: **2**
Clock Start/From: **7**
Clock To: **5**
1st Value:
2nd Value:
Value Percent: **10.000**
Continuous Index: **F01**
Within 8" of Joint: **NO**
Remarks:

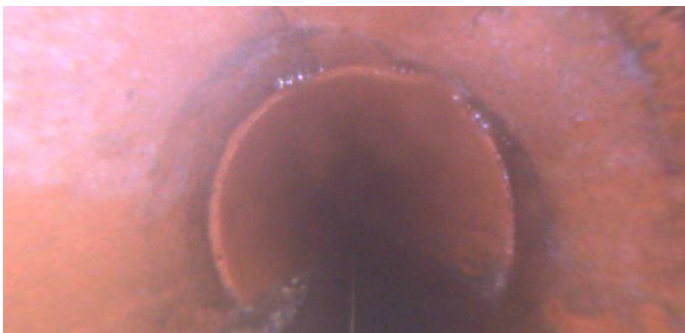
Code: **IW**
Description: **Infil Weeper**

Distance (ft): **55.2**
Structural Grade: **0**
O&M Grade: **2**
Clock Start/From: **8**
Clock To: **4**
1st Value:
2nd Value:
Value Percent:
Continuous Index:
Within 8" of Joint: **YES**
Remarks:

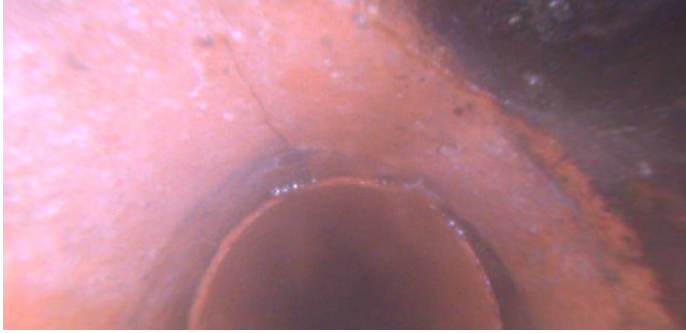
Code: **CL**
Description: **Crack Longitudinal**

Distance (ft): **55.3**
Structural Grade: **2**
O&M Grade: **0**
Clock Start/From: **12**
Clock To:
1st Value:
2nd Value:
Value Percent:
Continuous Index:
Within 8" of Joint:
Remarks:

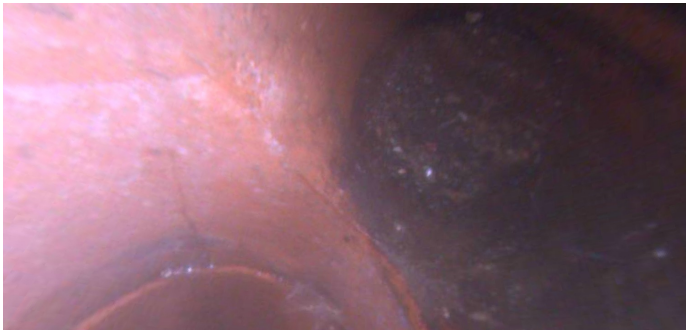
Code: **TFC**
Description: **Tap Factory Capped**

Distance (ft): **55.5**
Structural Grade: **0**
O&M Grade: **0**
Clock Start/From: **10**
Clock To:
1st Value: **4.000**
2nd Value:
Value Percent:
Continuous Index:
Within 8" of Joint:
Remarks:

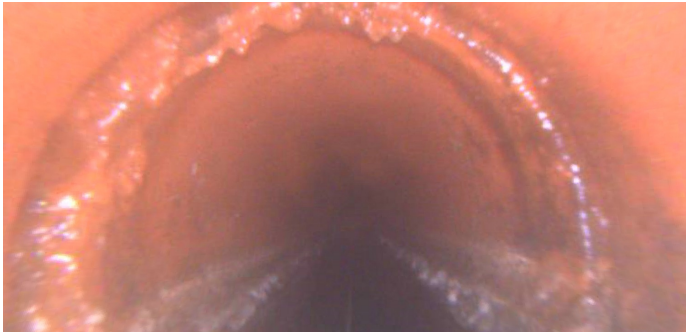
Code: **DAE**
Description: **Deposits Attached Encrustation**

Distance (ft): **82.0**
Structural Grade: **0**
O&M Grade: **2**
Clock Start/From: **8**
Clock To: **4**
1st Value:
2nd Value:
Value Percent: **5.000**
Continuous Index: **S03**
Within 8" of Joint: **YES**
Remarks:

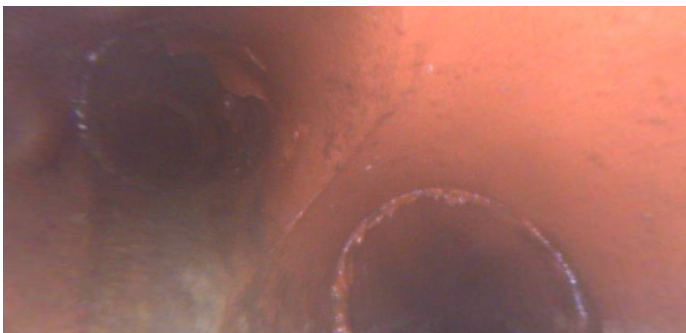
Code: **TF**
Description: **Tap Factory**

Distance (ft): **82.6**
Structural Grade: **0**
O&M Grade: **0**
Clock Start/From: **2**
Clock To:
1st Value: **4.000**
2nd Value:
Value Percent:
Continuous Index:
Within 8" of Joint:
Remarks:

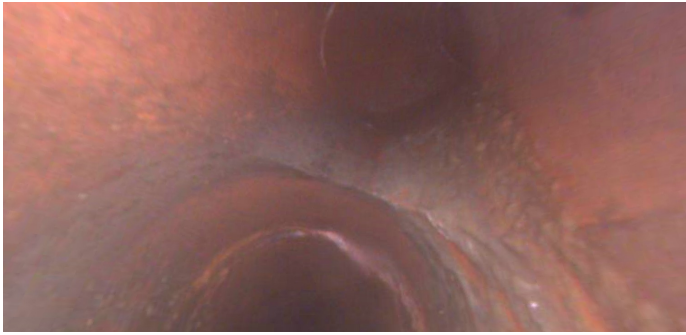
Code: **TF**
Description: **Tap Factory**

Distance (ft): **104.8**
Structural Grade: **0**
O&M Grade: **0**
Clock Start/From: **10**
Clock To:
1st Value: **4.000**
2nd Value:
Value Percent:
Continuous Index:
Within 8" of Joint:
Remarks:

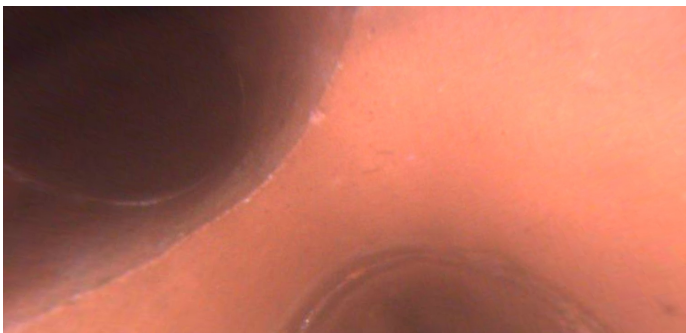
Code: **TF**
Description: **Tap Factory**

Distance (ft): **111.5**
Structural Grade: **0**
O&M Grade: **0**
Clock Start/From: **2**
Clock To:
1st Value: **4.000**
2nd Value:
Value Percent:
Continuous Index:
Within 8" of Joint:
Remarks:

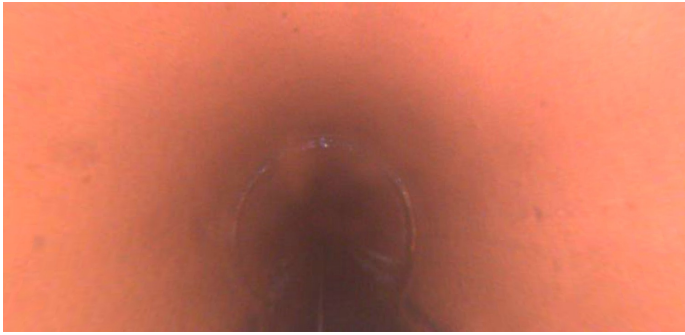
Code: **DAE**
Description: **Deposits Attached Encrustation**

Distance (ft): **123.9**
Structural Grade: **0**
O&M Grade: **2**
Clock Start/From: **8**
Clock To: **4**
1st Value:
2nd Value:
Value Percent: **5.000**
Continuous Index: **F03**
Within 8" of Joint: **YES**
Remarks:

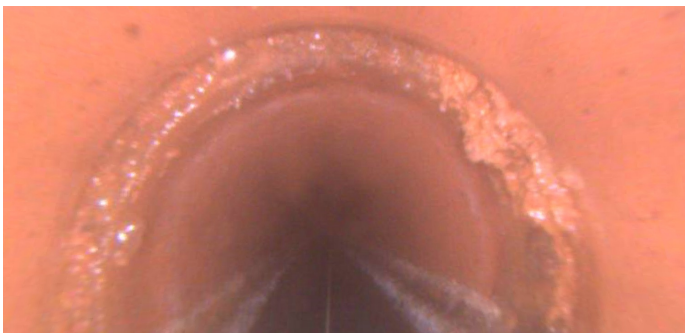
Code: **DAE**
Description: **Deposits Attached Encrustation**

Distance (ft): **143.1**
Structural Grade: **0**
O&M Grade: **2**
Clock Start/From: **8**
Clock To: **4**
1st Value:
2nd Value:
Value Percent: **5.000**
Continuous Index:
Within 8" of Joint: **YES**
Remarks:

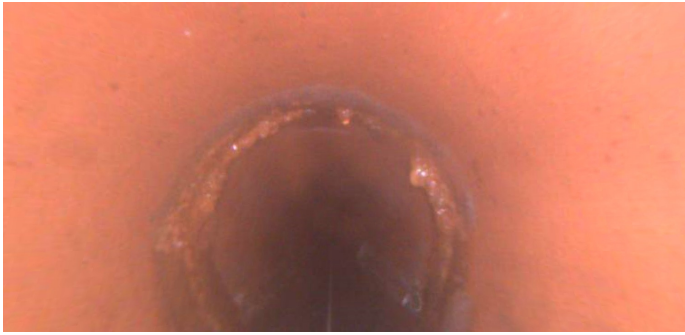
Code: ID
Description: Infil Dripper

Distance (ft): 148.5
Structural Grade: 0
O&M Grade: 3
Clock Start/From: 12
Clock To:
1st Value:
2nd Value:
Value Percent:
Continuous Index:
Within 8" of Joint: YES
Remarks:

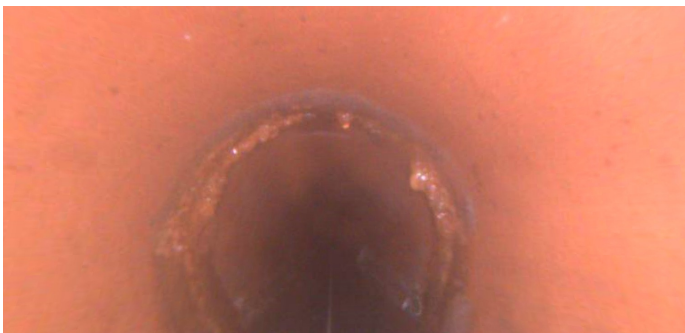
Code: DAE
Description: Deposits Attached Encrustation

Distance (ft): 148.5
Structural Grade: 0
O&M Grade: 2
Clock Start/From: 8
Clock To: 4
1st Value:
2nd Value:
Value Percent: 5.000
Continuous Index:
Within 8" of Joint: YES
Remarks:

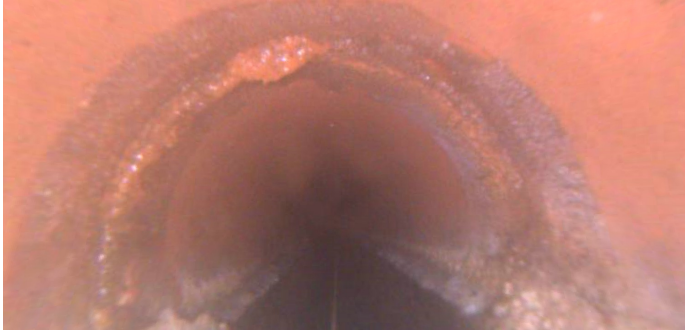
Code: ID
Description: Infil Dripper

Distance (ft): 153.2
Structural Grade: 0
O&M Grade: 3
Clock Start/From: 12
Clock To:
1st Value:
2nd Value:
Value Percent:
Continuous Index:
Within 8" of Joint: YES
Remarks:

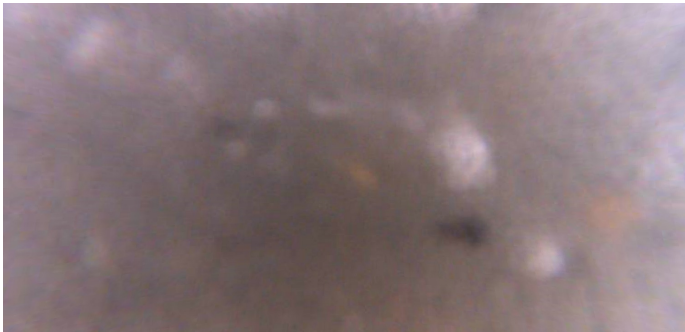
Code: AMH
Description: Manhole

Distance (ft): 179.1
Structural Grade: 0
O&M Grade: 0
Clock Start/From:
Clock To:
1st Value:
2nd Value:
Value Percent:
Continuous Index:
Within 8" of Joint: NO
Remarks: M-503-069
