## Profile/Photo Observation Report

Street:	<b>W 40th ave</b>	Flow Control:	<b>Not Controlled</b>
City:	<b>Hobart, IN</b>	Year Renewed:	
Location:	<b>Other</b>	Tape/Media #:	
Purpose:	<b>Not Known</b>	Dia/Height:	<b>8"</b>
Use:	<b>Sanitary</b>	Material:	<b>VCP</b>
Drain Area:	<b>NA</b>	Lining:	
Category:	<b>NA</b>		
Comment:

Location Details:		Direction of Survey:	<b>Downstream</b>
US MH:	<b>M-503-068</b>	DS MH:	<b>M-503-069</b>
		Total Length Surveyed (ft):	<b>179.1</b>

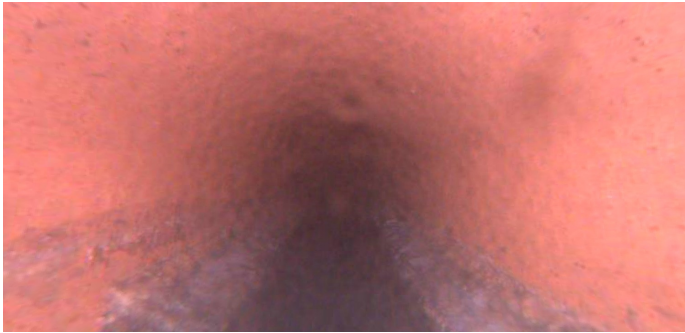
Code:	<b>AMH</b>
Description:	<b>Manhole</b>

Distance (ft):	<b>.0</b>
Structural Grade:	<b>0</b>
O&M Grade:	<b>0</b>
Clock Start/From:	
Clock To:	
1st Value:	
2nd Value:	
Value Percent:	
Continuous Index:	
Within 8" of Joint:	<b>NO</b>
Remarks:	<b>M-503-068</b>

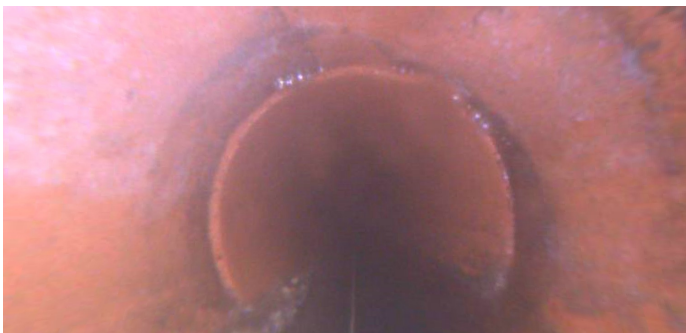
Code: **IW**  
Description: **Infil Weeper**

Distance (ft): **55.2**  
Structural Grade: **0**  
O&M Grade: **2**  
Clock Start/From: **8**  
Clock To: **4**  
1st Value:  
2nd Value:  
Value Percent:  
Continuous Index:  
Within 8" of Joint: **YES**  
Remarks:

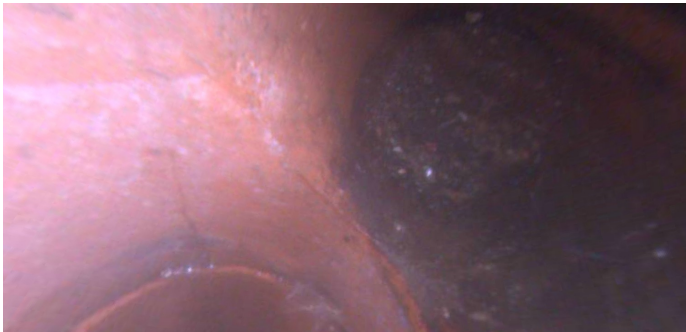
Code: **TFC**  
Description: **Tap Factory Capped**

Distance (ft): **55.5**  
Structural Grade: **0**  
O&M Grade: **0**  
Clock Start/From: **10**  
Clock To:  
1st Value: **4.000**  
2nd Value:  
Value Percent:  
Continuous Index:  
Within 8" of Joint:  
Remarks:

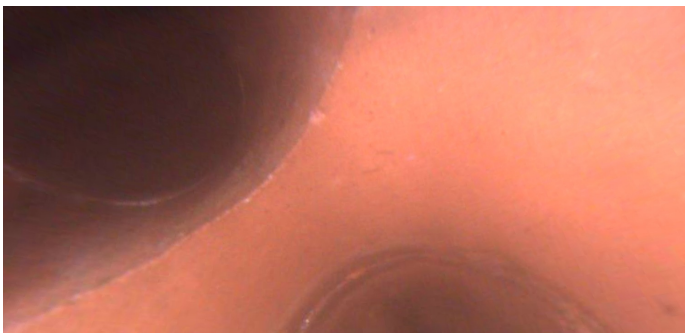
Code: **TF**  
Description: **Tap Factory**

Distance (ft): **111.5**  
Structural Grade: **0**  
O&M Grade: **0**  
Clock Start/From: **2**  
Clock To:  
1st Value: **4.000**  
2nd Value:  
Value Percent:  
Continuous Index:  
Within 8" of Joint:  
Remarks:

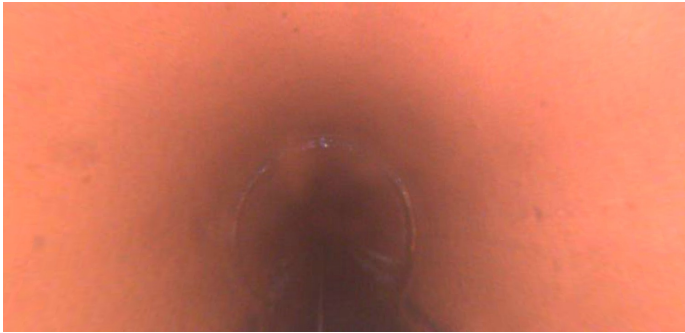
Code: **DAE**  
Description: **Deposits Attached Encrustation**

Distance (ft): **123.9**  
Structural Grade: **0**  
O&M Grade: **2**  
Clock Start/From: **8**  
Clock To: **4**  
1st Value:  
2nd Value:  
Value Percent: **5.000**  
Continuous Index: **F03**  
Within 8" of Joint: **YES**  
Remarks:

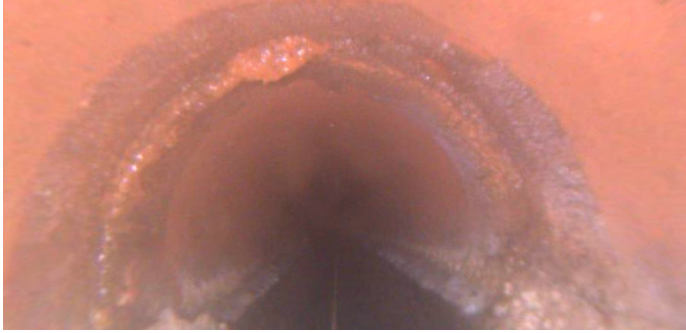
Code: ID  
Description: Infil Dripper

Distance (ft): 153.2  
Structural Grade: 0  
O&M Grade: 3  
Clock Start/From: 12  
Clock To:  
1st Value:  
2nd Value:  
Value Percent:  
Continuous Index:  
Within 8" of Joint: YES  
Remarks:

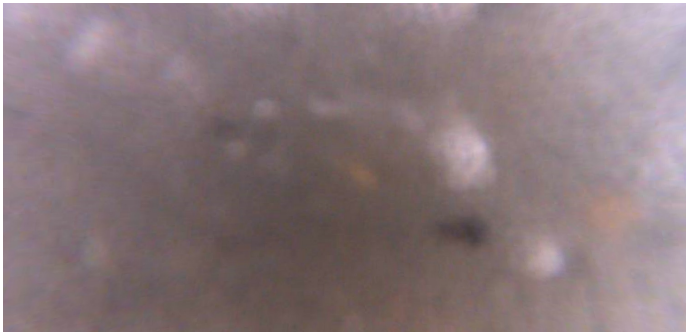
Code: AMH  
Description: Manhole

Distance (ft): 179.1  
Structural Grade: 0  
O&M Grade: 0  
Clock Start/From:  
Clock To:  
1st Value:  
2nd Value:  
Value Percent:  
Continuous Index:  
Within 8" of Joint: NO  
Remarks: M-503-069
