## Profile/Photo Observation Report

Street:	<b>IOWA ST</b>	Flow Control:	<b>Not Controlled</b>
City:	<b>Hobart, IN</b>	Year Renewed:	
Location:	<b>Other</b>	Tape/Media #:	
Purpose:	<b>Not Known</b>	Dia/Height:	<b>8"</b>
Use:	<b>Sanitary</b>	Material:	<b>PVC</b>
Drain Area:	<b>NA</b>	Lining:	
Category:	<b>NA</b>		
Comment:

Location Details:		Direction of Survey:	<b>Downstream</b>
US MH:	<b>M-503-069</b>	DS MH:	<b>M-503-070</b>
		Total Length Surveyed (ft):	<b>226.1</b>

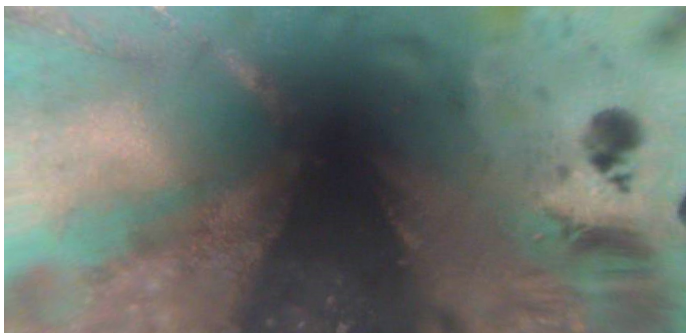
Code: **DAGS**  
Description: **Deposits Attached Grease**

Distance (ft): **.0**  
Structural Grade: **0**  
O&M Grade: **2**  
Clock Start/From: **8**  
Clock To: **4**  
1st Value:  
2nd Value:  
Value Percent: **5.000**  
Continuous Index: **S01**  
Within 8" of Joint: **NO**  
Remarks:

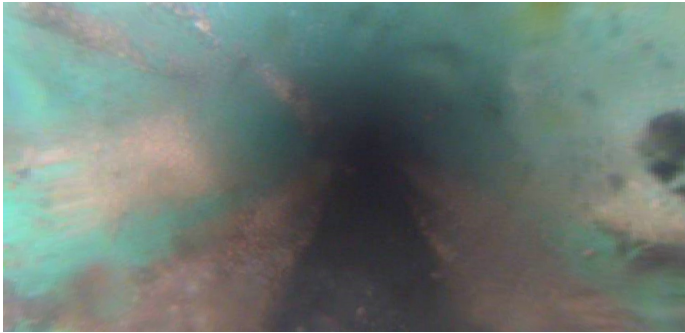
Code:	<b>AMH</b>
Description:	<b>Manhole</b>

Distance (ft):	<b>.0</b>
Structural Grade:	<b>0</b>
O&M Grade:	<b>0</b>
Clock Start/From:	
Clock To:	
1st Value:	
2nd Value:	
Value Percent:	
Continuous Index:	
Within 8" of Joint:	<b>NO</b>
Remarks:	<b>M-503-069</b>

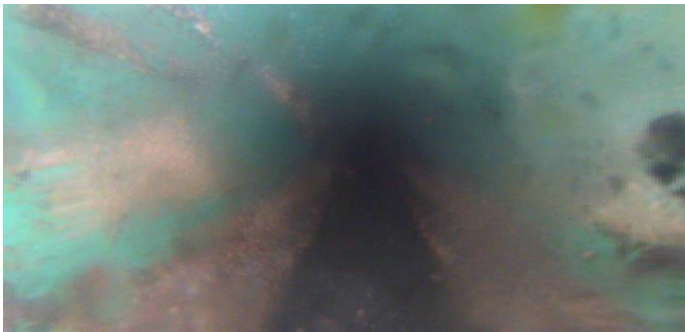
Code:	<b>MWL</b>
Description:	<b>Water Level</b>

Distance (ft):	<b>.0</b>
Structural Grade:	<b>0</b>
O&M Grade:	<b>0</b>
Clock Start/From:	
Clock To:	
1st Value:	
2nd Value:	
Value Percent:	<b>5.000</b>
Continuous Index:	
Within 8" of Joint:	<b>NO</b>
Remarks:

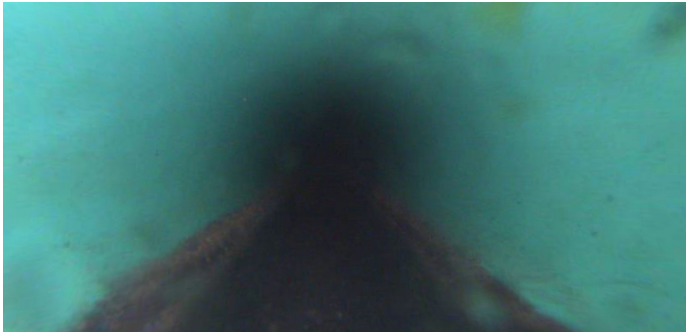
Code: **DAGS**  
Description: **Deposits Attached Grease**

Distance (ft): **48.2**  
Structural Grade: **0**  
O&M Grade: **2**  
Clock Start/From: **8**  
Clock To: **4**  
1st Value:  
2nd Value:  
Value Percent: **5.000**  
Continuous Index: **F01**  
Within 8" of Joint: **NO**  
Remarks:

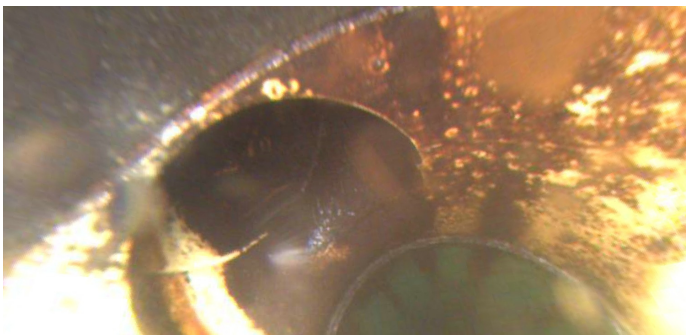
Code: **TF**  
Description: **Tap Factory**

Distance (ft): **63.8**  
Structural Grade: **0**  
O&M Grade: **0**  
Clock Start/From: **1**  
Clock To:  
1st Value: **4.000**  
2nd Value:  
Value Percent:  
Continuous Index:  
Within 8" of Joint:  
Remarks:

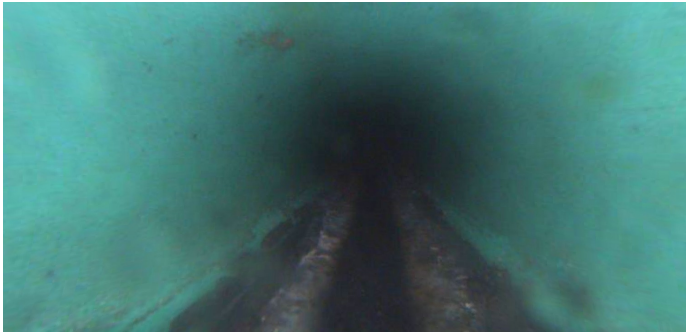
Code: **DAGS**  
Description: **Deposits Attached Grease**

Distance (ft): **130.3**  
Structural Grade: **0**  
O&M Grade: **2**  
Clock Start/From: **4**  
Clock To: **8**  
1st Value:  
2nd Value:  
Value Percent: **10.000**  
Continuous Index: **S02**  
Within 8" of Joint: **NO**  
Remarks:

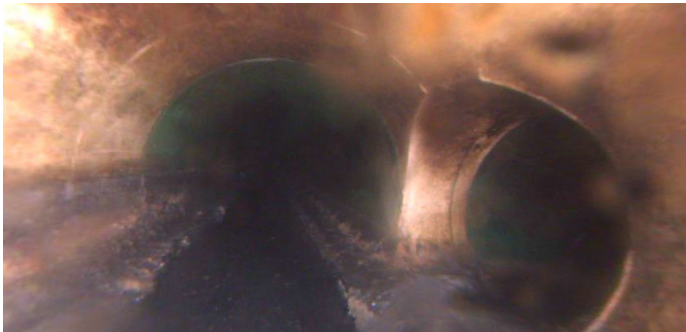
Code: **TF**  
Description: **Tap Factory**

Distance (ft): **159.5**  
Structural Grade: **0**  
O&M Grade: **0**  
Clock Start/From: **3**  
Clock To:  
1st Value: **4.000**  
2nd Value:  
Value Percent:  
Continuous Index:  
Within 8" of Joint:  
Remarks:

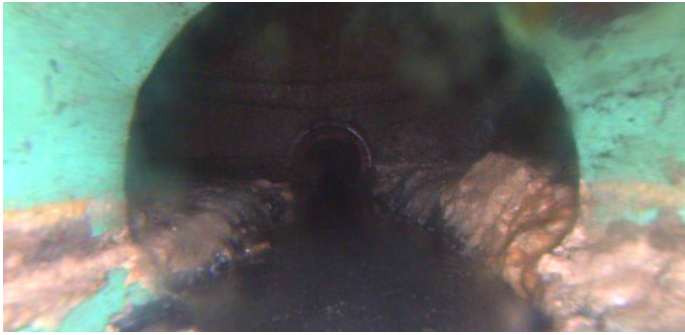
Code: **DAGS**  
Description: **Deposits Attached Grease**

Distance (ft): **224.4**  
Structural Grade: **0**  
O&M Grade: **2**  
Clock Start/From: **4**  
Clock To: **8**  
1st Value:  
2nd Value:  
Value Percent: **10.000**  
Continuous Index: **F02**  
Within 8" of Joint: **NO**  
Remarks:

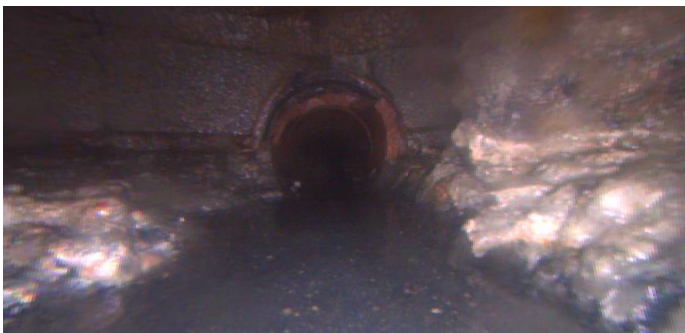
Code: **AMH**  
Description: **Manhole**

Distance (ft): **226.1**  
Structural Grade: **0**  
O&M Grade: **0**  
Clock Start/From:  
Clock To:  
1st Value:  
2nd Value:  
Value Percent:  
Continuous Index:  
Within 8" of Joint: **NO**  
Remarks: **M-503-070**
