## Profile/Photo Observation Report

Street:	<b>W 40th ave</b>	Flow Control:	<b>Not Controlled</b>
City:	<b>Hobart, IN</b>	Year Renewed:	
Location:	<b>Other</b>	Tape/Media #:	
Purpose:	<b>Not Known</b>	Dia/Height:	<b>8"</b>
Use:	<b>Sanitary</b>	Material:	<b>PVC</b>
Drain Area:	<b>NA</b>	Lining:	
Category:	<b>NA</b>		
Comment:

Location Details:		Direction of Survey:	<b>Downstream</b>
US MH:	<b>M-503-069</b>	DS MH:	<b>M-503-070</b>
		Total Length Surveyed (ft):	<b>226.1</b>

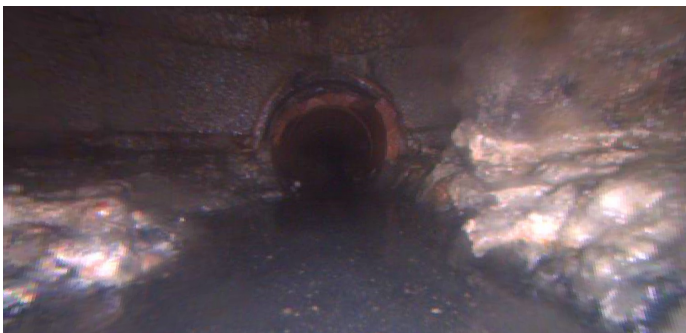
Code: **AMH**  
Description: **Manhole**

Distance (ft): **226.1**  
Structural Grade: **0**  
O&M Grade: **0**  
Clock Start/From:  
Clock To:  
1st Value:  
2nd Value:  
Value Percent:  
Continuous Index:  
Within 8" of Joint: **NO**  
Remarks: **M-503-070**
