## Profile/Photo Observation Report

Street:	<b>W 38TH AVE</b>	Flow Control:	<b>Not Controlled</b>
City:	<b>Hobart, IN</b>	Year Renewed:	
Location:	<b>Other</b>	Tape/Media #:	
Purpose:	<b>Not Known</b>	Dia/Height:	<b>12"</b>
Use:	<b>Sanitary</b>	Material:	<b>VCP</b>
Drain Area:	<b>NA</b>	Lining:	
Category:	<b>NA</b>		
Comment:

Location Details:		Direction of Survey:	<b>Downstream</b>
US MH:	<b>M-503-072</b>	DS MH:	<b>M-503-071</b>
		Total Length Surveyed (ft):	<b>305.6</b>

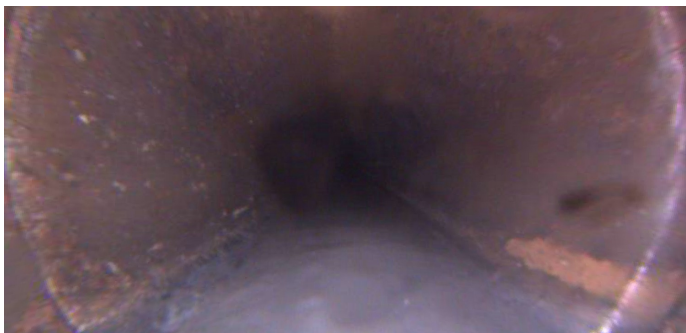
Code: **AMH**  
Description: **Manhole**

Distance (ft): **.0**  
Structural Grade: **0**  
O&M Grade: **0**  
Clock Start/From:  
Clock To:  
1st Value:  
2nd Value:  
Value Percent:  
Continuous Index:  
Within 8" of Joint: **NO**  
Remarks: **M-503-072**

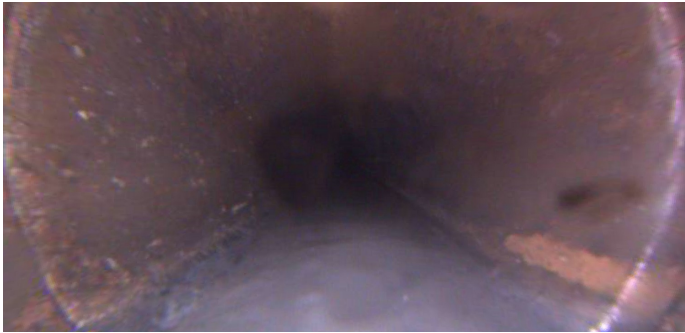
Code:	<b>MWL</b>
Description:	<b>Water Level</b>

Distance (ft):	<b>.0</b>
Structural Grade:	<b>0</b>
O&M Grade:	<b>0</b>
Clock Start/From:	
Clock To:	
1st Value:	
2nd Value:	
Value Percent:	<b>10.000</b>
Continuous Index:	
Within 8" of Joint:	<b>NO</b>
Remarks:

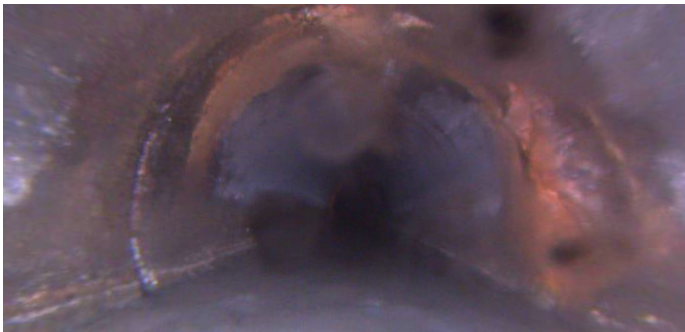
Code:	<b>DAE</b>
Description:	<b>Deposits Attached Encrustation</b>

Distance (ft):	<b>16.4</b>
Structural Grade:	<b>0</b>
O&M Grade:	<b>2</b>
Clock Start/From:	<b>2</b>
Clock To:	<b>4</b>
1st Value:	
2nd Value:	
Value Percent:	<b>10.000</b>
Continuous Index:	
Within 8" of Joint:	<b>YES</b>
Remarks:

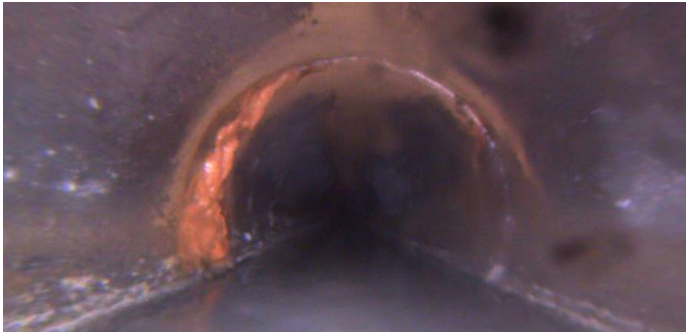
Code: **DAE**  
Description: **Deposits Attached Encrustation**

Distance (ft): **20.0**  
Structural Grade: **0**  
O&M Grade: **2**  
Clock Start/From: **8**  
Clock To: **4**  
1st Value:  
2nd Value:  
Value Percent: **10.000**  
Continuous Index:  
Within 8" of Joint: **YES**  
Remarks:

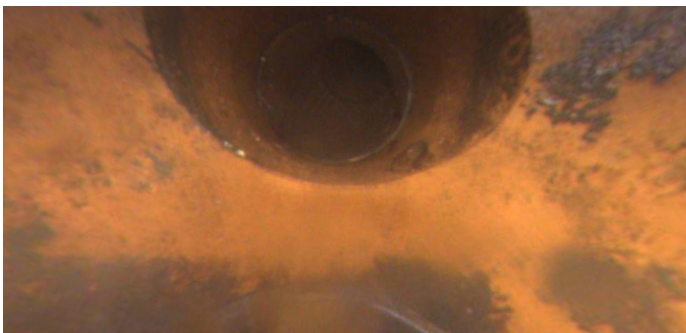
Code: **TF**  
Description: **Tap Factory**

Distance (ft): **25.7**  
Structural Grade: **0**  
O&M Grade: **0**  
Clock Start/From: **12**  
Clock To:  
1st Value: **4.000**  
2nd Value:  
Value Percent:  
Continuous Index:  
Within 8" of Joint:  
Remarks:

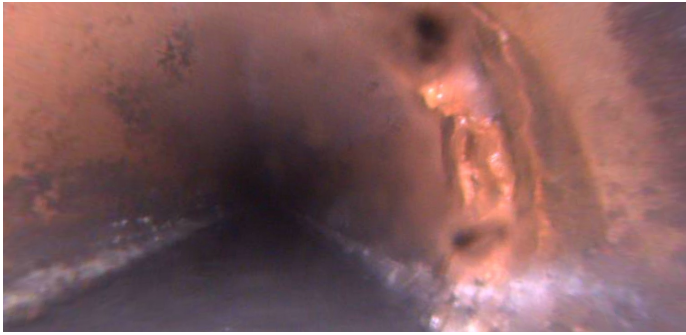
Code: **DAE**  
Description: **Deposits Attached Encrustation**

Distance (ft): **49.9**  
Structural Grade: **0**  
O&M Grade: **2**  
Clock Start/From: **2**  
Clock To: **4**  
1st Value:  
2nd Value:  
Value Percent: **5.000**  
Continuous Index:  
Within 8" of Joint: **YES**  
Remarks:

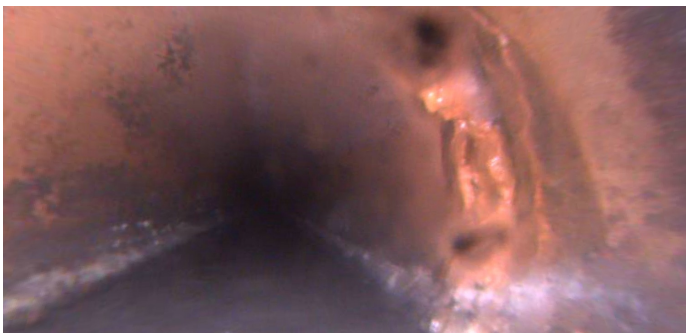
Code: **ID**  
Description: **Infil Dripper**

Distance (ft): **49.9**  
Structural Grade: **0**  
O&M Grade: **3**  
Clock Start/From: **2**  
Clock To:  
1st Value:  
2nd Value:  
Value Percent:  
Continuous Index:  
Within 8" of Joint: **YES**  
Remarks:

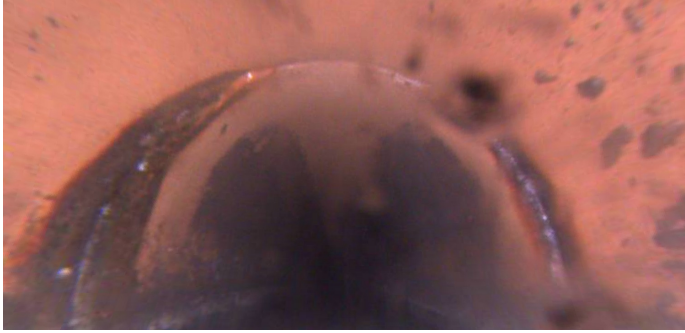
Code: **IW**  
Description: **Infil Weeper**

Distance (ft): **73.2**  
Structural Grade: **0**  
O&M Grade: **2**  
Clock Start/From: **8**  
Clock To: **4**  
1st Value:  
2nd Value:  
Value Percent:  
Continuous Index: **S01**  
Within 8" of Joint: **YES**  
Remarks:

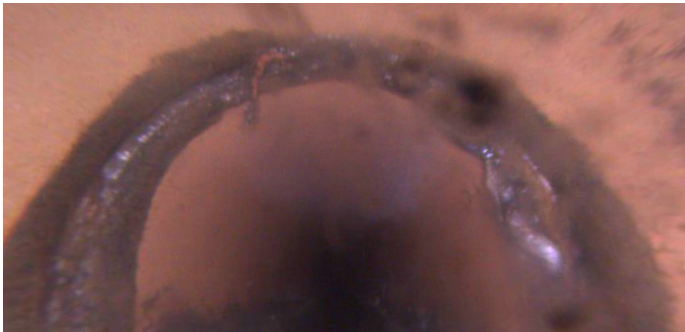
Code: **DAE**  
Description: **Deposits Attached Encrustation**

Distance (ft): **147.8**  
Structural Grade: **0**  
O&M Grade: **2**  
Clock Start/From: **8**  
Clock To: **4**  
1st Value:  
2nd Value:  
Value Percent: **5.000**  
Continuous Index:  
Within 8" of Joint: **YES**  
Remarks:

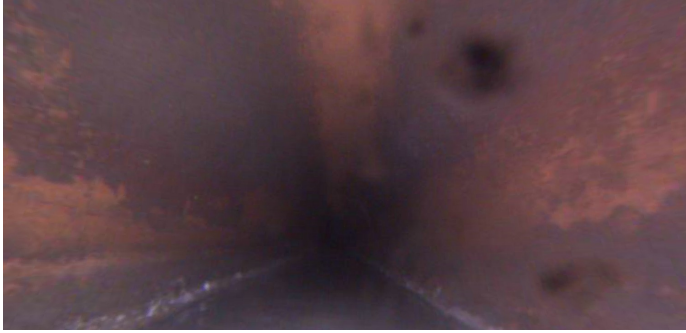
Code: **IW**  
Description: **Infil Weeper**

Distance (ft): **168.0**  
Structural Grade: **0**  
O&M Grade: **2**  
Clock Start/From: **8**  
Clock To: **4**  
1st Value:  
2nd Value:  
Value Percent:  
Continuous Index: **F01**  
Within 8" of Joint: **YES**  
Remarks:

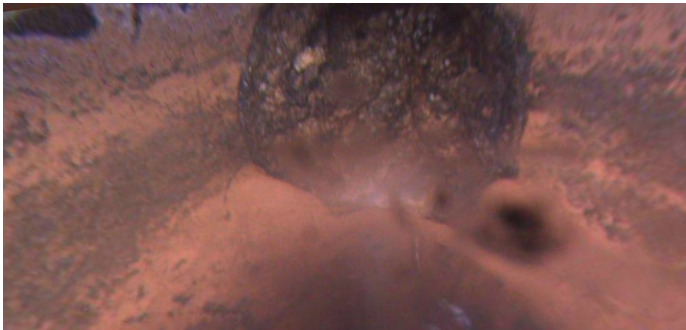
Code: **TF**  
Description: **Tap Factory**

Distance (ft): **180.2**  
Structural Grade: **0**  
O&M Grade: **0**  
Clock Start/From: **12**  
Clock To:  
1st Value: **4.000**  
2nd Value:  
Value Percent:  
Continuous Index:  
Within 8" of Joint:  
Remarks:

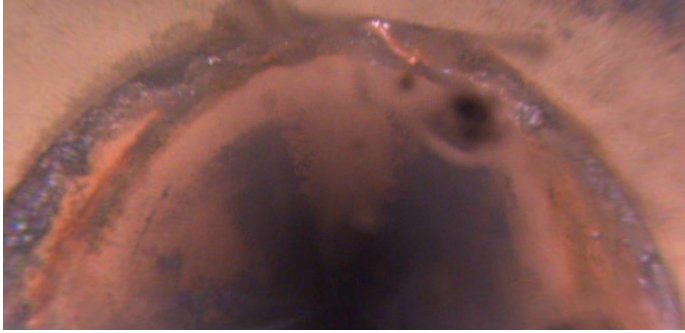
Code: ID  
Description: Infil Dripper

Distance (ft): 208.9  
Structural Grade: 0  
O&M Grade: 3  
Clock Start/From: 12  
Clock To:  
1st Value:  
2nd Value:  
Value Percent:  
Continuous Index:  
Within 8" of Joint: YES  
Remarks:

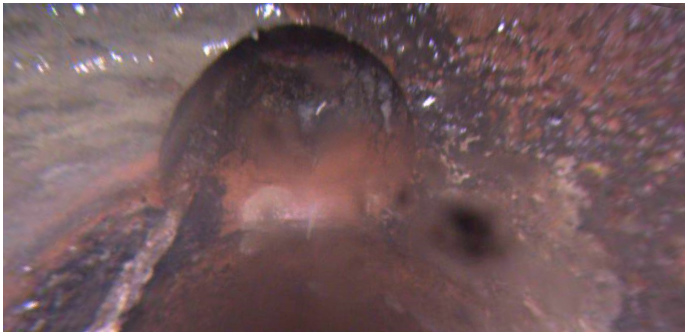
Code: TFD  
Description: Tap Factory Defective

Distance (ft): 217.4  
Structural Grade: 0  
O&M Grade: 2  
Clock Start/From: 12  
Clock To:  
1st Value: 4.000  
2nd Value:  
Value Percent:  
Continuous Index:  
Within 8" of Joint:  
Remarks: roots

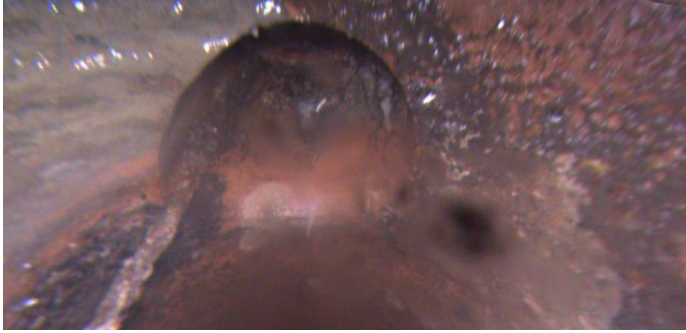
Code: **RFL**  
Description: **Roots Fine Lateral**

Distance (ft): **217.4**  
Structural Grade: **0**  
O&M Grade: **1**  
Clock Start/From: **12**  
Clock To:  
1st Value:  
2nd Value:  
Value Percent:  
Continuous Index:  
Within 8" of Joint: **NO**  
Remarks:

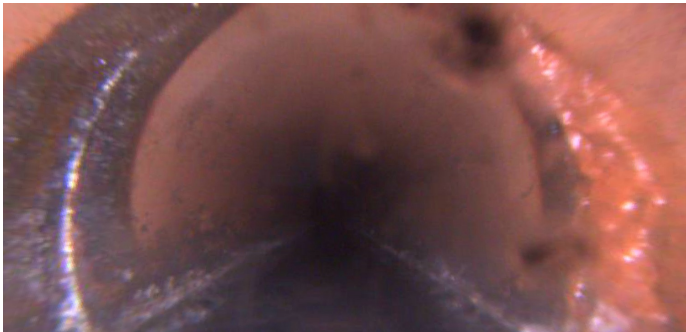
Code: **DAE**  
Description: **Deposits Attached Encrustation**

Distance (ft): **253.8**  
Structural Grade: **0**  
O&M Grade: **2**  
Clock Start/From: **8**  
Clock To: **4**  
1st Value:  
2nd Value:  
Value Percent: **5.000**  
Continuous Index:  
Within 8" of Joint: **YES**  
Remarks:

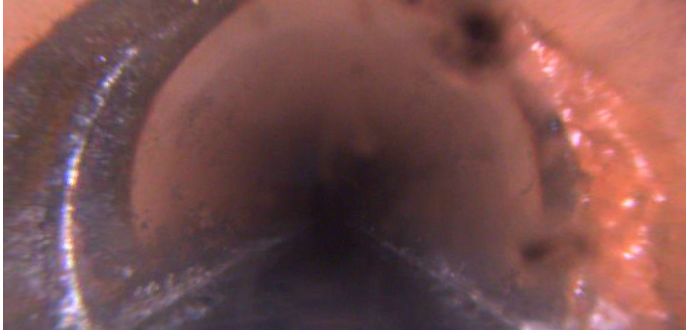
Code: **IW**  
Description: **Infil Weeper**

Distance (ft): **253.8**  
Structural Grade: **0**  
O&M Grade: **2**  
Clock Start/From: **8**  
Clock To: **4**  
1st Value:  
2nd Value:  
Value Percent:  
Continuous Index:  
Within 8" of Joint: **YES**  
Remarks:

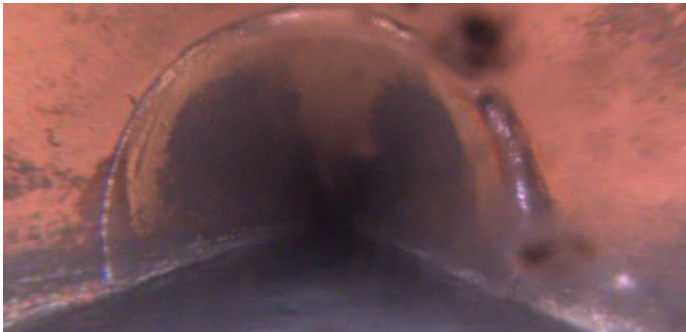
Code: **IW**  
Description: **Infil Weeper**

Distance (ft): **269.3**  
Structural Grade: **0**  
O&M Grade: **2**  
Clock Start/From: **8**  
Clock To: **4**  
1st Value:  
2nd Value:  
Value Percent:  
Continuous Index: **S02**  
Within 8" of Joint: **YES**  
Remarks:

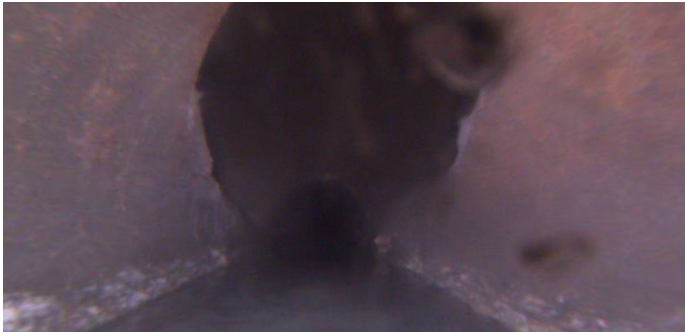
Code: **IW**  
Description: **Infil Weeper**

Distance (ft): **303.4**  
Structural Grade: **0**  
O&M Grade: **2**  
Clock Start/From: **8**  
Clock To: **4**  
1st Value:  
2nd Value:  
Value Percent:  
Continuous Index: **F02**  
Within 8" of Joint: **YES**  
Remarks:

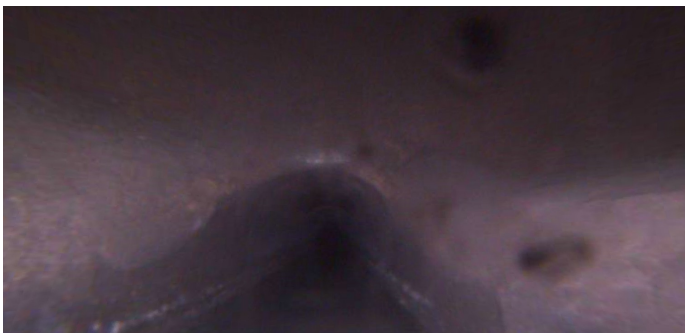
Code: **AMH**  
Description: **Manhole**

Distance (ft): **305.6**  
Structural Grade: **0**  
O&M Grade: **0**  
Clock Start/From:  
Clock To:  
1st Value:  
2nd Value:  
Value Percent:  
Continuous Index:  
Within 8" of Joint: **NO**  
Remarks: **M-503-071**
