Profile/Photo Observation Report

Date:	04/13/2018	Weather:		Coding:	PACP 6.0
Pipe Length (ft):	325.2	Owner:	NA	Pre Clean:	Not Known
P.O.#:		Surveyor:	Jen Costello	PSR:	P-503-072-071
Customer:		Clean Date:	01/01/1900	Shape:	C

Street:	W 40th ave	Flow Control:	Not Controlled
City:	Hobart, IN	Year Renewed:	
Location:	Other	Tape/Media #:	
Purpose:	Not Known	Dia/Height:	12"
Use:	Sanitary	Material:	VCP
Drain Area:	NA	Lining:	
Category:	NA		
Comment:

Location Details:		Direction of Survey:	Downstream
US MH:	M-503-072	DS MH:	M-503-071
		Total Length Surveyed (ft):	305.6

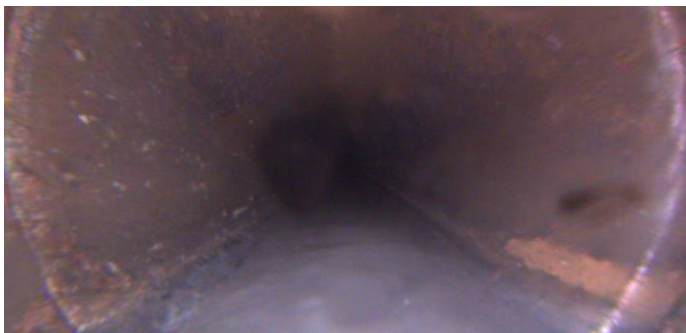
Code: **AMH**
Description: **Manhole**

Distance (ft): **.0**
Structural Grade: **0**
O&M Grade: **0**
Clock Start/From:
Clock To:
1st Value:
2nd Value:
Value Percent:
Continuous Index:
Within 8" of Joint: **NO**
Remarks: **M-503-072**

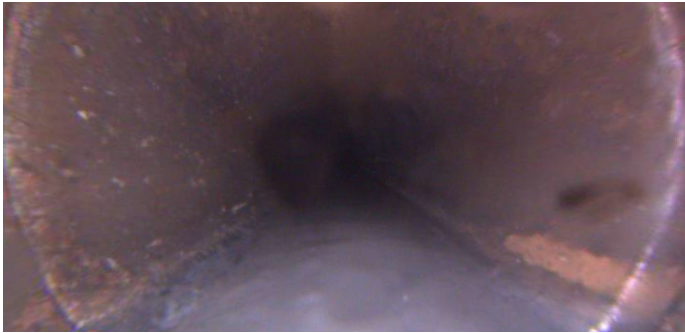
Code:	MWL
Description:	Water Level

Distance (ft):	.0
Structural Grade:	0
O&M Grade:	0
Clock Start/From:	
Clock To:	
1st Value:	
2nd Value:	
Value Percent:	10.000
Continuous Index:	
Within 8" of Joint:	NO
Remarks:

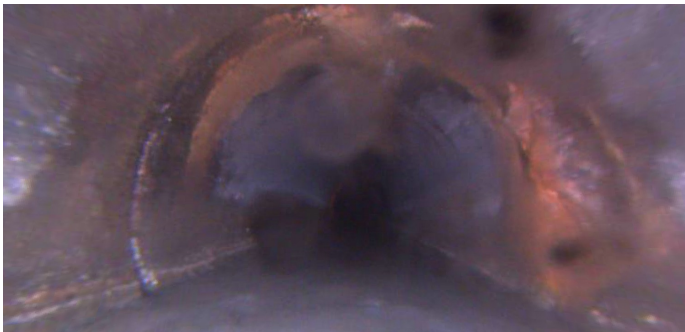
Code:	DAE
Description:	Deposits Attached Encrustation

Distance (ft):	16.4
Structural Grade:	0
O&M Grade:	2
Clock Start/From:	2
Clock To:	4
1st Value:	
2nd Value:	
Value Percent:	10.000
Continuous Index:	
Within 8" of Joint:	YES
Remarks:

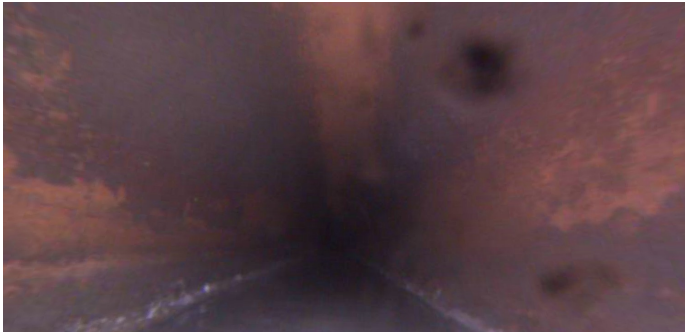
Code: **IW**
Description: **Infil Weeper**

Distance (ft): **168.0**
Structural Grade: **0**
O&M Grade: **2**
Clock Start/From: **8**
Clock To: **4**
1st Value:
2nd Value:
Value Percent:
Continuous Index: **F01**
Within 8" of Joint: **YES**
Remarks:

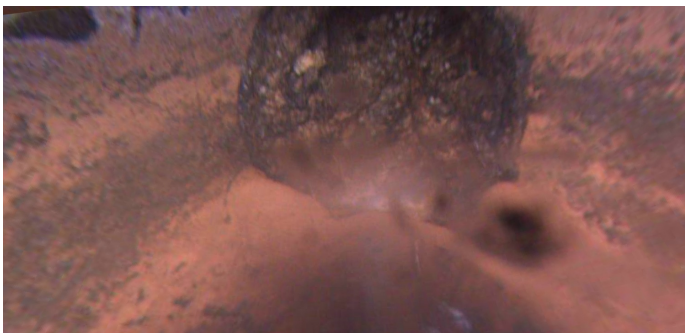
Code: **TF**
Description: **Tap Factory**

Distance (ft): **180.2**
Structural Grade: **0**
O&M Grade: **0**
Clock Start/From: **12**
Clock To:
1st Value: **4.000**
2nd Value:
Value Percent:
Continuous Index:
Within 8" of Joint:
Remarks:

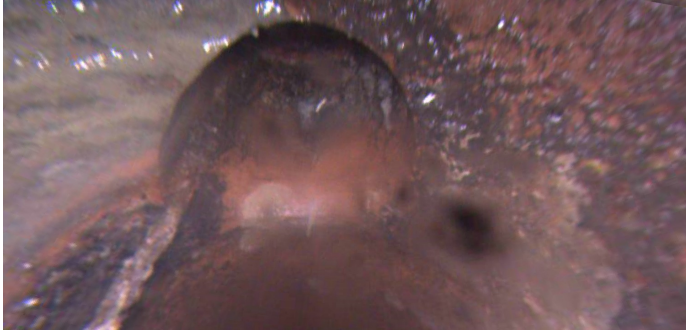
Code: **RFL**
Description: **Roots Fine Lateral**

Distance (ft): **217.4**
Structural Grade: **0**
O&M Grade: **1**
Clock Start/From: **12**
Clock To:
1st Value:
2nd Value:
Value Percent:
Continuous Index:
Within 8" of Joint: **NO**
Remarks:

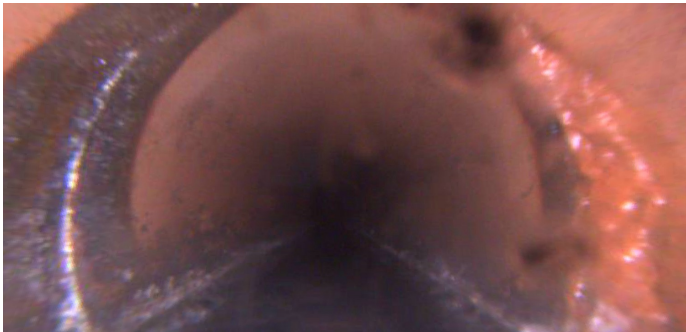
Code: **DAE**
Description: **Deposits Attached Encrustation**

Distance (ft): **253.8**
Structural Grade: **0**
O&M Grade: **2**
Clock Start/From: **8**
Clock To: **4**
1st Value:
2nd Value:
Value Percent: **5.000**
Continuous Index:
Within 8" of Joint: **YES**
Remarks:

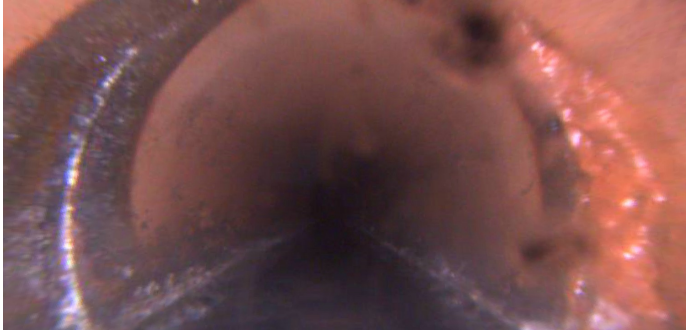
Code: **IW**
Description: **Infil Weeper**

Distance (ft): **253.8**
Structural Grade: **0**
O&M Grade: **2**
Clock Start/From: **8**
Clock To: **4**
1st Value:
2nd Value:
Value Percent:
Continuous Index:
Within 8" of Joint: **YES**
Remarks:

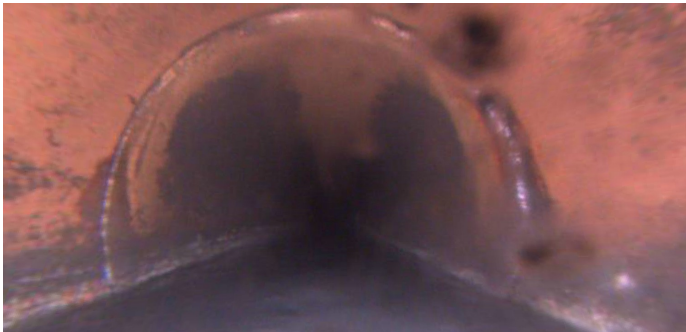
Code: **IW**
Description: **Infil Weeper**

Distance (ft): **269.3**
Structural Grade: **0**
O&M Grade: **2**
Clock Start/From: **8**
Clock To: **4**
1st Value:
2nd Value:
Value Percent:
Continuous Index: **S02**
Within 8" of Joint: **YES**
Remarks:

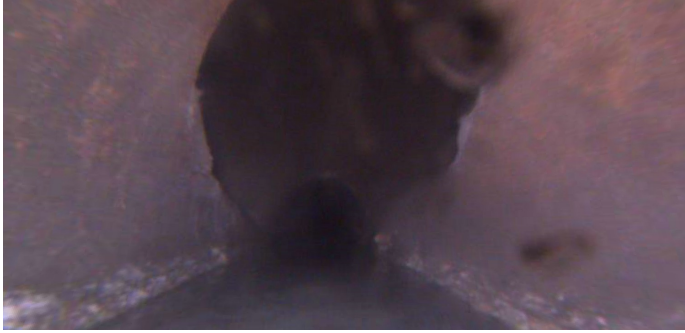
Code: **IW**
Description: **Infil Weeper**

Distance (ft): **303.4**
Structural Grade: **0**
O&M Grade: **2**
Clock Start/From: **8**
Clock To: **4**
1st Value:
2nd Value:
Value Percent:
Continuous Index: **F02**
Within 8" of Joint: **YES**
Remarks:
