Profile/Photo Observation Report

Date:	08/22/2021	Weather:		Coding:	PACP 7.0
Pipe Length (ft):	279.6	Owner:	City of Hobart	Pre Clean:	Light Cleaning
P.O.#:	YES502259	Surveyor:	S. Bucklin	PSR:	P-503-072.1-072
Customer:	City of Hobart	Clean Date:	08/22/2021	Shape:	C

Street:	West 38th Avenue	Flow Control:	Not Controlled
City:	Hobart, IN	Year Renewed:	
Location:	Levee Pump Station	Tape/Media #:	
Purpose:	Routine Assessment	Dia/Height:	8"
Use:	Sanitary Sewage Pipe	Material:	VCP
Drain Area:		Lining:

US MH: **M-503-072** DS MH: **M-503-072.1** Total Length Surveyed (ft): **279.6**

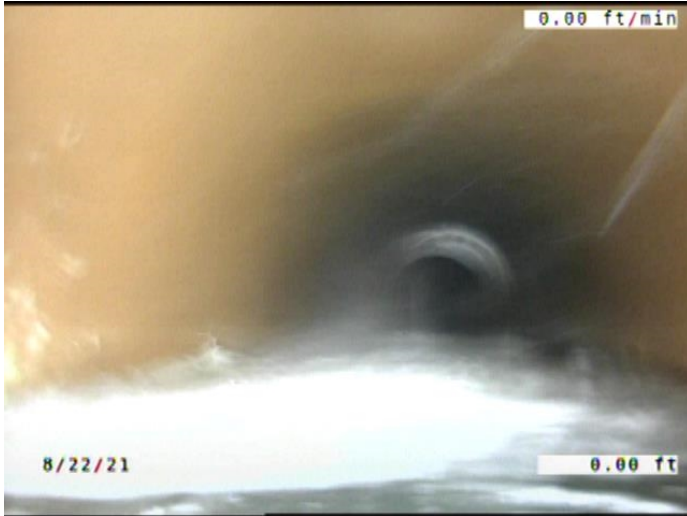
Code:	MWL
Description:	Miscellaneous Water Level
Distance (ft):	.0
Structural Grade:	0
O&M Grade:	0
Clock Start/From:	
Clock To:	
1st Value:	
2nd Value:	
Value Percent:	15.000
Continuous Index:	
Within 8" of Joint:	NO
Remarks:

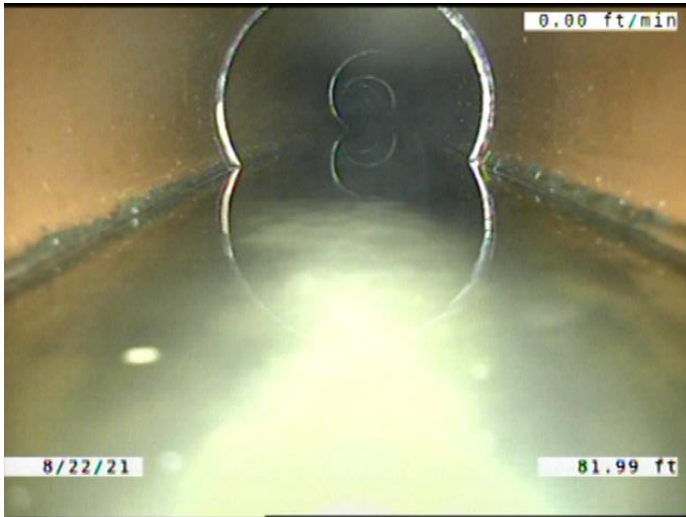
Code: **DSF**
Description: **Deposits Settled Fine**

Distance (ft): **82.0**
Structural Grade: **0**
O&M Grade: **2**
Clock Start/From: **5**
Clock To: **7**
1st Value:
2nd Value:
Value Percent: **5.000**
Continuous Index:
Within 8" of Joint: **YES**
Remarks:

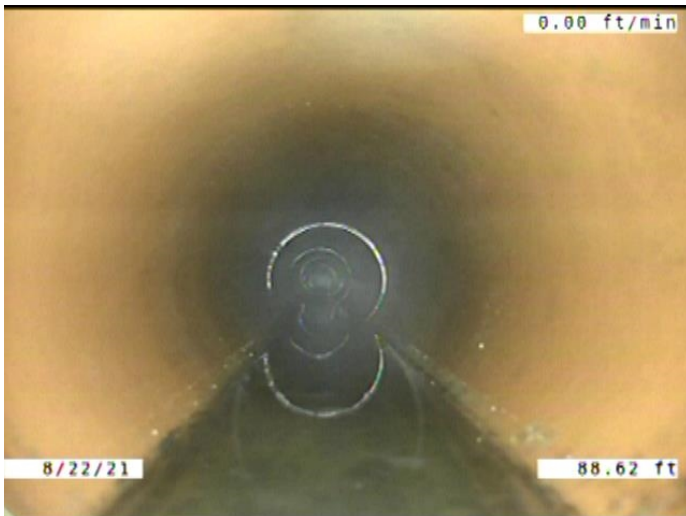
Code: **MWLS**
Description: **Miscellaneous Water Level Sag**

Distance (ft): **88.6**
Structural Grade: **2**
O&M Grade: **0**
Clock Start/From:
Clock To:
1st Value:
2nd Value:
Value Percent: **5.000**
Continuous Index: **F01**
Within 8" of Joint: **NO**
Remarks:

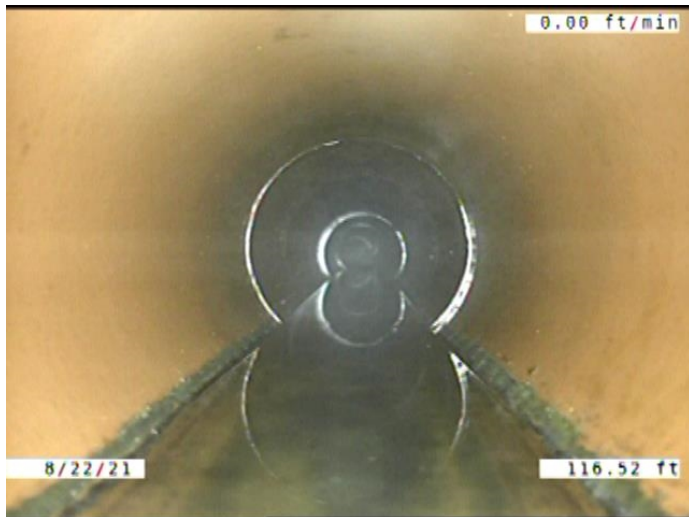
Code: **MWLS**
 Description: **Miscellaneous Water Level Sag**

Distance (ft): **116.5**
 Structural Grade: **2**
 O&M Grade: **0**
 Clock Start/From:
 Clock To:
 1st Value:
 2nd Value:
 Value Percent: **5.000**
 Continuous Index: **S02**
 Within 8" of Joint: **NO**
 Remarks:

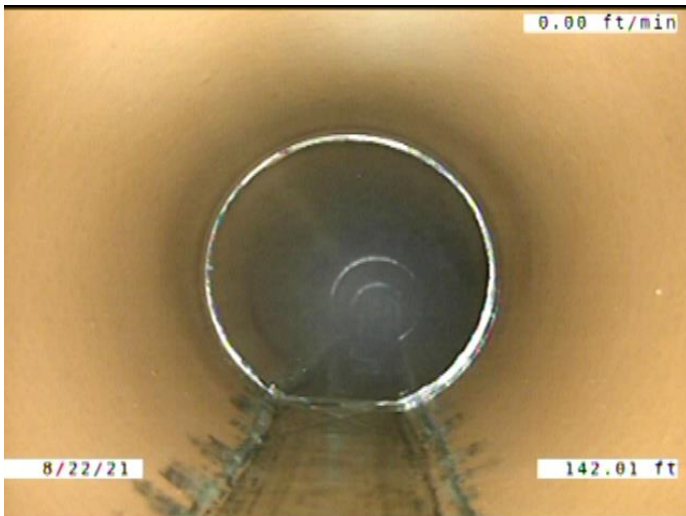
Code: **MWLS**
Description: **Miscellaneous Water Level Sag**

Distance (ft): **142.0**
Structural Grade: **2**
O&M Grade: **0**
Clock Start/From:
Clock To:
1st Value:
2nd Value:
Value Percent: **5.000**
Continuous Index: **F03**
Within 8" of Joint: **NO**
Remarks:

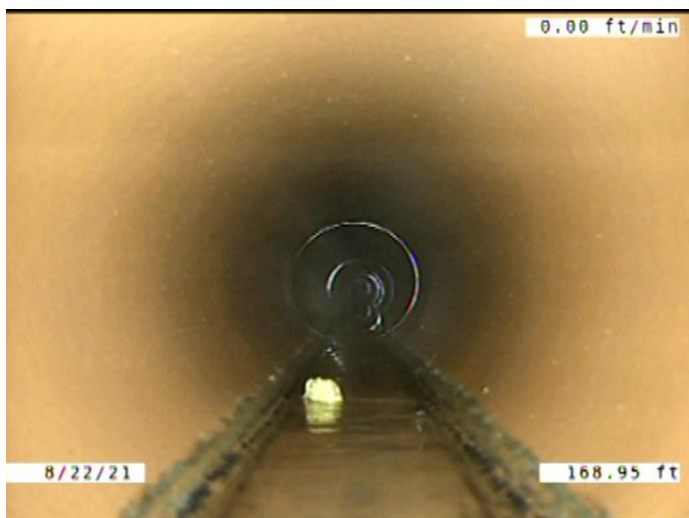
Code: **MWLS**
Description: **Miscellaneous Water Level Sag**

Distance (ft): **168.9**
Structural Grade: **2**
O&M Grade: **0**
Clock Start/From:
Clock To:
1st Value:
2nd Value:
Value Percent: **5.000**
Continuous Index: **F04**
Within 8" of Joint: **NO**
Remarks:

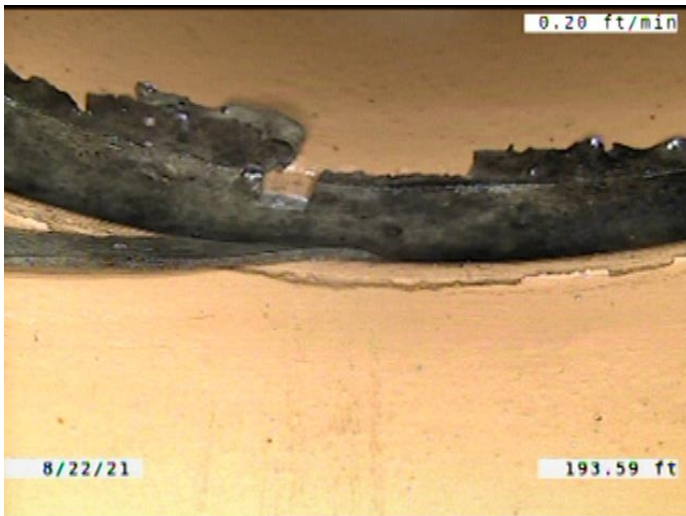
Code: **ISSRL**
 Description: **Intruding Sealing Material Sealing Ring Loose/Poorly Fitting**

Distance (ft): **193.6**
 Structural Grade: **0**
 O&M Grade: **2**
 Clock Start/From: **2**
 Clock To: **5**
 1st Value:
 2nd Value:
 Value Percent: **5.000**
 Continuous Index:
 Within 8" of Joint: **NO**
 Remarks:
