## Profile/Photo Observation Report

Street:	<b>W 40th ave</b>	Flow Control:	<b>Not Controlled</b>
City:	<b>Hobart, IN</b>	Year Renewed:	
Location:	<b>Other</b>	Tape/Media #:	
Purpose:	<b>Not Known</b>	Dia/Height:	<b>12"</b>
Use:	<b>Sanitary</b>	Material:	<b>VCP</b>
Drain Area:	<b>NA</b>	Lining:	
Category:	<b>NA</b>		
Comment:

Location Details:		Direction of Survey:	<b>Downstream</b>
US MH:	<b>M-503-073</b>	DS MH:	<b>M-503-072</b>
		Total Length Surveyed (ft):	<b>13.4</b>

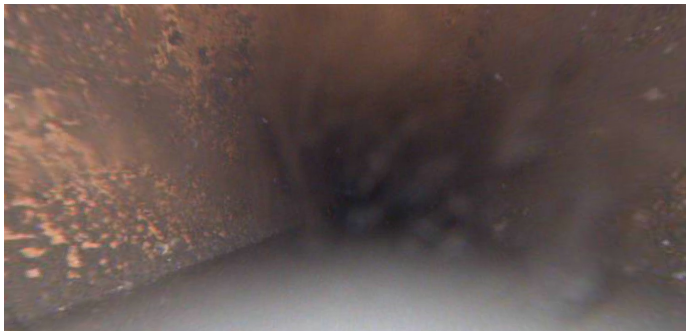
Code: AMH

Description: Manhole

Distance (ft): .0

Remarks: M-503-073

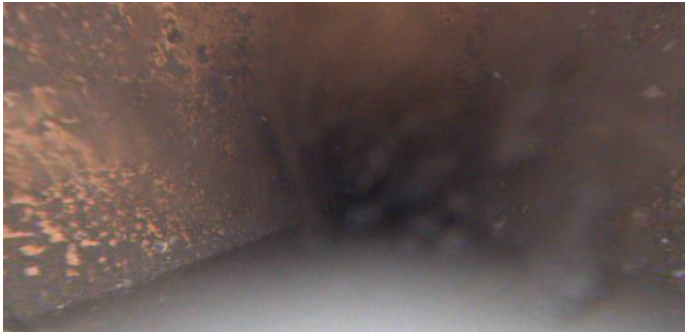
Code:	<b>MWL</b>
Description:	<b>Water Level</b>

Distance (ft):	<b>.0</b>
Structural Grade:	<b>0</b>
O&M Grade:	<b>0</b>
Clock Start/From:	
Clock To:	
1st Value:	
2nd Value:	
Value Percent:	<b>20.000</b>
Continuous Index:	
Within 8" of Joint:	<b>NO</b>
Remarks:

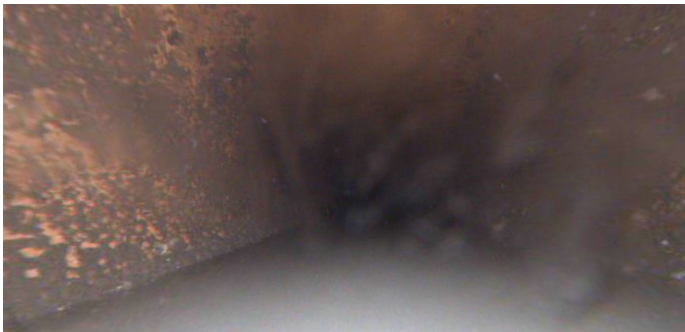
Code:	<b>DAGS</b>
Description:	<b>Deposits Attached Grease</b>

Distance (ft):	<b>.0</b>
Structural Grade:	<b>0</b>
O&M Grade:	<b>2</b>
Clock Start/From:	<b>8</b>
Clock To:	<b>4</b>
1st Value:	
2nd Value:	
Value Percent:	<b>5.000</b>
Continuous Index:	
Within 8" of Joint:	<b>NO</b>
Remarks:

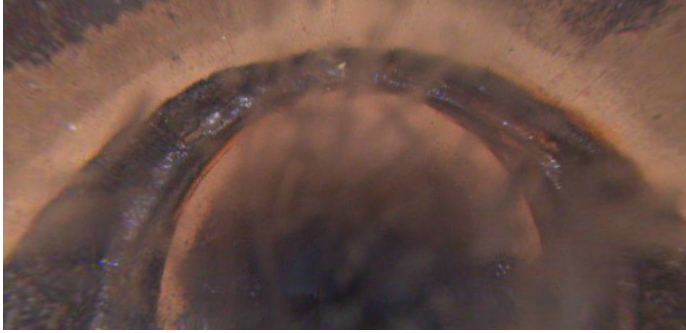
Code: ID  
Description: Infil Dripper

Distance (ft): 2.9  
Structural Grade: 0  
O&M Grade: 3  
Clock Start/From: 12  
Clock To:  
1st Value:  
2nd Value:  
Value Percent:  
Continuous Index:  
Within 8" of Joint: YES  
Remarks:

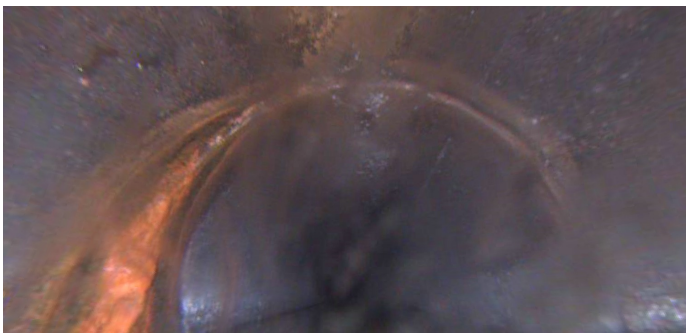
Code: DAE  
Description: Deposits Attached Encrustation

Distance (ft): 6.6  
Structural Grade: 0  
O&M Grade: 2  
Clock Start/From: 9  
Clock To: 12  
1st Value:  
2nd Value:  
Value Percent: 5.000  
Continuous Index:  
Within 8" of Joint: YES  
Remarks:

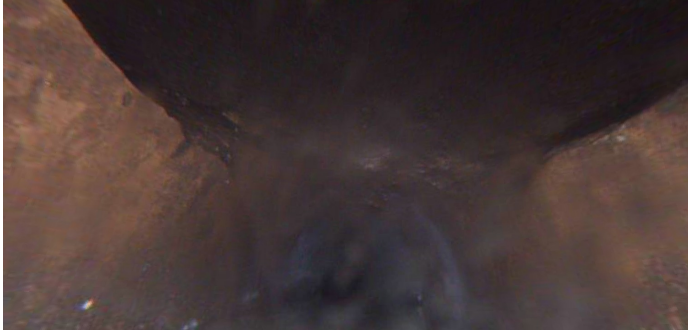
Code:	AMH
Description:	Manhole
Distance (ft):	13.4
Structural Grade:	0
O&M Grade:	0
Clock Start/From:	
Clock To:	
1st Value:	
2nd Value:	
Value Percent:	
Continuous Index:	
Within 8" of Joint:	NO
Remarks:	M-503-072
