Profile/Photo Observation Report

Date:	04/13/2018	Weather:		Coding:	PACP 6.0
Pipe Length (ft):	326.3	Owner:	NA	Pre Clean:	Not Known
P.O.#:		Surveyor:	Jen Costello	PSR:	P-503-073-072
Customer:		Clean Date:	01/01/1900	Shape:	C

Street:	W 38TH AVE	Flow Control:	Not Controlled
City:	Hobart, IN	Year Renewed:	
Location:	Other	Tape/Media #:	
Purpose:	Not Known	Dia/Height:	12"
Use:	Sanitary	Material:	VCP
Drain Area:	NA	Lining:	
Category:	NA		
Comment:

Location Details:		Direction of Survey:	Downstream
US MH:	M-503-073	DS MH:	M-503-072
		Total Length Surveyed (ft):	324.7

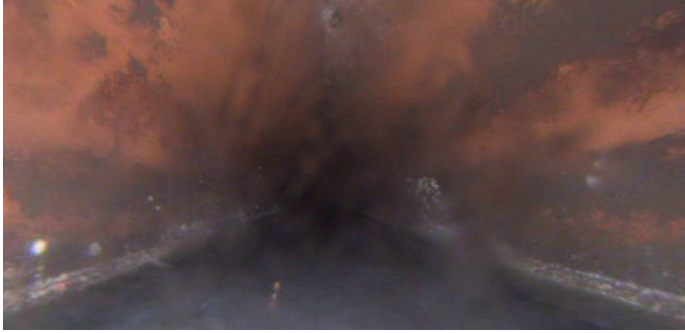
Code: **AMH**
Description: **Manhole**

Distance (ft): **.0**
Structural Grade: **0**
O&M Grade: **0**
Clock Start/From:
Clock To:
1st Value:
2nd Value:
Value Percent:
Continuous Index:
Within 8" of Joint: **NO**
Remarks: **M-503-073**

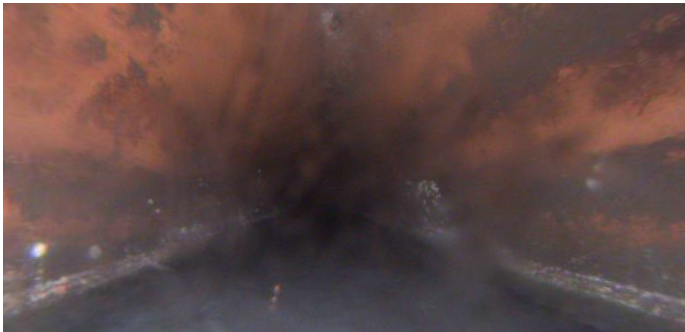
Code: **MWL**
Description: **Water Level**

Distance (ft): **.0**
Structural Grade: **0**
O&M Grade: **0**
Clock Start/From:
Clock To:
1st Value:
2nd Value:
Value Percent: **20.000**
Continuous Index:
Within 8" of Joint: **NO**
Remarks:

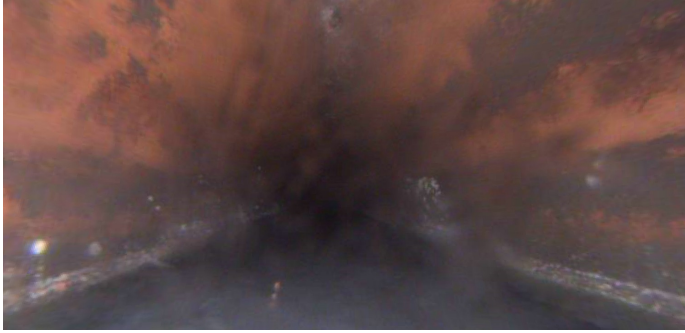
Code: **DAGS**
Description: **Deposits Attached Grease**

Distance (ft): **.0**
Structural Grade: **0**
O&M Grade: **2**
Clock Start/From: **8**
Clock To: **4**
1st Value:
2nd Value:
Value Percent: **5.000**
Continuous Index: **S01**
Within 8" of Joint: **NO**
Remarks:

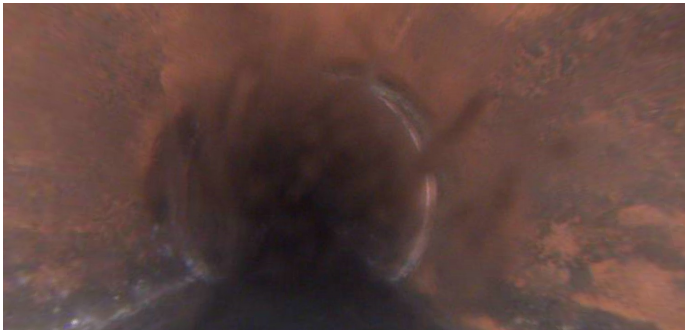
Code: **IW**
Description: **Infil Weeper**

Distance (ft): **49.6**
Structural Grade: **0**
O&M Grade: **2**
Clock Start/From: **8**
Clock To: **4**
1st Value:
2nd Value:
Value Percent:
Continuous Index:
Within 8" of Joint: **YES**
Remarks:

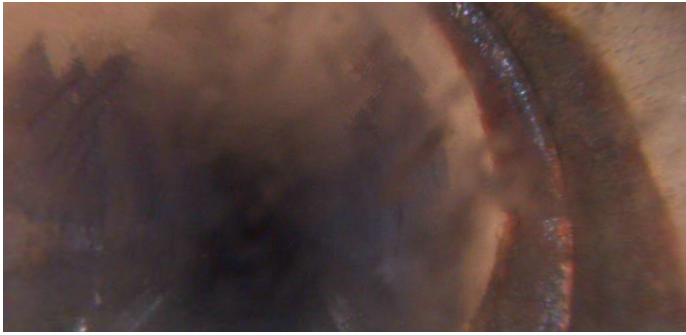
Code: **IW**
Description: **Infil Weeper**

Distance (ft): **70.4**
Structural Grade: **0**
O&M Grade: **2**
Clock Start/From: **1**
Clock To: **4**
1st Value:
2nd Value:
Value Percent:
Continuous Index:
Within 8" of Joint: **YES**
Remarks:

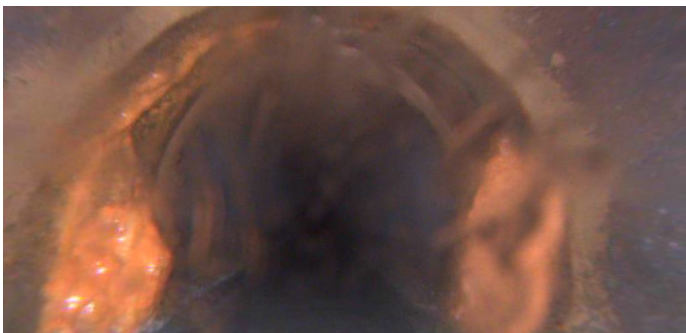
Code: **DAE**
Description: **Deposits Attached Encrustation**

Distance (ft): **97.9**
Structural Grade: **0**
O&M Grade: **2**
Clock Start/From: **8**
Clock To: **4**
1st Value:
2nd Value:
Value Percent: **10.000**
Continuous Index:
Within 8" of Joint: **YES**
Remarks:

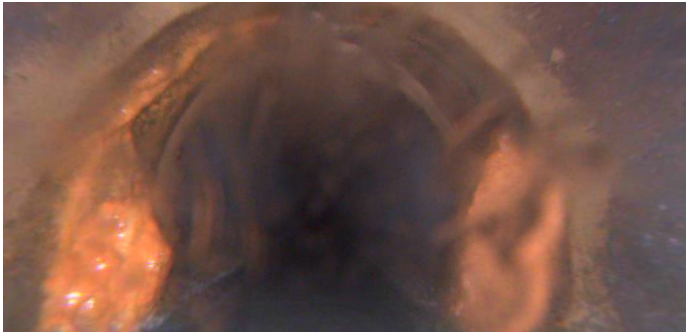
Code: **IW**
Description: **Infil Weeper**

Distance (ft): **97.9**
Structural Grade: **0**
O&M Grade: **2**
Clock Start/From: **8**
Clock To: **4**
1st Value:
2nd Value:
Value Percent:
Continuous Index:
Within 8" of Joint: **YES**
Remarks:

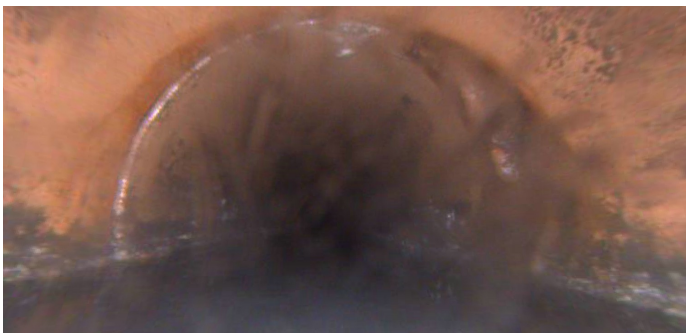
Code: **IW**
Description: **Infil Weeper**

Distance (ft): **121.8**
Structural Grade: **0**
O&M Grade: **2**
Clock Start/From: **8**
Clock To: **4**
1st Value:
2nd Value:
Value Percent:
Continuous Index:
Within 8" of Joint: **YES**
Remarks:

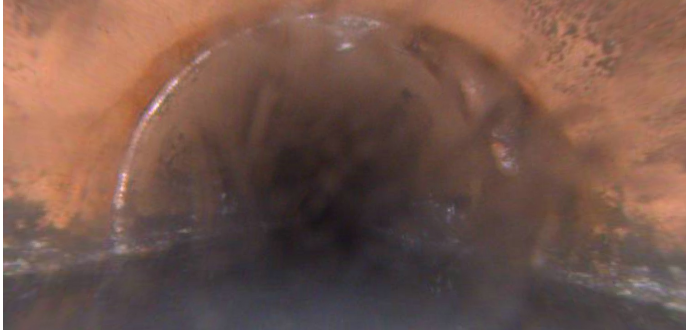
Code: **DAE**
Description: **Deposits Attached Encrustation**

Distance (ft): **121.8**
Structural Grade: **0**
O&M Grade: **2**
Clock Start/From: **8**
Clock To: **4**
1st Value:
2nd Value:
Value Percent: **5.000**
Continuous Index:
Within 8" of Joint: **YES**
Remarks:

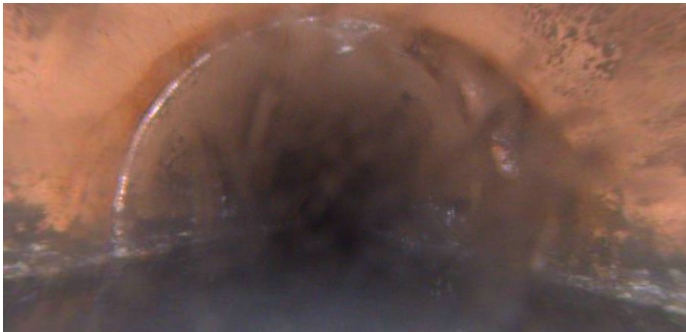
Code: **DAGS**
Description: **Deposits Attached Grease**

Distance (ft): **121.8**
Structural Grade: **0**
O&M Grade: **2**
Clock Start/From: **8**
Clock To: **4**
1st Value:
2nd Value:
Value Percent: **5.000**
Continuous Index: **F01**
Within 8" of Joint: **NO**
Remarks:

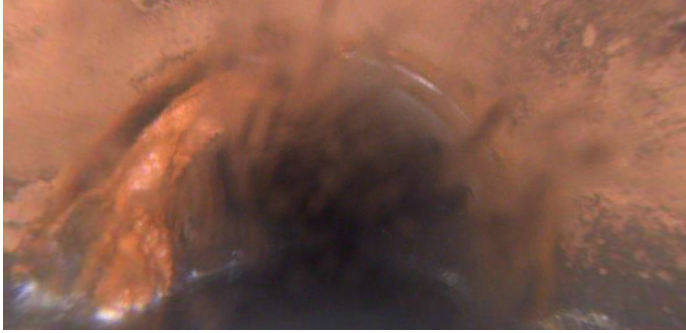
Code: **DAE**
Description: **Deposits Attached Encrustation**

Distance (ft): **125.7**
Structural Grade: **0**
O&M Grade: **2**
Clock Start/From: **8**
Clock To: **4**
1st Value:
2nd Value:
Value Percent: **10.000**
Continuous Index:
Within 8" of Joint: **YES**
Remarks:

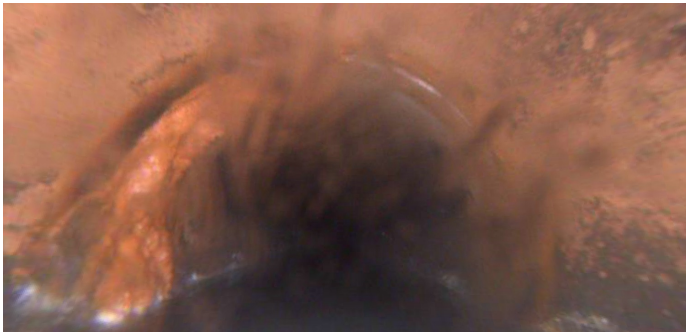
Code: **IW**
Description: **Infil Weeper**

Distance (ft): **125.7**
Structural Grade: **0**
O&M Grade: **2**
Clock Start/From: **8**
Clock To: **4**
1st Value:
2nd Value:
Value Percent:
Continuous Index: **S02**
Within 8" of Joint: **YES**
Remarks:

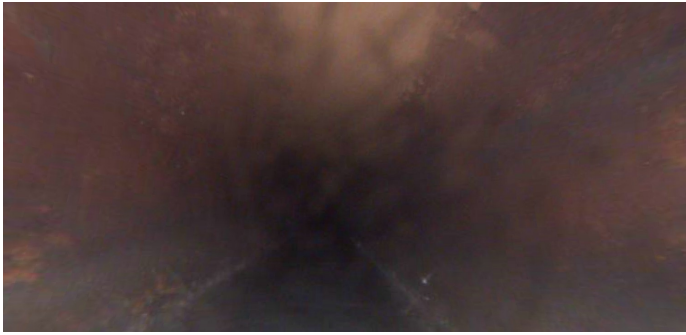
Code: **IW**
Description: **Infil Weeper**

Distance (ft): **152.2**
Structural Grade: **0**
O&M Grade: **2**
Clock Start/From: **8**
Clock To: **4**
1st Value:
2nd Value:
Value Percent:
Continuous Index: **F02**
Within 8" of Joint: **YES**
Remarks:

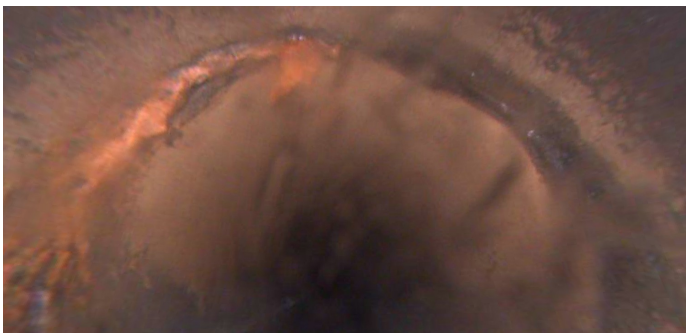
Code: **DAE**
Description: **Deposits Attached Encrustation**

Distance (ft): **175.6**
Structural Grade: **0**
O&M Grade: **2**
Clock Start/From: **8**
Clock To: **4**
1st Value:
2nd Value:
Value Percent: **5.000**
Continuous Index:
Within 8" of Joint: **YES**
Remarks:

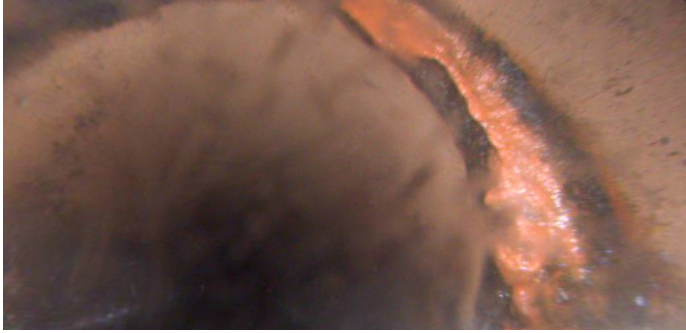
Code: **DAE**
Description: **Deposits Attached Encrustation**

Distance (ft): **211.5**
Structural Grade: **0**
O&M Grade: **2**
Clock Start/From: **12**
Clock To: **4**
1st Value:
2nd Value:
Value Percent: **5.000**
Continuous Index: **S03**
Within 8" of Joint: **YES**
Remarks:

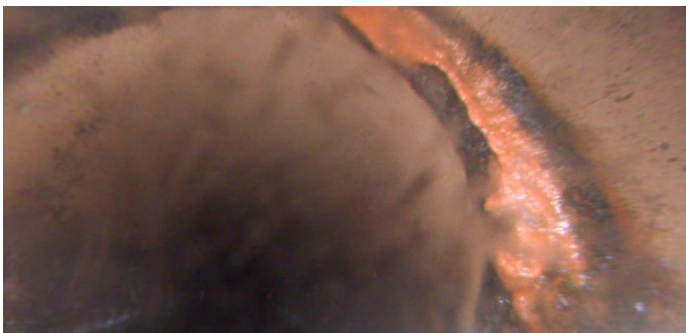
Code: **IW**
Description: **Infil Weeper**

Distance (ft): **211.5**
Structural Grade: **0**
O&M Grade: **2**
Clock Start/From: **8**
Clock To: **4**
1st Value:
2nd Value:
Value Percent:
Continuous Index: **S04**
Within 8" of Joint: **YES**
Remarks:

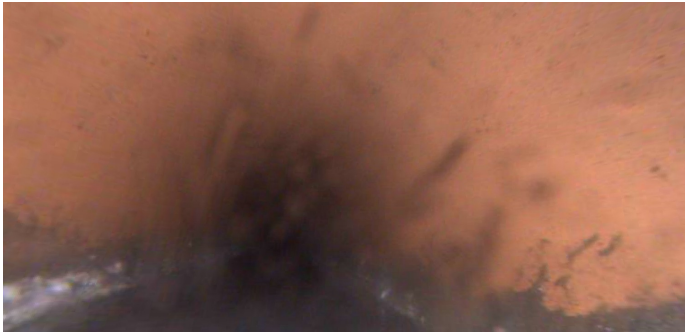
Code: **IW**
Description: **Infil Weeper**

Distance (ft): **291.1**
Structural Grade: **0**
O&M Grade: **2**
Clock Start/From: **8**
Clock To: **4**
1st Value:
2nd Value:
Value Percent:
Continuous Index: **F04**
Within 8" of Joint: **YES**
Remarks:

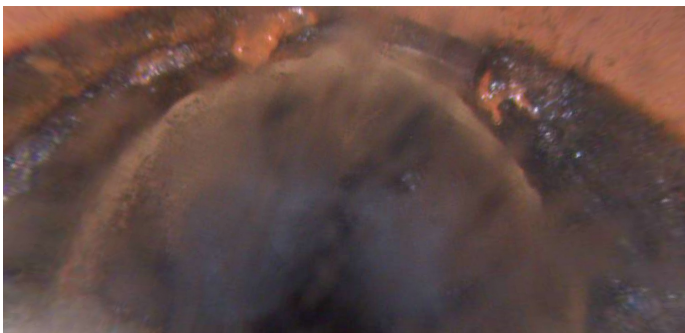
Code: **ID**
Description: **Infil Dripper**

Distance (ft): **302.5**
Structural Grade: **0**
O&M Grade: **3**
Clock Start/From: **12**
Clock To: **1**
1st Value:
2nd Value:
Value Percent:
Continuous Index:
Within 8" of Joint: **YES**
Remarks:

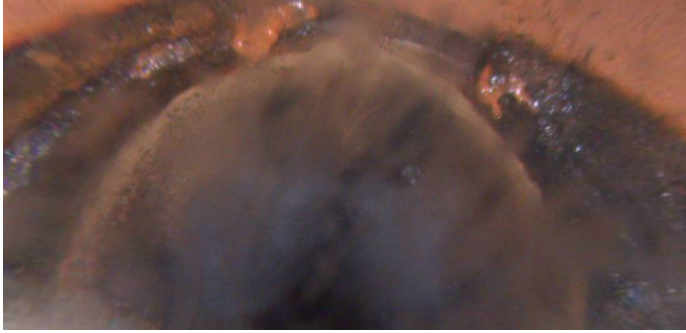
Code: **IW**
Description: **Infil Weeper**

Distance (ft): **302.5**
Structural Grade: **0**
O&M Grade: **2**
Clock Start/From: **8**
Clock To: **4**
1st Value:
2nd Value:
Value Percent:
Continuous Index:
Within 8" of Joint: **YES**
Remarks:

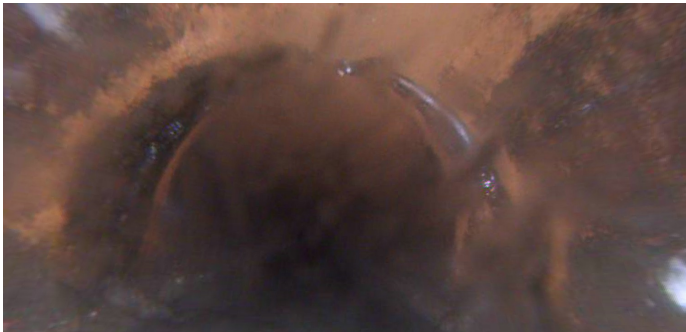
Code: **IW**
Description: **Infil Weeper**

Distance (ft): **306.1**
Structural Grade: **0**
O&M Grade: **2**
Clock Start/From: **8**
Clock To: **4**
1st Value:
2nd Value:
Value Percent:
Continuous Index:
Within 8" of Joint: **YES**
Remarks:

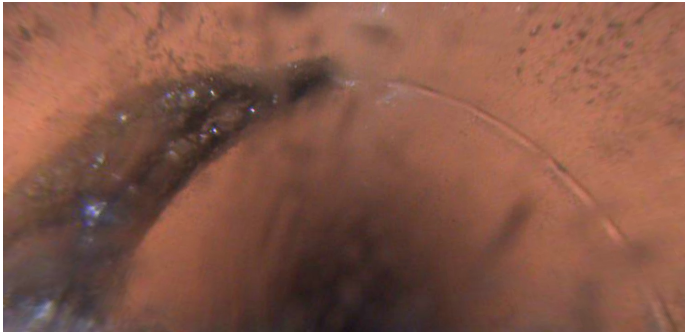
Code: **IW**
Description: **Infil Weeper**

Distance (ft): **310.6**
Structural Grade: **0**
O&M Grade: **2**
Clock Start/From: **8**
Clock To: **12**
1st Value:
2nd Value:
Value Percent:
Continuous Index:
Within 8" of Joint: **YES**
Remarks:

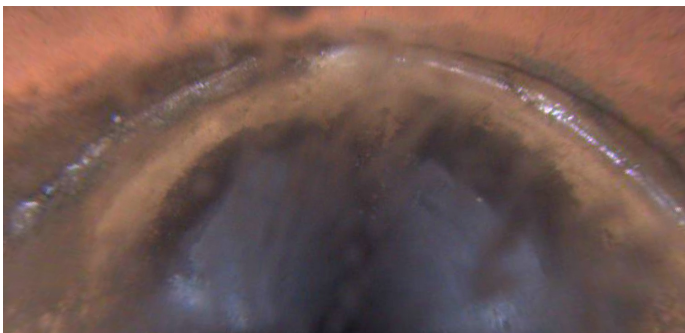
Code: **IW**
Description: **Infil Weeper**

Distance (ft): **318.8**
Structural Grade: **0**
O&M Grade: **2**
Clock Start/From: **8**
Clock To: **4**
1st Value:
2nd Value:
Value Percent:
Continuous Index:
Within 8" of Joint: **YES**
Remarks:

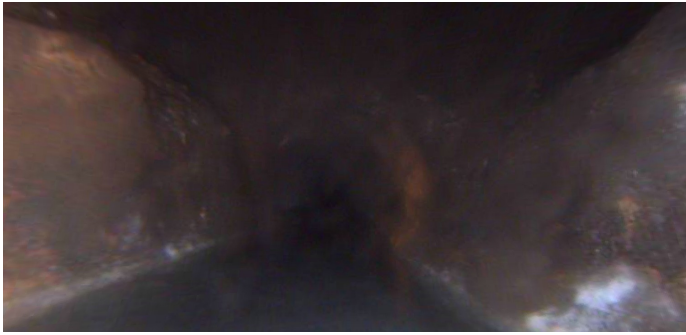
Code: **DAE**
Description: **Deposits Attached Encrustation**

Distance (ft): **324.7**
Structural Grade: **0**
O&M Grade: **2**
Clock Start/From: **12**
Clock To: **4**
1st Value:
2nd Value:
Value Percent: **5.000**
Continuous Index: **F03**
Within 8" of Joint: **YES**
Remarks:

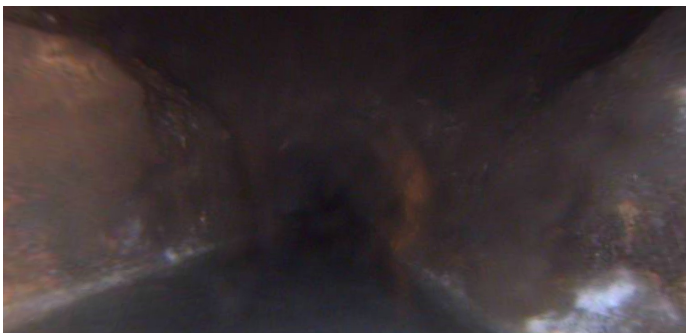
Code: **AMH**
Description: **Manhole**

Distance (ft): **324.7**
Structural Grade: **0**
O&M Grade: **0**
Clock Start/From:
Clock To:
1st Value:
2nd Value:
Value Percent:
Continuous Index:
Within 8" of Joint: **NO**
Remarks: **M-503-072**
