## Profile/Photo Observation Report

Date:	<b>04/13/2018</b>	Weather:		Coding:	<b>PACP 6.0</b>
Pipe Length (ft):	<b>326.3</b>	Owner:	<b>NA</b>	Pre Clean:	<b>Not Known</b>
P.O.#:		Surveyor:	<b>Jen Costello</b>	PSR:	<b>P-503-073-072</b>
Customer:		Clean Date:	<b>01/01/1900</b>	Shape:	<b>C</b>

Street:	<b>W 40th ave</b>	Flow Control:	<b>Not Controlled</b>
City:	<b>Hobart, IN</b>	Year Renewed:	
Location:	<b>Other</b>	Tape/Media #:	
Purpose:	<b>Not Known</b>	Dia/Height:	<b>12"</b>
Use:	<b>Sanitary</b>	Material:	<b>VCP</b>
Drain Area:	<b>NA</b>	Lining:	
Category:	<b>NA</b>		
Comment:

Location Details:		Direction of Survey:	<b>Downstream</b>
US MH:	<b>M-503-073</b>	DS MH:	<b>M-503-072</b>
		Total Length Surveyed (ft):	<b>324.7</b>

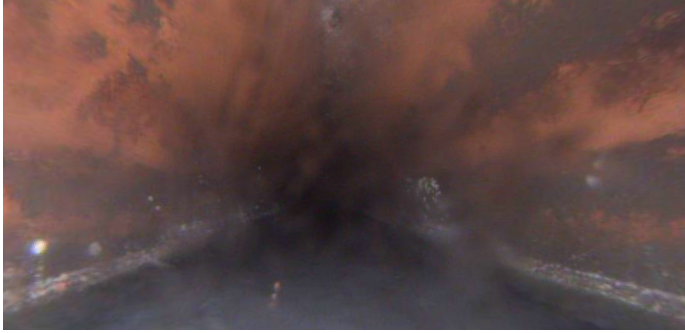
Code: **AMH**  
Description: **Manhole**

Distance (ft): **.0**  
Structural Grade: **0**  
O&M Grade: **0**  
Clock Start/From:  
Clock To:  
1st Value:  
2nd Value:  
Value Percent:  
Continuous Index:  
Within 8" of Joint: **NO**  
Remarks: **M-503-073**

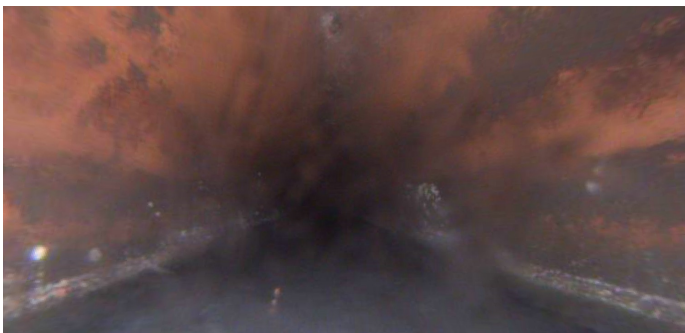
Code: **MWL**  
Description: **Water Level**

Distance (ft): **.0**  
Structural Grade: **0**  
O&M Grade: **0**  
Clock Start/From:  
Clock To:  
1st Value:  
2nd Value:  
Value Percent: **20.000**  
Continuous Index:  
Within 8" of Joint: **NO**  
Remarks:

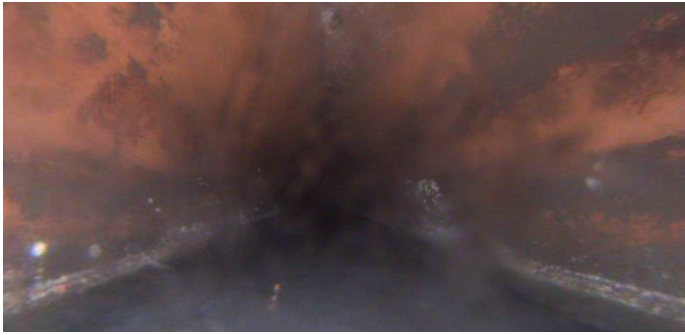
Code: **DAGS**  
Description: **Deposits Attached Grease**

Distance (ft): **.0**  
Structural Grade: **0**  
O&M Grade: **2**  
Clock Start/From: **8**  
Clock To: **4**  
1st Value:  
2nd Value:  
Value Percent: **5.000**  
Continuous Index: **S01**  
Within 8" of Joint: **NO**  
Remarks:

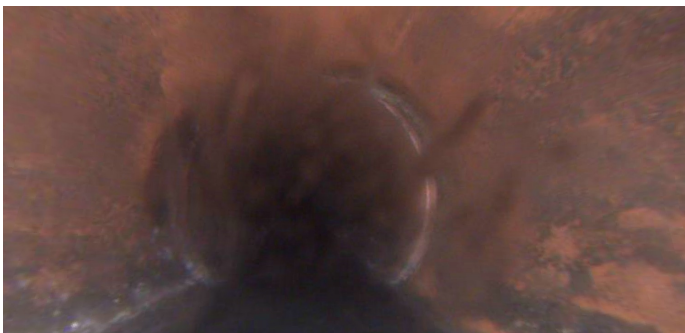
Code: **IW**  
Description: **Infil Weeper**

Distance (ft): **49.6**  
Structural Grade: **0**  
O&M Grade: **2**  
Clock Start/From: **8**  
Clock To: **4**  
1st Value:  
2nd Value:  
Value Percent:  
Continuous Index:  
Within 8" of Joint: **YES**  
Remarks:

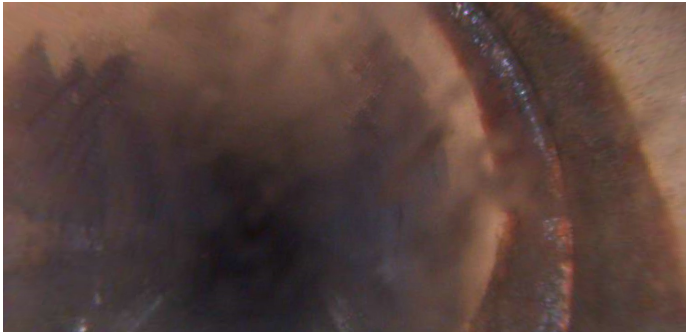
Code: **IW**  
Description: **Infil Weeper**

Distance (ft): **70.4**  
Structural Grade: **0**  
O&M Grade: **2**  
Clock Start/From: **1**  
Clock To: **4**  
1st Value:  
2nd Value:  
Value Percent:  
Continuous Index:  
Within 8" of Joint: **YES**  
Remarks:

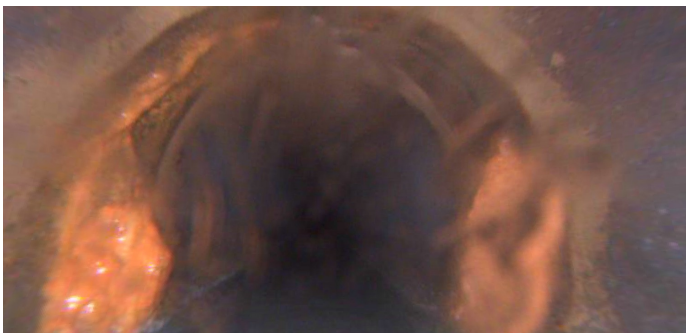
Code: **DAE**  
Description: **Deposits Attached Encrustation**

Distance (ft): **97.9**  
Structural Grade: **0**  
O&M Grade: **2**  
Clock Start/From: **8**  
Clock To: **4**  
1st Value:  
2nd Value:  
Value Percent: **10.000**  
Continuous Index:  
Within 8" of Joint: **YES**  
Remarks:

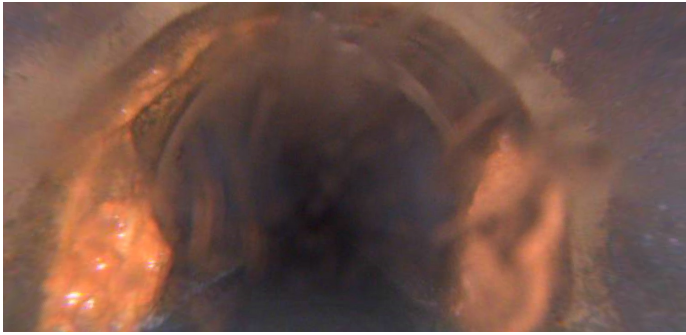
Code: **IW**  
Description: **Infil Weeper**

Distance (ft): **97.9**  
Structural Grade: **0**  
O&M Grade: **2**  
Clock Start/From: **8**  
Clock To: **4**  
1st Value:  
2nd Value:  
Value Percent:  
Continuous Index:  
Within 8" of Joint: **YES**  
Remarks:

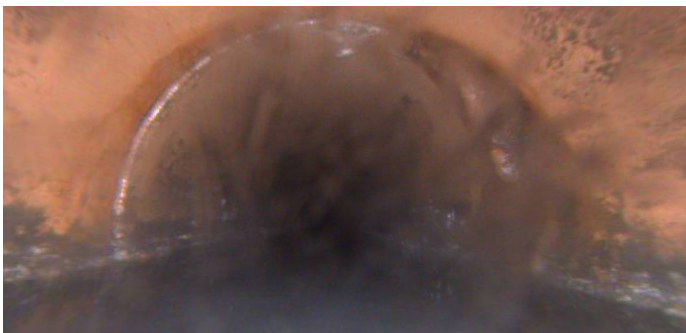
Code: **IW**  
Description: **Infil Weeper**

Distance (ft): **121.8**  
Structural Grade: **0**  
O&M Grade: **2**  
Clock Start/From: **8**  
Clock To: **4**  
1st Value:  
2nd Value:  
Value Percent:  
Continuous Index:  
Within 8" of Joint: **YES**  
Remarks:

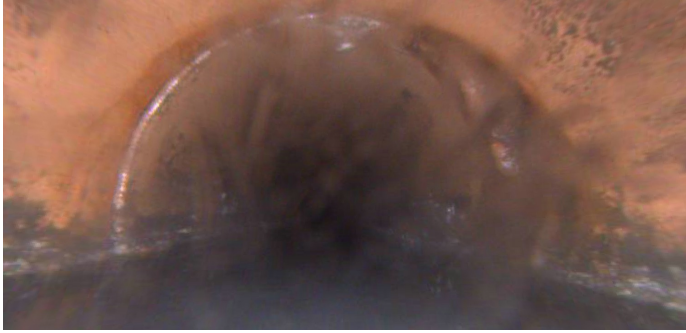
Code: **DAE**  
Description: **Deposits Attached Encrustation**

Distance (ft): **121.8**  
Structural Grade: **0**  
O&M Grade: **2**  
Clock Start/From: **8**  
Clock To: **4**  
1st Value:  
2nd Value:  
Value Percent: **5.000**  
Continuous Index:  
Within 8" of Joint: **YES**  
Remarks:

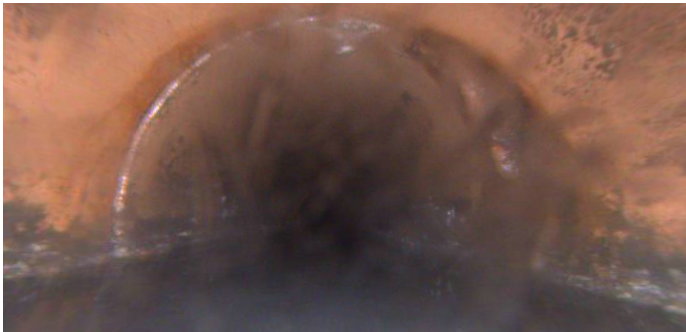
Code: **DAGS**  
Description: **Deposits Attached Grease**

Distance (ft): **121.8**  
Structural Grade: **0**  
O&M Grade: **2**  
Clock Start/From: **8**  
Clock To: **4**  
1st Value:  
2nd Value:  
Value Percent: **5.000**  
Continuous Index: **F01**  
Within 8" of Joint: **NO**  
Remarks:

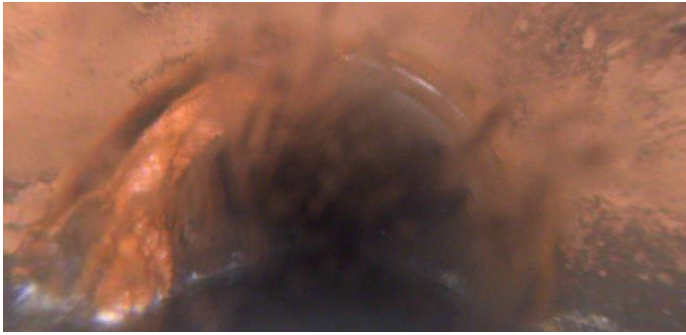
Code: **DAE**  
Description: **Deposits Attached Encrustation**

Distance (ft): **125.7**  
Structural Grade: **0**  
O&M Grade: **2**  
Clock Start/From: **8**  
Clock To: **4**  
1st Value:  
2nd Value:  
Value Percent: **10.000**  
Continuous Index:  
Within 8" of Joint: **YES**  
Remarks:

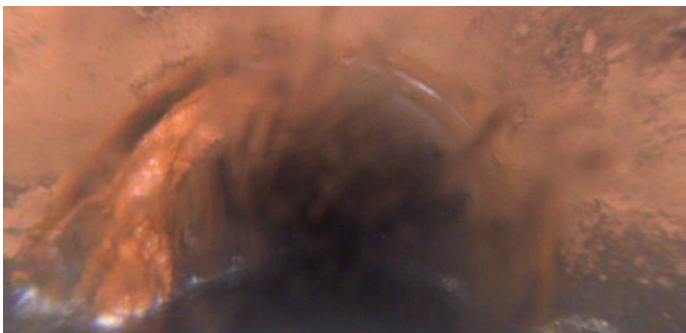
Code: **IW**  
Description: **Infil Weeper**

Distance (ft): **125.7**  
Structural Grade: **0**  
O&M Grade: **2**  
Clock Start/From: **8**  
Clock To: **4**  
1st Value:  
2nd Value:  
Value Percent:  
Continuous Index: **S02**  
Within 8" of Joint: **YES**  
Remarks:

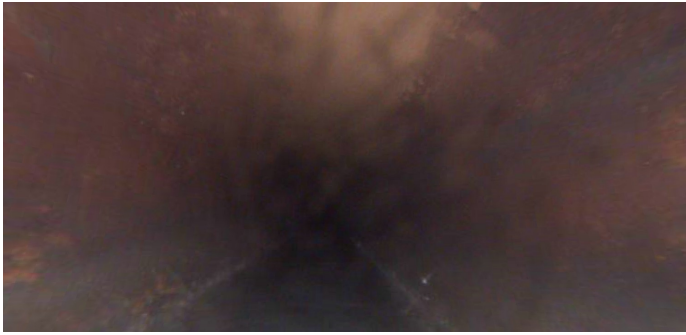
Code: **IW**  
Description: **Infil Weeper**

Distance (ft): **152.2**  
Structural Grade: **0**  
O&M Grade: **2**  
Clock Start/From: **8**  
Clock To: **4**  
1st Value:  
2nd Value:  
Value Percent:  
Continuous Index: **F02**  
Within 8" of Joint: **YES**  
Remarks:

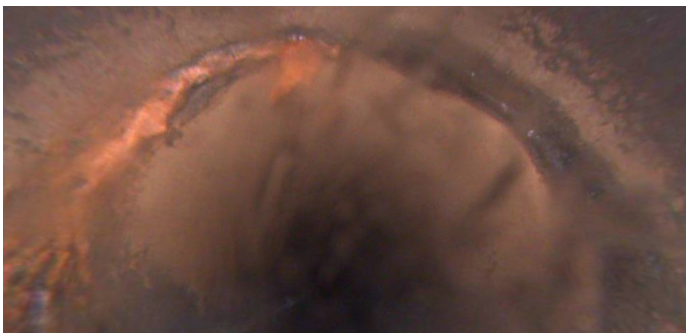
Code: **DAE**  
Description: **Deposits Attached Encrustation**

Distance (ft): **175.6**  
Structural Grade: **0**  
O&M Grade: **2**  
Clock Start/From: **8**  
Clock To: **4**  
1st Value:  
2nd Value:  
Value Percent: **5.000**  
Continuous Index:  
Within 8" of Joint: **YES**  
Remarks:

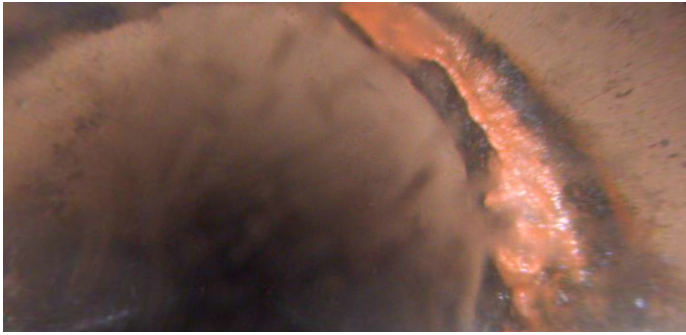
Code: **DAE**  
Description: **Deposits Attached Encrustation**

Distance (ft): **211.5**  
Structural Grade: **0**  
O&M Grade: **2**  
Clock Start/From: **12**  
Clock To: **4**  
1st Value:  
2nd Value:  
Value Percent: **5.000**  
Continuous Index: **S03**  
Within 8" of Joint: **YES**  
Remarks:

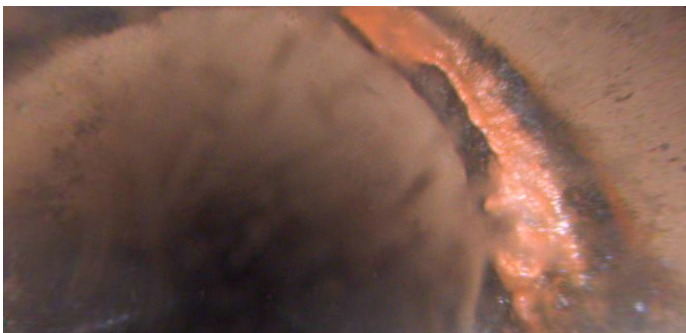
Code: **IW**  
Description: **Infil Weeper**

Distance (ft): **211.5**  
Structural Grade: **0**  
O&M Grade: **2**  
Clock Start/From: **8**  
Clock To: **4**  
1st Value:  
2nd Value:  
Value Percent:  
Continuous Index: **S04**  
Within 8" of Joint: **YES**  
Remarks:

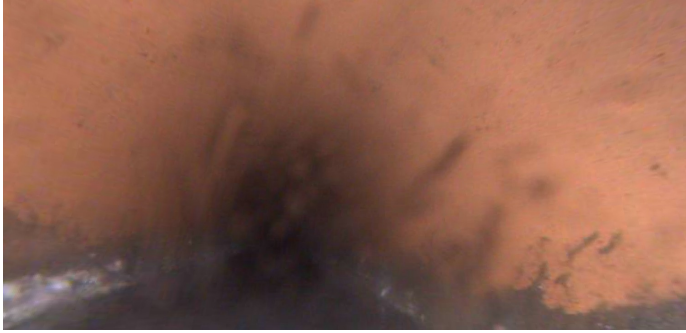
Code: **IW**  
Description: **Infil Weeper**

Distance (ft): **291.1**  
Structural Grade: **0**  
O&M Grade: **2**  
Clock Start/From: **8**  
Clock To: **4**  
1st Value:  
2nd Value:  
Value Percent:  
Continuous Index: **F04**  
Within 8" of Joint: **YES**  
Remarks:

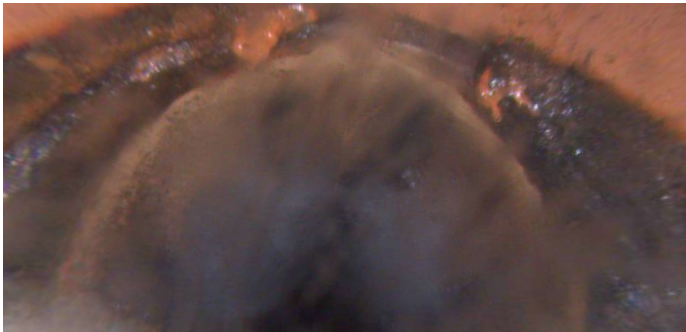
Code: **ID**  
Description: **Infil Dripper**

Distance (ft): **302.5**  
Structural Grade: **0**  
O&M Grade: **3**  
Clock Start/From: **12**  
Clock To: **1**  
1st Value:  
2nd Value:  
Value Percent:  
Continuous Index:  
Within 8" of Joint: **YES**  
Remarks:

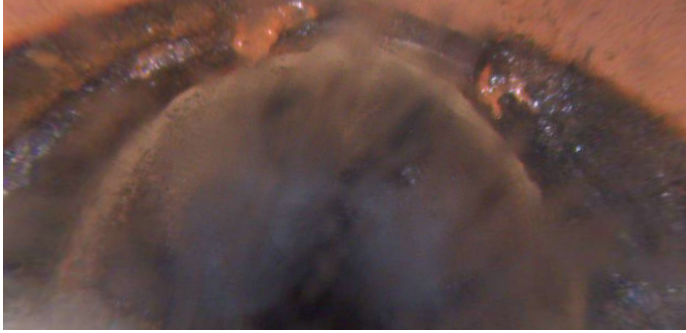
Code: **IW**  
Description: **Infil Weeper**

Distance (ft): **302.5**  
Structural Grade: **0**  
O&M Grade: **2**  
Clock Start/From: **8**  
Clock To: **4**  
1st Value:  
2nd Value:  
Value Percent:  
Continuous Index:  
Within 8" of Joint: **YES**  
Remarks:

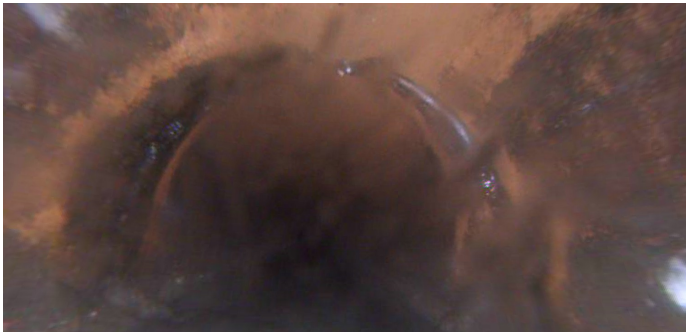
Code: **IW**  
Description: **Infil Weeper**

Distance (ft): **306.1**  
Structural Grade: **0**  
O&M Grade: **2**  
Clock Start/From: **8**  
Clock To: **4**  
1st Value:  
2nd Value:  
Value Percent:  
Continuous Index:  
Within 8" of Joint: **YES**  
Remarks:

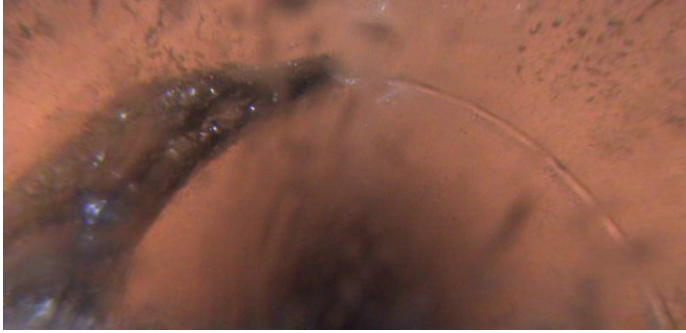
Code: **IW**  
Description: **Infil Weeper**

Distance (ft): **310.6**  
Structural Grade: **0**  
O&M Grade: **2**  
Clock Start/From: **8**  
Clock To: **12**  
1st Value:  
2nd Value:  
Value Percent:  
Continuous Index:  
Within 8" of Joint: **YES**  
Remarks:

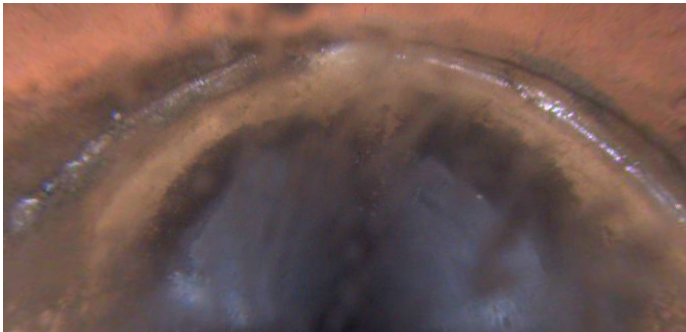
Code: **IW**  
Description: **Infil Weeper**

Distance (ft): **318.8**  
Structural Grade: **0**  
O&M Grade: **2**  
Clock Start/From: **8**  
Clock To: **4**  
1st Value:  
2nd Value:  
Value Percent:  
Continuous Index:  
Within 8" of Joint: **YES**  
Remarks:

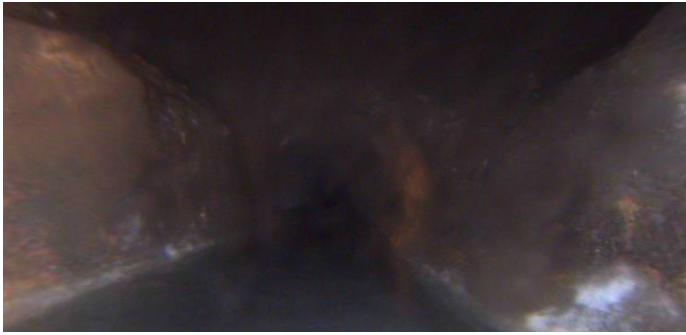
Code: **DAE**  
Description: **Deposits Attached Encrustation**

Distance (ft): **324.7**  
Structural Grade: **0**  
O&M Grade: **2**  
Clock Start/From: **12**  
Clock To: **4**  
1st Value:  
2nd Value:  
Value Percent: **5.000**  
Continuous Index: **F03**  
Within 8" of Joint: **YES**  
Remarks:

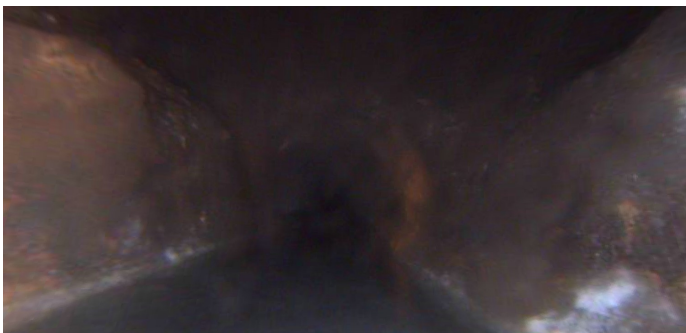
Code: **AMH**  
Description: **Manhole**

Distance (ft): **324.7**  
Structural Grade: **0**  
O&M Grade: **0**  
Clock Start/From:  
Clock To:  
1st Value:  
2nd Value:  
Value Percent:  
Continuous Index:  
Within 8" of Joint: **NO**  
Remarks: **M-503-072**
