Profile/Photo Observation Report

Date:	04/13/2018	Weather:		Coding:	PACP 6.0
Pipe Length (ft):	320.3	Owner:	NA	Pre Clean:	Not Known
P.O.#:		Surveyor:	Jen Costello	PSR:	P-503-074-073
Customer:		Clean Date:	01/01/1900	Shape:	C

Street:	W 38TH AVE & N COLORADO ST	Flow Control:	Not Controlled
City:	Hobart, IN	Year Renewed:	
Location:	Other	Tape/Media #:	
Purpose:	Not Known	Dia/Height:	12"
Use:	Sanitary	Material:	VCP
Drain Area:	NA	Lining:	
Category:	NA		
Comment:

Location Details:		Direction of Survey:	Downstream
US MH:	M-503-074	DS MH:	M-503-073
		Total Length Surveyed (ft):	237.0

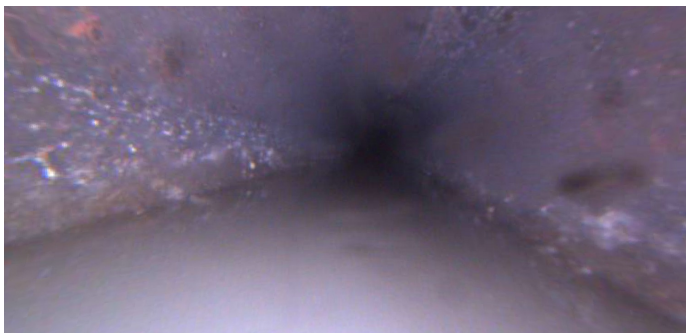
Code: **AMH**
Description: **Manhole**

Distance (ft): **.0**
Structural Grade: **0**
O&M Grade: **0**
Clock Start/From:
Clock To:
1st Value:
2nd Value:
Value Percent:
Continuous Index:
Within 8" of Joint: **NO**
Remarks: **M-503-074**

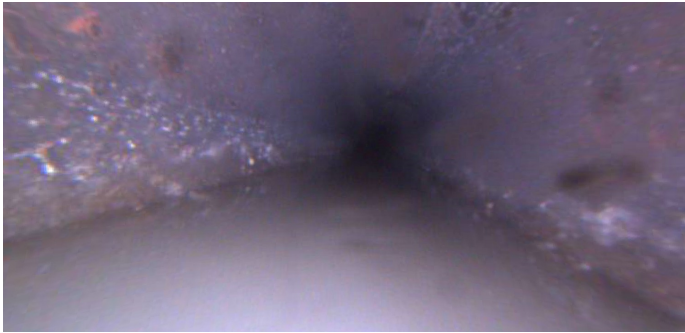
Code:	MWL
Description:	Water Level

Distance (ft):	.0
Structural Grade:	0
O&M Grade:	0
Clock Start/From:	
Clock To:	
1st Value:	
2nd Value:	
Value Percent:	30.000
Continuous Index:	
Within 8" of Joint:	NO
Remarks:

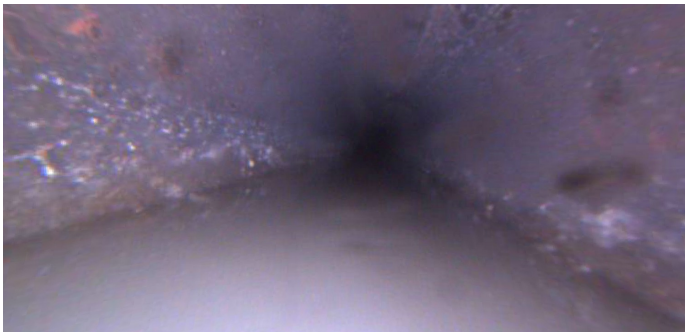
Code:	DAGS
Description:	Deposits Attached Grease

Distance (ft):	.0
Structural Grade:	0
O&M Grade:	2
Clock Start/From:	8
Clock To:	4
1st Value:	
2nd Value:	
Value Percent:	5.000
Continuous Index:	S01
Within 8" of Joint:	NO
Remarks:

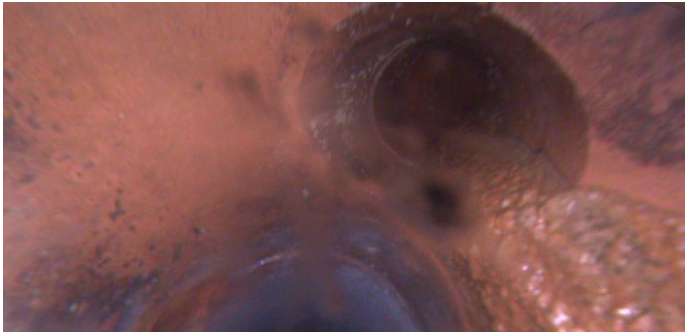
Code: **TF**
Description: **Tap Factory**

Distance (ft): **12.5**
Structural Grade: **0**
O&M Grade: **0**
Clock Start/From: **1**
Clock To:
1st Value: **4.000**
2nd Value:
Value Percent:
Continuous Index:
Within 8" of Joint:
Remarks:

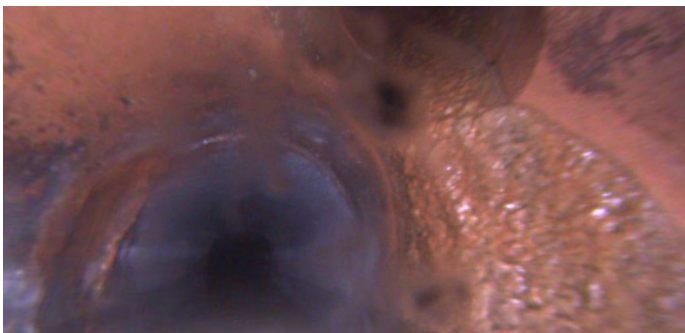
Code: **DAE**
Description: **Deposits Attached Encrustation**

Distance (ft): **12.5**
Structural Grade: **0**
O&M Grade: **2**
Clock Start/From: **1**
Clock To: **4**
1st Value:
2nd Value:
Value Percent: **5.000**
Continuous Index:
Within 8" of Joint: **NO**
Remarks:

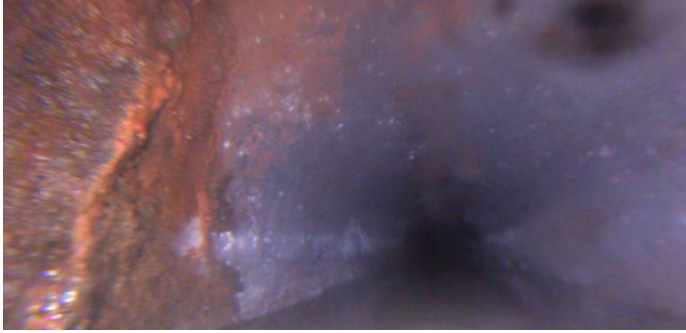
Code: **DAE**
Description: **Deposits Attached Encrustation**

Distance (ft): **13.5**
Structural Grade: **0**
O&M Grade: **2**
Clock Start/From: **8**
Clock To: **10**
1st Value:
2nd Value:
Value Percent: **5.000**
Continuous Index:
Within 8" of Joint: **YES**
Remarks:

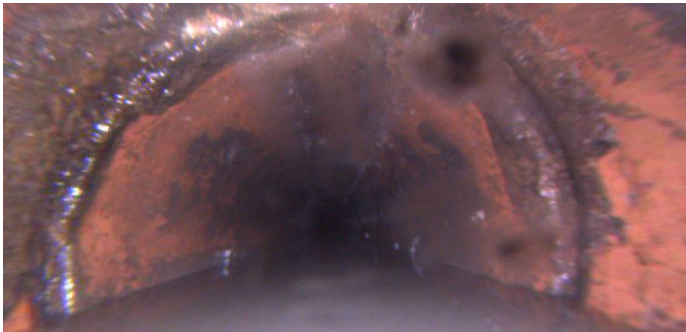
Code: **DAE**
Description: **Deposits Attached Encrustation**

Distance (ft): **20.4**
Structural Grade: **0**
O&M Grade: **2**
Clock Start/From: **8**
Clock To: **4**
1st Value:
2nd Value:
Value Percent: **5.000**
Continuous Index:
Within 8" of Joint: **YES**
Remarks:

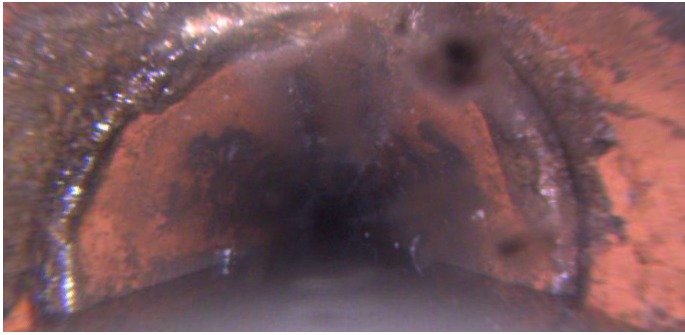
Code: **IW**
Description: **Infil Weeper**

Distance (ft): **20.4**
Structural Grade: **0**
O&M Grade: **2**
Clock Start/From: **8**
Clock To: **4**
1st Value:
2nd Value:
Value Percent:
Continuous Index:
Within 8" of Joint: **YES**
Remarks:

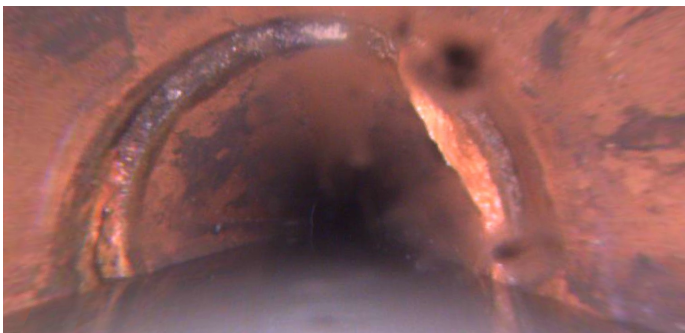
Code: **DAE**
Description: **Deposits Attached Encrustation**

Distance (ft): **40.6**
Structural Grade: **0**
O&M Grade: **2**
Clock Start/From: **8**
Clock To: **4**
1st Value:
2nd Value:
Value Percent: **5.000**
Continuous Index:
Within 8" of Joint: **YES**
Remarks:

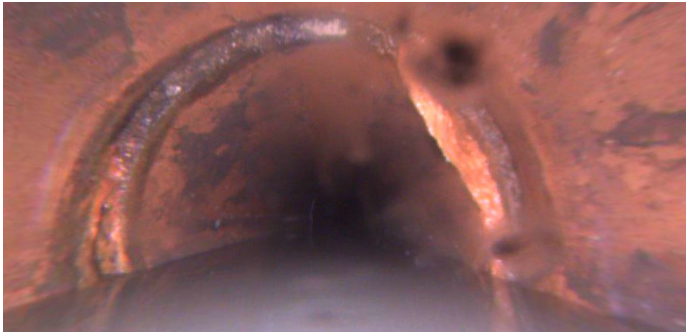
Code: **IW**
Description: **Infil Weeper**

Distance (ft): **40.6**
Structural Grade: **0**
O&M Grade: **2**
Clock Start/From: **8**
Clock To: **4**
1st Value:
2nd Value:
Value Percent:
Continuous Index: **S02**
Within 8" of Joint: **YES**
Remarks:

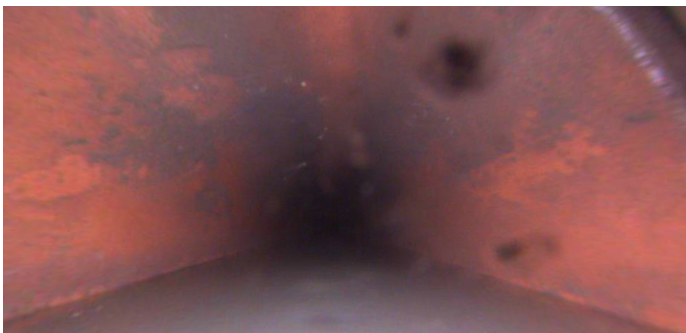
Code: **IW**
Description: **Infil Weeper**

Distance (ft): **135.2**
Structural Grade: **0**
O&M Grade: **2**
Clock Start/From: **8**
Clock To: **4**
1st Value:
2nd Value:
Value Percent:
Continuous Index: **F02**
Within 8" of Joint: **YES**
Remarks:

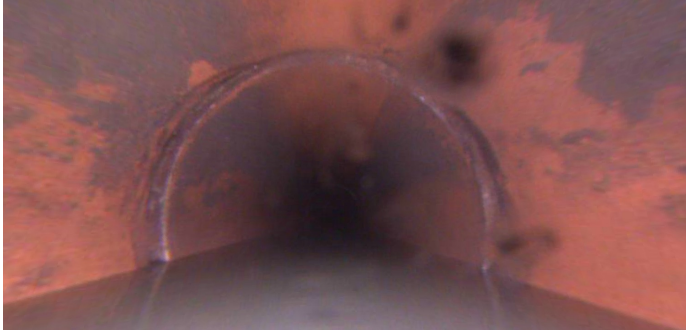
Code: **IW**
Description: **Infil Weeper**

Distance (ft): **166.1**
Structural Grade: **0**
O&M Grade: **2**
Clock Start/From: **8**
Clock To: **4**
1st Value:
2nd Value:
Value Percent:
Continuous Index: **S03**
Within 8" of Joint: **YES**
Remarks:

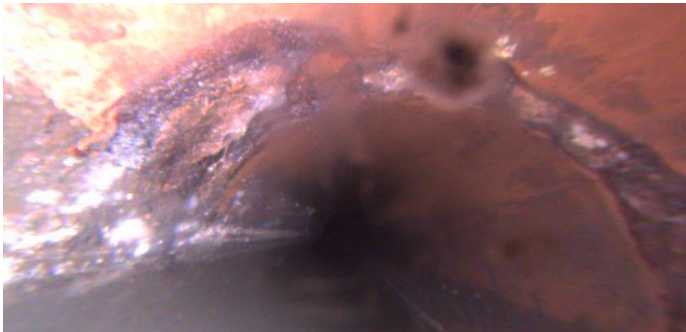
Code: **DAE**
Description: **Deposits Attached Encrustation**

Distance (ft): **237.0**
Structural Grade: **0**
O&M Grade: **2**
Clock Start/From: **8**
Clock To: **4**
1st Value:
2nd Value:
Value Percent: **5.000**
Continuous Index:
Within 8" of Joint: **YES**
Remarks:

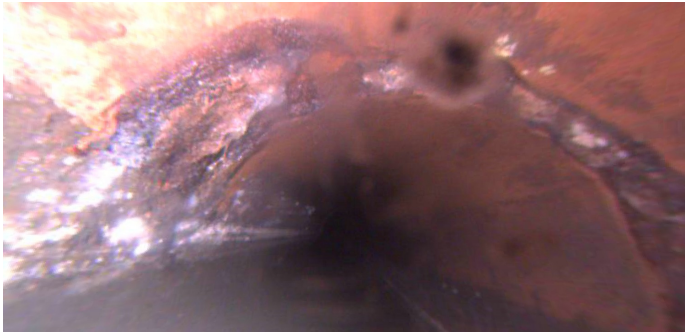
Code: **DAGS**
Description: **Deposits Attached Grease**

Distance (ft): **237.0**
Structural Grade: **0**
O&M Grade: **2**
Clock Start/From: **8**
Clock To: **4**
1st Value:
2nd Value:
Value Percent: **5.000**
Continuous Index: **F01**
Within 8" of Joint: **NO**
Remarks:

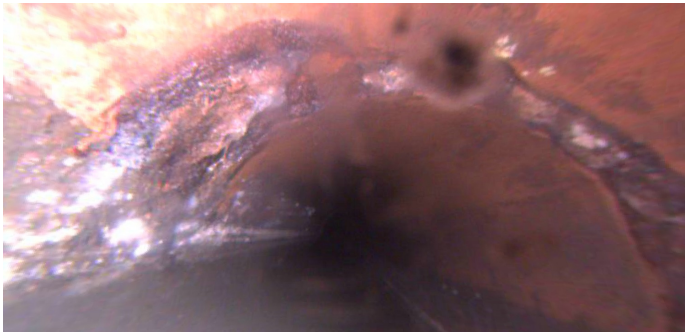
Code: **IW**
Description: **Infil Weeper**

Distance (ft): **237.0**
Structural Grade: **0**
O&M Grade: **2**
Clock Start/From: **8**
Clock To: **4**
1st Value:
2nd Value:
Value Percent:
Continuous Index: **F03**
Within 8" of Joint: **YES**
Remarks:

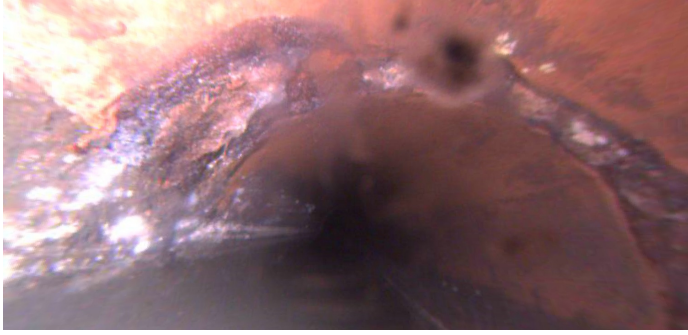
Code:	MSA
Description:	Abandoned Survey
Distance (ft):	237.0
Structural Grade:	0
O&M Grade:	0
Clock Start/From:	
Clock To:	
1st Value:	
2nd Value:	
Value Percent:	
Continuous Index:	
Within 8" of Joint:	NO
Remarks:	overturned
