Profile/Photo Observation Report

Date:	04/13/2018	Weather:		Coding:	PACP 6.0
Pipe Length (ft):	320.3	Owner:	NA	Pre Clean:	Not Known
P.O.#:		Surveyor:	Jen Costello	PSR:	P-503-074-073
Customer:		Clean Date:	01/01/1900	Shape:	C

Street:	W 40th ave	Flow Control:	Not Controlled
City:	Hobart, IN	Year Renewed:	
Location:	Other	Tape/Media #:	
Purpose:	Not Known	Dia/Height:	12"
Use:	Sanitary	Material:	VCP
Drain Area:	NA	Lining:	
Category:	NA		
Comment:

Location Details:		Direction of Survey:	Downstream
US MH:	M-503-074	DS MH:	M-503-073
		Total Length Surveyed (ft):	237.0

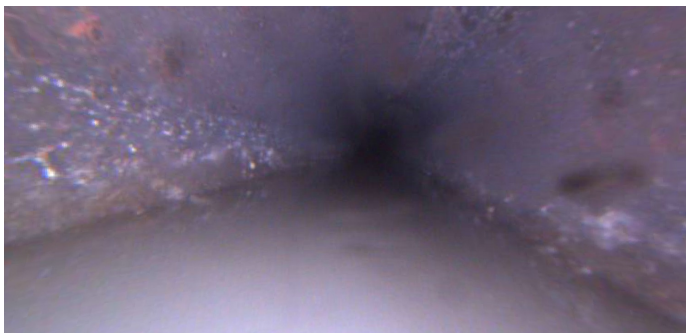
Code: **AMH**
Description: **Manhole**

Distance (ft): **.0**
Structural Grade: **0**
O&M Grade: **0**
Clock Start/From:
Clock To:
1st Value:
2nd Value:
Value Percent:
Continuous Index:
Within 8" of Joint: **NO**
Remarks: **M-503-074**

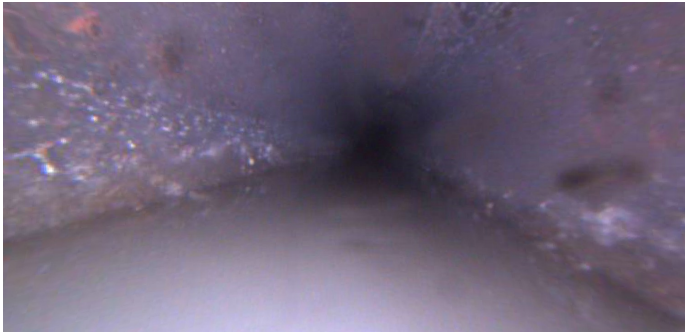
Code:	MWL
Description:	Water Level

Distance (ft):	.0
Structural Grade:	0
O&M Grade:	0
Clock Start/From:	
Clock To:	
1st Value:	
2nd Value:	
Value Percent:	30.000
Continuous Index:	
Within 8" of Joint:	NO
Remarks:

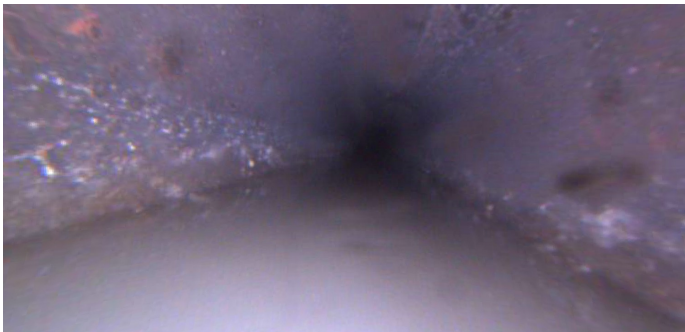
Code:	DAGS
Description:	Deposits Attached Grease

Distance (ft):	.0
Structural Grade:	0
O&M Grade:	2
Clock Start/From:	8
Clock To:	4
1st Value:	
2nd Value:	
Value Percent:	5.000
Continuous Index:	S01
Within 8" of Joint:	NO
Remarks:

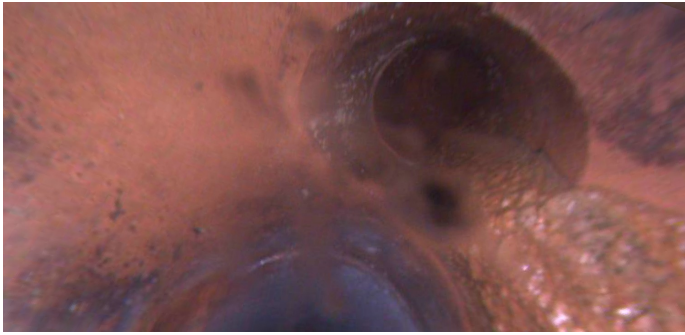
Code: **TF**
Description: **Tap Factory**

Distance (ft): **12.5**
Structural Grade: **0**
O&M Grade: **0**
Clock Start/From: **1**
Clock To:
1st Value: **4.000**
2nd Value:
Value Percent:
Continuous Index:
Within 8" of Joint:
Remarks:

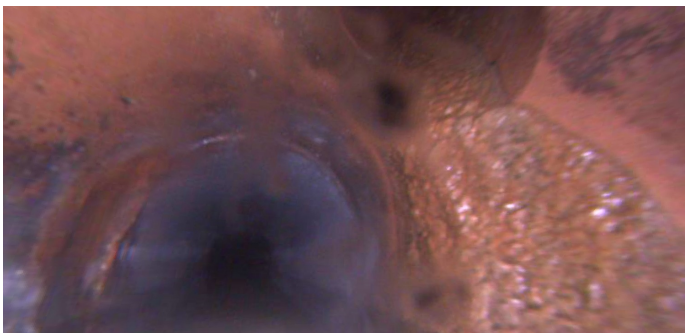
Code: **DAE**
Description: **Deposits Attached Encrustation**

Distance (ft): **12.5**
Structural Grade: **0**
O&M Grade: **2**
Clock Start/From: **1**
Clock To: **4**
1st Value:
2nd Value:
Value Percent: **5.000**
Continuous Index:
Within 8" of Joint: **NO**
Remarks:

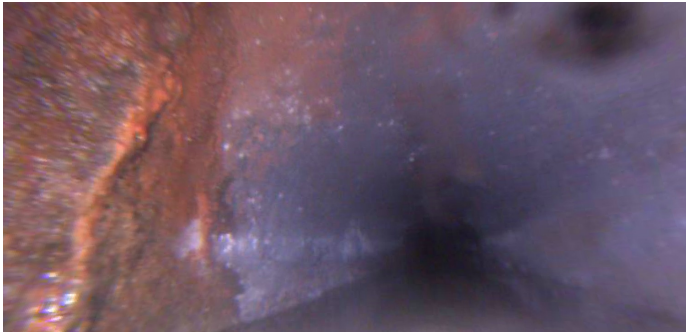
Code: **DAE**
Description: **Deposits Attached Encrustation**

Distance (ft): **13.5**
Structural Grade: **0**
O&M Grade: **2**
Clock Start/From: **8**
Clock To: **10**
1st Value:
2nd Value:
Value Percent: **5.000**
Continuous Index:
Within 8" of Joint: **YES**
Remarks:

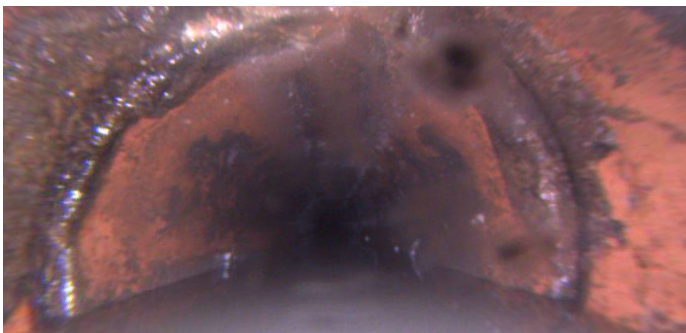
Code: **DAE**
Description: **Deposits Attached Encrustation**

Distance (ft): **20.4**
Structural Grade: **0**
O&M Grade: **2**
Clock Start/From: **8**
Clock To: **4**
1st Value:
2nd Value:
Value Percent: **5.000**
Continuous Index:
Within 8" of Joint: **YES**
Remarks:

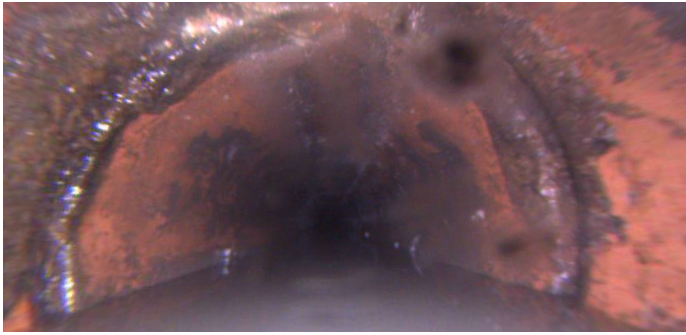
Code: **IW**
Description: **Infil Weeper**

Distance (ft): **20.4**
Structural Grade: **0**
O&M Grade: **2**
Clock Start/From: **8**
Clock To: **4**
1st Value:
2nd Value:
Value Percent:
Continuous Index:
Within 8" of Joint: **YES**
Remarks:

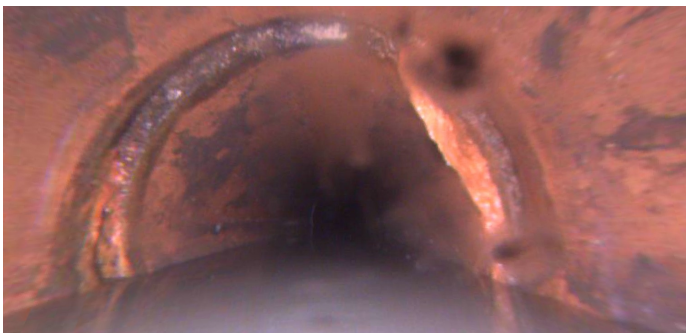
Code: **DAE**
Description: **Deposits Attached Encrustation**

Distance (ft): **40.6**
Structural Grade: **0**
O&M Grade: **2**
Clock Start/From: **8**
Clock To: **4**
1st Value:
2nd Value:
Value Percent: **5.000**
Continuous Index:
Within 8" of Joint: **YES**
Remarks:

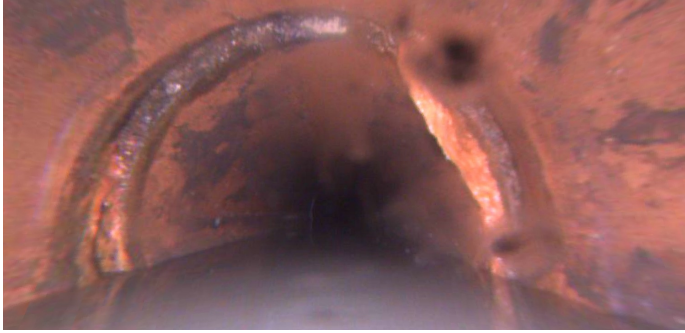
Code: **IW**
Description: **Infil Weeper**

Distance (ft): **40.6**
Structural Grade: **0**
O&M Grade: **2**
Clock Start/From: **8**
Clock To: **4**
1st Value:
2nd Value:
Value Percent:
Continuous Index: **S02**
Within 8" of Joint: **YES**
Remarks:

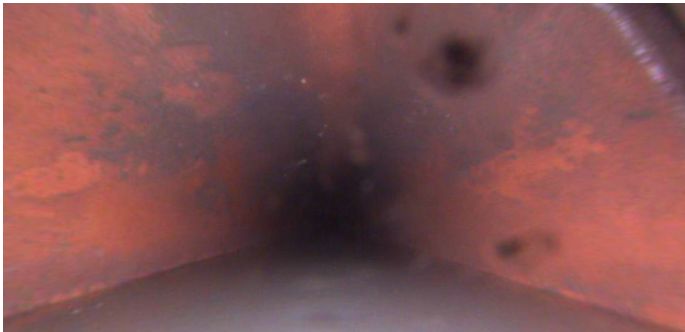
Code: **IW**
Description: **Infil Weeper**

Distance (ft): **135.2**
Structural Grade: **0**
O&M Grade: **2**
Clock Start/From: **8**
Clock To: **4**
1st Value:
2nd Value:
Value Percent:
Continuous Index: **F02**
Within 8" of Joint: **YES**
Remarks:

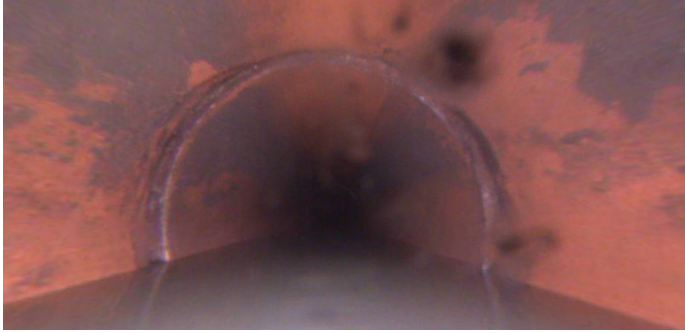
Code: **IW**
Description: **Infil Weeper**

Distance (ft): **166.1**
Structural Grade: **0**
O&M Grade: **2**
Clock Start/From: **8**
Clock To: **4**
1st Value:
2nd Value:
Value Percent:
Continuous Index: **S03**
Within 8" of Joint: **YES**
Remarks:

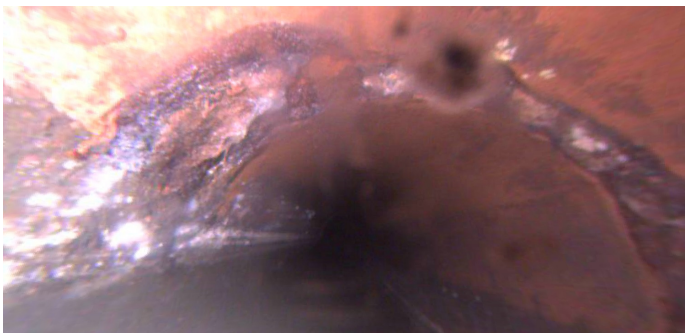
Code: **DAE**
Description: **Deposits Attached Encrustation**

Distance (ft): **237.0**
Structural Grade: **0**
O&M Grade: **2**
Clock Start/From: **8**
Clock To: **4**
1st Value:
2nd Value:
Value Percent: **5.000**
Continuous Index:
Within 8" of Joint: **YES**
Remarks:

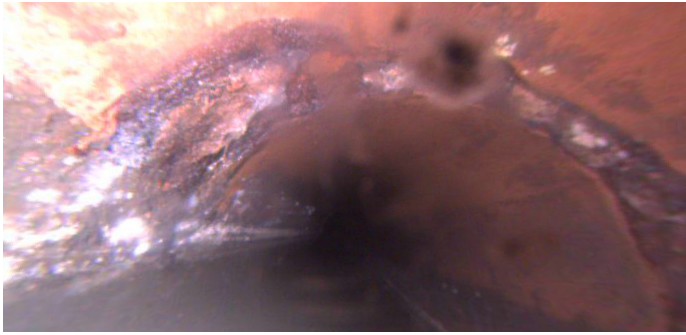
Code: **DAGS**
Description: **Deposits Attached Grease**

Distance (ft): **237.0**
Structural Grade: **0**
O&M Grade: **2**
Clock Start/From: **8**
Clock To: **4**
1st Value:
2nd Value:
Value Percent: **5.000**
Continuous Index: **F01**
Within 8" of Joint: **NO**
Remarks:

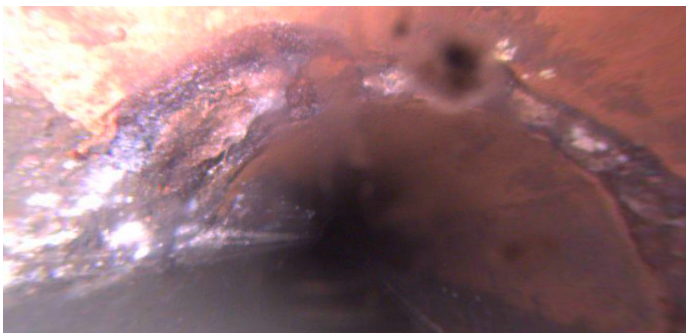
Code: **IW**
Description: **Infil Weeper**

Distance (ft): **237.0**
Structural Grade: **0**
O&M Grade: **2**
Clock Start/From: **8**
Clock To: **4**
1st Value:
2nd Value:
Value Percent:
Continuous Index: **F03**
Within 8" of Joint: **YES**
Remarks:

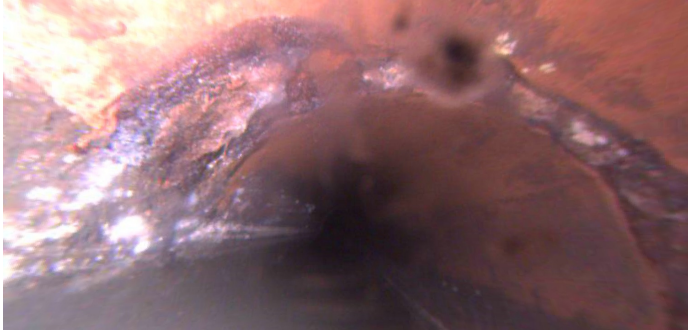
Code:	MSA
Description:	Abandoned Survey
Distance (ft):	237.0
Structural Grade:	0
O&M Grade:	0
Clock Start/From:	
Clock To:	
1st Value:	
2nd Value:	
Value Percent:	
Continuous Index:	
Within 8" of Joint:	NO
Remarks:	overturned
