## Profile/Photo Observation Report

Street:	<b>W 38TH AVE &amp; N COLORADO ST</b>	Flow Control:	<b>Not Controlled</b>
City:	<b>Hobart, IN</b>	Year Renewed:	
Location:	<b>Other</b>	Tape/Media #:	
Purpose:	<b>Not Known</b>	Dia/Height:	<b>10"</b>
Use:	<b>Sanitary</b>	Material:	<b>VCP</b>
Drain Area:	<b>NA</b>	Lining:	
Category:	<b>NA</b>		
Comment:

Location Details:		Direction of Survey:	<b>Downstream</b>
US MH:	<b>M-503-074</b>	DS MH:	<b>M-503-075</b>
		Total Length Surveyed (ft):	<b>60.5</b>

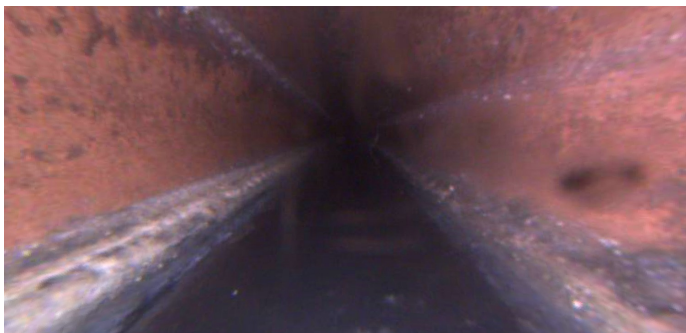
Code: **AMH**  
Description: **Manhole**

Distance (ft): **.0**  
Structural Grade: **0**  
O&M Grade: **0**  
Clock Start/From:  
Clock To:  
1st Value:  
2nd Value:  
Value Percent:  
Continuous Index:  
Within 8" of Joint: **NO**  
Remarks: **M-503-074**

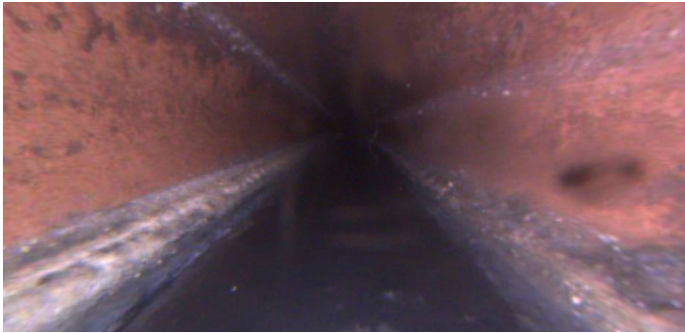
Code:	<b>MWL</b>
Description:	<b>Water Level</b>

Distance (ft):	<b>.0</b>
Structural Grade:	<b>0</b>
O&M Grade:	<b>0</b>
Clock Start/From:	
Clock To:	
1st Value:	
2nd Value:	
Value Percent:	<b>20.000</b>
Continuous Index:	
Within 8" of Joint:	<b>NO</b>
Remarks:

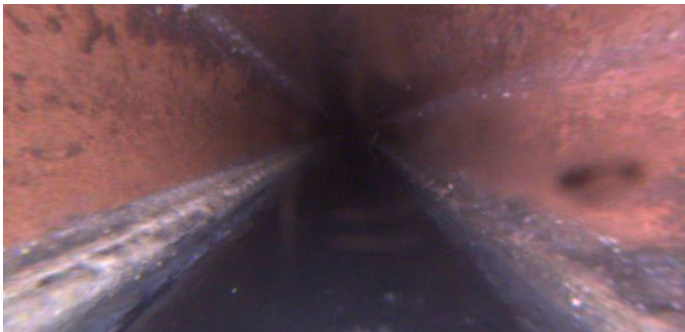
Code:	<b>DAGS</b>
Description:	<b>Deposits Attached Grease</b>

Distance (ft):	<b>.0</b>
Structural Grade:	<b>0</b>
O&M Grade:	<b>2</b>
Clock Start/From:	<b>8</b>
Clock To:	<b>4</b>
1st Value:	
2nd Value:	
Value Percent:	<b>5.000</b>
Continuous Index:	<b>S01</b>
Within 8" of Joint:	<b>NO</b>
Remarks:

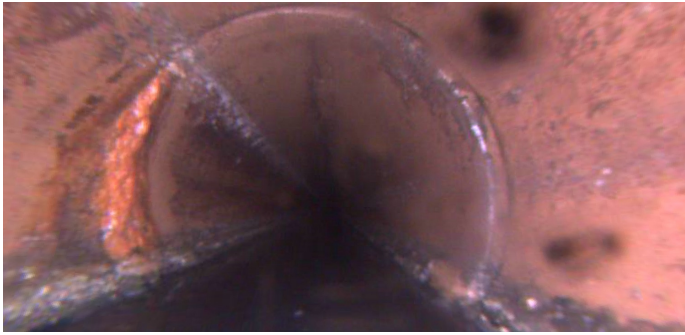
Code: **IW**  
Description: **Infil Weeper**

Distance (ft): **9.3**  
Structural Grade: **0**  
O&M Grade: **2**  
Clock Start/From: **8**  
Clock To: **10**  
1st Value:  
2nd Value:  
Value Percent:  
Continuous Index:  
Within 8" of Joint: **YES**  
Remarks:

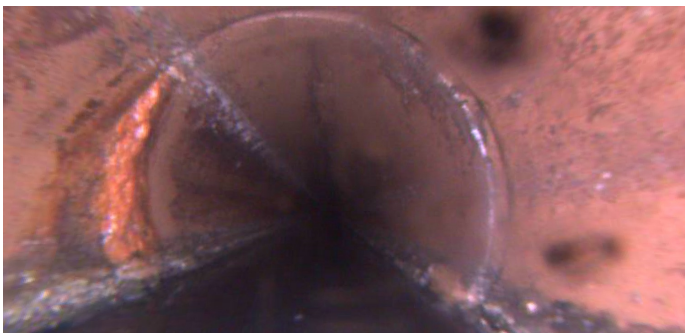
Code: **DAE**  
Description: **Deposits Attached Encrustation**

Distance (ft): **9.3**  
Structural Grade: **0**  
O&M Grade: **2**  
Clock Start/From: **8**  
Clock To: **10**  
1st Value:  
2nd Value:  
Value Percent: **5.000**  
Continuous Index:  
Within 8" of Joint: **YES**  
Remarks:

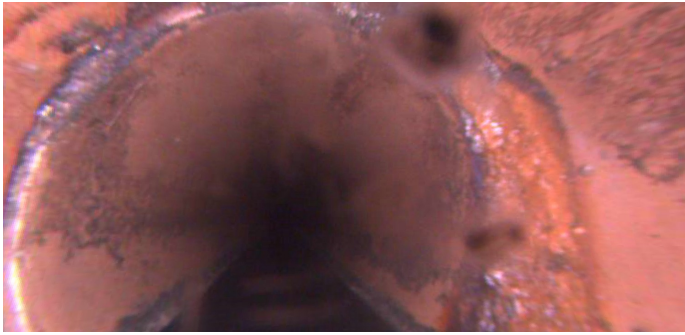
Code: **IW**  
Description: **Infil Weeper**

Distance (ft): **49.3**  
Structural Grade: **0**  
O&M Grade: **2**  
Clock Start/From: **1**  
Clock To: **4**  
1st Value:  
2nd Value:  
Value Percent:  
Continuous Index:  
Within 8" of Joint: **YES**  
Remarks:

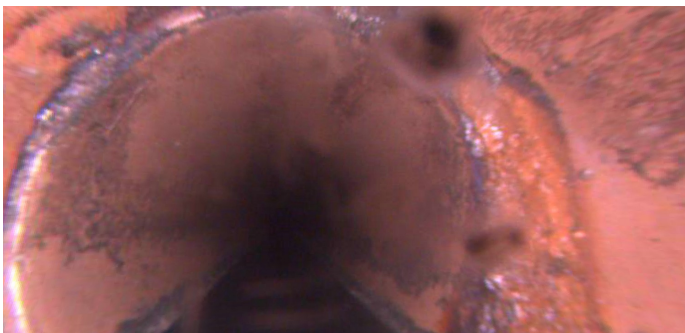
Code: **DAE**  
Description: **Deposits Attached Encrustation**

Distance (ft): **49.3**  
Structural Grade: **0**  
O&M Grade: **2**  
Clock Start/From: **1**  
Clock To: **4**  
1st Value:  
2nd Value:  
Value Percent: **5.000**  
Continuous Index:  
Within 8" of Joint: **YES**  
Remarks:

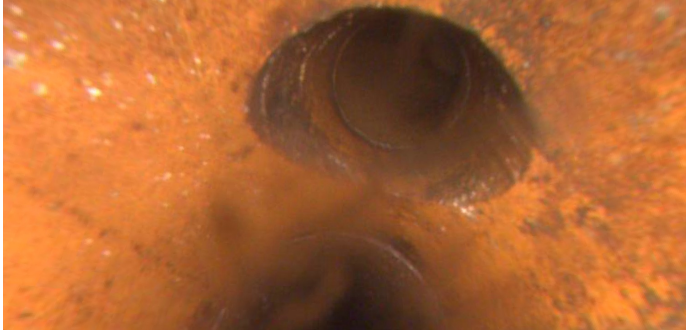
Code: **TF**  
Description: **Tap Factory**

Distance (ft): **55.8**  
Structural Grade: **0**  
O&M Grade: **0**  
Clock Start/From: **12**  
Clock To:  
1st Value: **4.000**  
2nd Value:  
Value Percent:  
Continuous Index:  
Within 8" of Joint:  
Remarks:

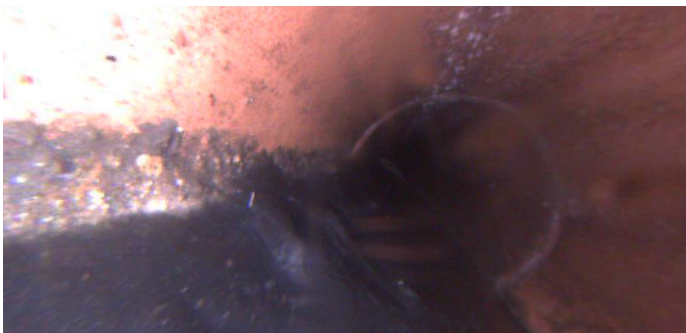
Code: **MSA**  
Description: **Abandoned Survey**

Distance (ft): **60.5**  
Structural Grade: **0**  
O&M Grade: **0**  
Clock Start/From:  
Clock To:  
1st Value:  
2nd Value:  
Value Percent:  
Continuous Index:  
Within 8" of Joint: **NO**  
Remarks: **overturned**

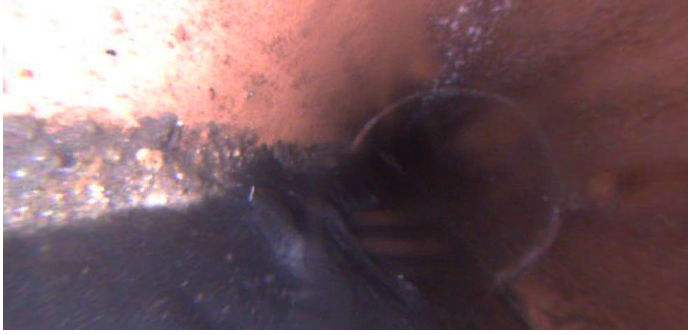
Code:	<b>DAGS</b>
Description:	<b>Deposits Attached Grease</b>
Distance (ft):	<b>60.5</b>
Structural Grade:	<b>0</b>
O&M Grade:	<b>2</b>
Clock Start/From:	<b>8</b>
Clock To:	<b>4</b>
1st Value:	
2nd Value:	
Value Percent:	<b>5.000</b>
Continuous Index:	<b>F01</b>
Within 8" of Joint:	<b>NO</b>
Remarks:
