Profile/Photo Observation Report

Street:	N COLORADO ST	Flow Control:	Not Controlled
City:	Hobart, IN	Year Renewed:	
Location:	Other	Tape/Media #:	
Purpose:	Not Known	Dia/Height:	10"
Use:	Sanitary	Material:	VCP
Drain Area:	NA	Lining:	
Category:	NA		
Comment:			
Location Details:		Direction of Survey:	Downstream
US MH:	M-503-075	DS MH:	M-503-076
		Total Length Surveyed (ft):	393.0

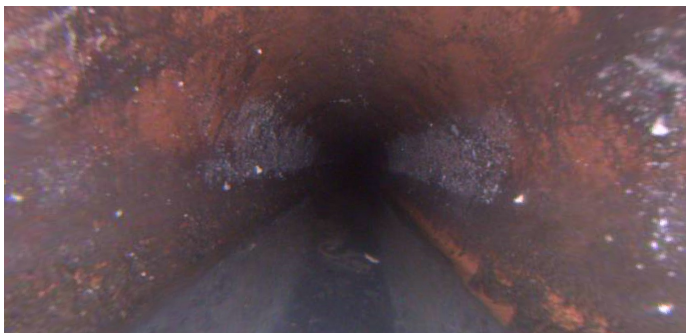
Code: **AMH**
Description: **Manhole**

Distance (ft): **.0**
Structural Grade: **0**
O&M Grade: **0**
Clock Start/From:
Clock To:
1st Value:
2nd Value:
Value Percent:
Continuous Index:
Within 8" of Joint: **NO**
Remarks: **M-503-075**

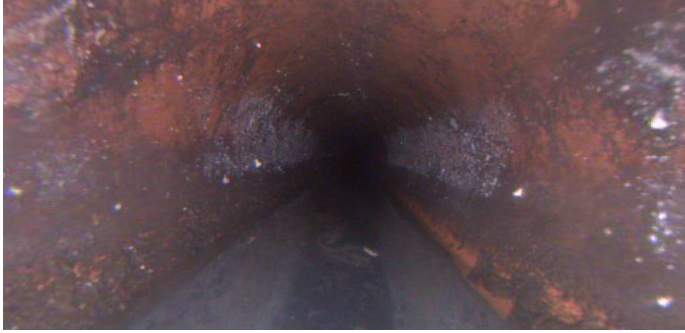
Code: **MWL**
Description: **Water Level**

Distance (ft): **.0**
Structural Grade: **0**
O&M Grade: **0**
Clock Start/From:
Clock To:
1st Value:
2nd Value:
Value Percent: **10.000**
Continuous Index:
Within 8" of Joint: **NO**
Remarks:

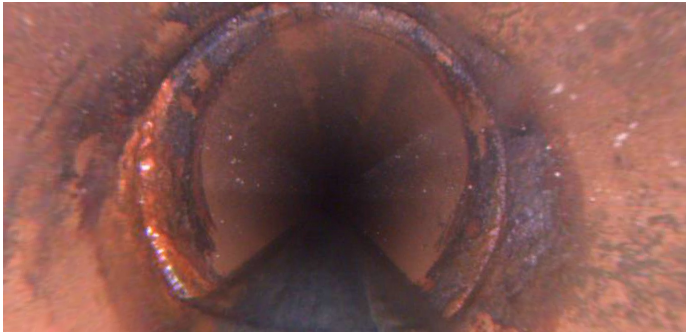
Code: **IW**
Description: **Infil Weeper**

Distance (ft): **29.4**
Structural Grade: **0**
O&M Grade: **2**
Clock Start/From: **8**
Clock To: **4**
1st Value:
2nd Value:
Value Percent:
Continuous Index:
Within 8" of Joint: **YES**
Remarks:

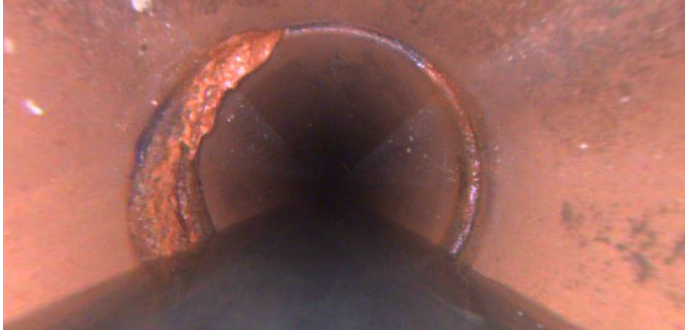
Code: **IW**
Description: **Infil Weeper**

Distance (ft): **39.7**
Structural Grade: **0**
O&M Grade: **2**
Clock Start/From: **8**
Clock To: **4**
1st Value:
2nd Value:
Value Percent:
Continuous Index: **S02**
Within 8" of Joint: **YES**
Remarks:

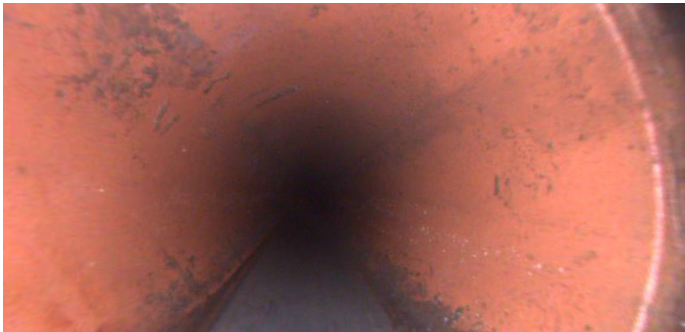
Code: **IW**
Description: **Infil Weeper**

Distance (ft): **76.6**
Structural Grade: **0**
O&M Grade: **2**
Clock Start/From: **8**
Clock To: **4**
1st Value:
2nd Value:
Value Percent:
Continuous Index: **F02**
Within 8" of Joint: **YES**
Remarks:

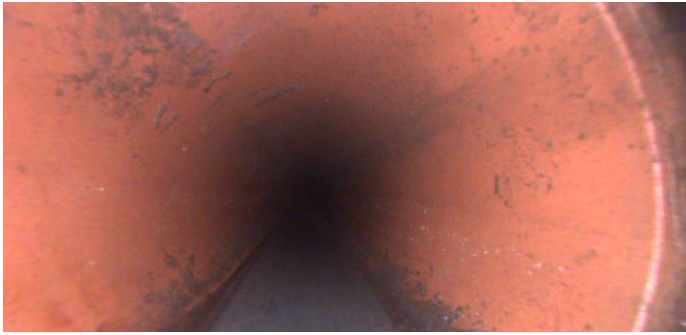
Code: **DAE**
Description: **Deposits Attached Encrustation**

Distance (ft): **76.6**
Structural Grade: **0**
O&M Grade: **2**
Clock Start/From: **8**
Clock To: **4**
1st Value:
2nd Value:
Value Percent: **5.000**
Continuous Index: **F01**
Within 8" of Joint: **YES**
Remarks:

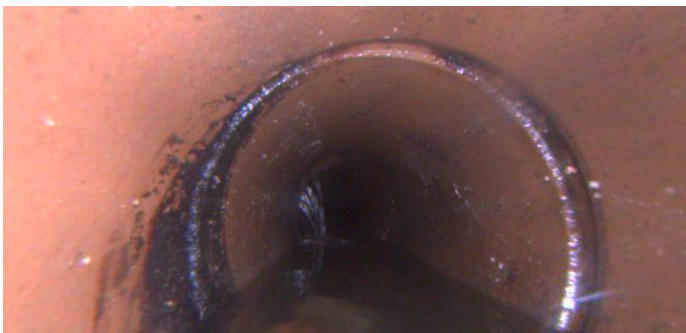
Code: **IW**
Description: **Infil Weeper**

Distance (ft): **92.2**
Structural Grade: **0**
O&M Grade: **2**
Clock Start/From: **8**
Clock To: **4**
1st Value:
2nd Value:
Value Percent:
Continuous Index:
Within 8" of Joint: **YES**
Remarks:

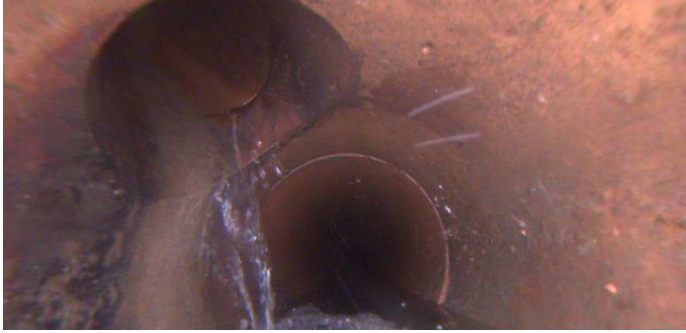
Code: **TFA**
Description: **Tap Factory Active**

Distance (ft): **93.6**
Structural Grade: **0**
O&M Grade: **0**
Clock Start/From: **11**
Clock To:
1st Value: **4.000**
2nd Value:
Value Percent:
Continuous Index:
Within 8" of Joint:
Remarks:

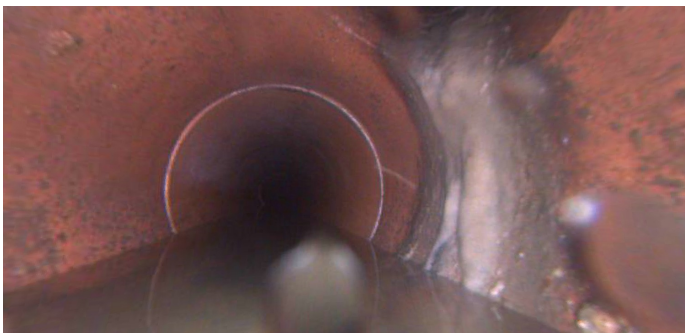
Code: **DAGS**
Description: **Deposits Attached Grease**

Distance (ft): **100.9**
Structural Grade: **0**
O&M Grade: **2**
Clock Start/From: **2**
Clock To: **4**
1st Value:
2nd Value:
Value Percent: **5.000**
Continuous Index:
Within 8" of Joint: **NO**
Remarks:

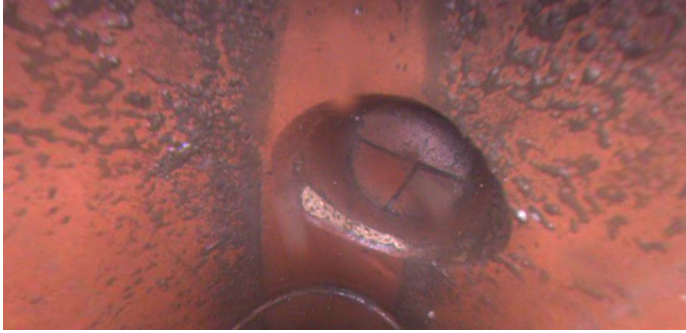
Code: **TFC**
Description: **Tap Factory Capped**

Distance (ft): **159.8**
Structural Grade: **0**
O&M Grade: **0**
Clock Start/From: **1**
Clock To:
1st Value: **4.000**
2nd Value:
Value Percent:
Continuous Index:
Within 8" of Joint:
Remarks:

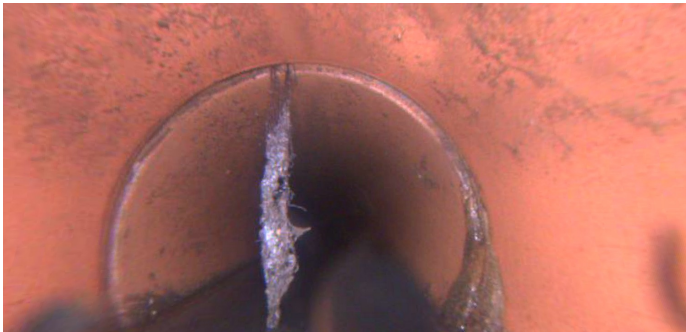
Code: **RMJ**
Description: **Roots Medium Joint**

Distance (ft): **176.0**
Structural Grade: **0**
O&M Grade: **3**
Clock Start/From: **12**
Clock To:
1st Value:
2nd Value:
Value Percent: **5.000**
Continuous Index:
Within 8" of Joint: **YES**
Remarks:

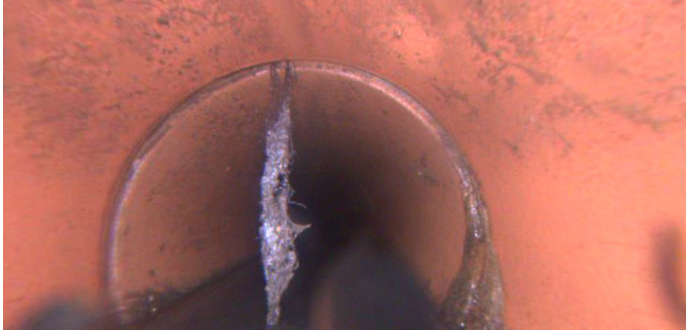
Code: **IW**
Description: **Infil Weeper**

Distance (ft): **176.0**
Structural Grade: **0**
O&M Grade: **2**
Clock Start/From: **2**
Clock To: **4**
1st Value:
2nd Value:
Value Percent:
Continuous Index:
Within 8" of Joint: **YES**
Remarks:

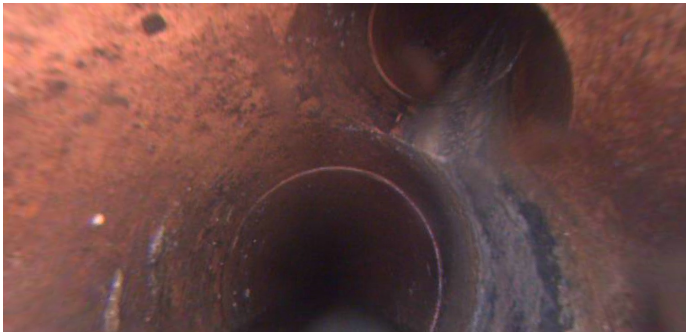
Code: **TF**
Description: **Tap Factory**

Distance (ft): **182.7**
Structural Grade: **0**
O&M Grade: **0**
Clock Start/From: **1**
Clock To:
1st Value: **4.000**
2nd Value:
Value Percent:
Continuous Index:
Within 8" of Joint:
Remarks:

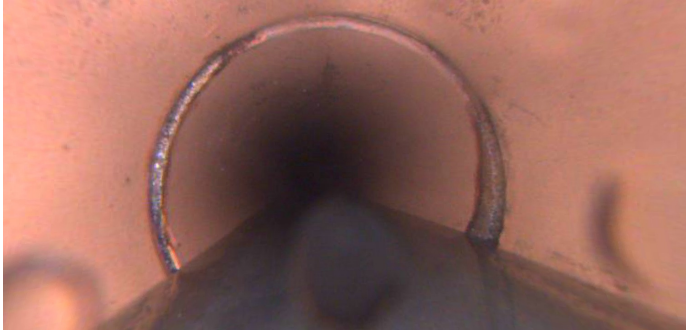
Code: **IW**
Description: **Infil Weeper**

Distance (ft): **193.5**
Structural Grade: **0**
O&M Grade: **2**
Clock Start/From: **8**
Clock To: **4**
1st Value:
2nd Value:
Value Percent:
Continuous Index:
Within 8" of Joint: **YES**
Remarks:

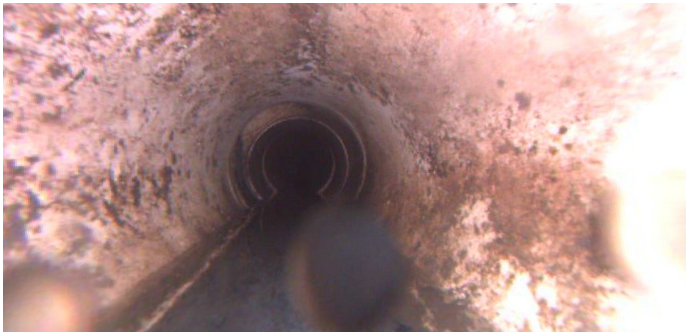
Code: **MMC**
Description: **Material Change**

Distance (ft): **208.7**
Structural Grade: **0**
O&M Grade: **0**
Clock Start/From:
Clock To:
1st Value:
2nd Value:
Value Percent:
Continuous Index:
Within 8" of Joint: **NO**
Remarks: **PVC**

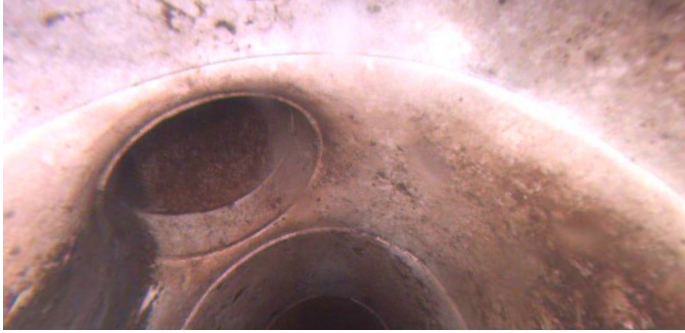
Code: **TF**
Description: **Tap Factory**

Distance (ft): **210.3**
Structural Grade: **0**
O&M Grade: **0**
Clock Start/From: **11**
Clock To:
1st Value: **4.000**
2nd Value:
Value Percent:
Continuous Index:
Within 8" of Joint:
Remarks:

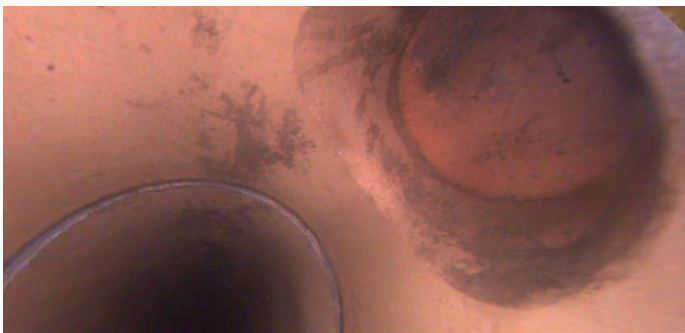
Code: **TFC**
Description: **Tap Factory Capped**

Distance (ft): **259.3**
Structural Grade: **0**
O&M Grade: **0**
Clock Start/From: **2**
Clock To:
1st Value: **4.000**
2nd Value:
Value Percent:
Continuous Index:
Within 8" of Joint:
Remarks:

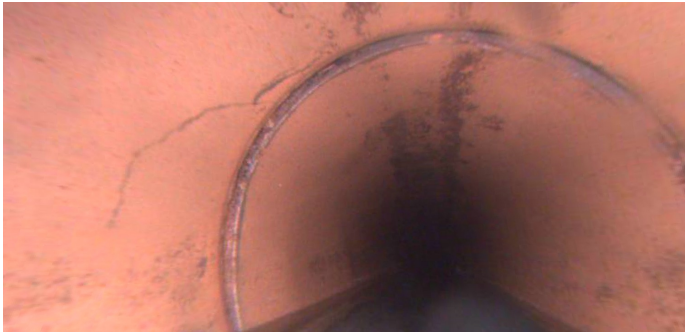
Code: **FC**
Description: **Fracture Circumferential**

Distance (ft): **280.3**
Structural Grade: **2**
O&M Grade: **0**
Clock Start/From: **9**
Clock To: **11**
1st Value:
2nd Value:
Value Percent:
Continuous Index:
Within 8" of Joint: **YES**
Remarks:

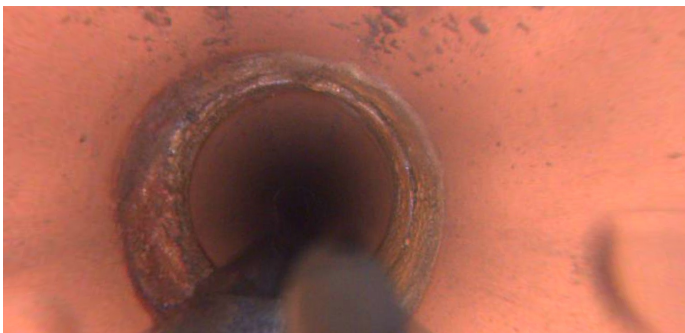
Code: **DAE**
Description: **Deposits Attached Encrustation**

Distance (ft): **295.3**
Structural Grade: **0**
O&M Grade: **2**
Clock Start/From: **8**
Clock To: **4**
1st Value:
2nd Value:
Value Percent: **5.000**
Continuous Index:
Within 8" of Joint: **YES**
Remarks:

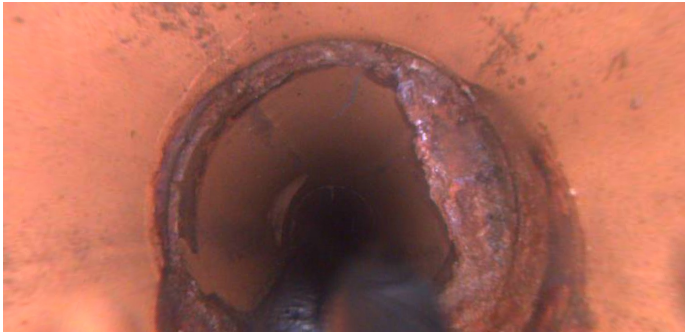
Code: **DAE**
Description: **Deposits Attached Encrustation**

Distance (ft): **305.8**
Structural Grade: **0**
O&M Grade: **2**
Clock Start/From: **8**
Clock To: **4**
1st Value:
2nd Value:
Value Percent: **10.000**
Continuous Index:
Within 8" of Joint: **YES**
Remarks:

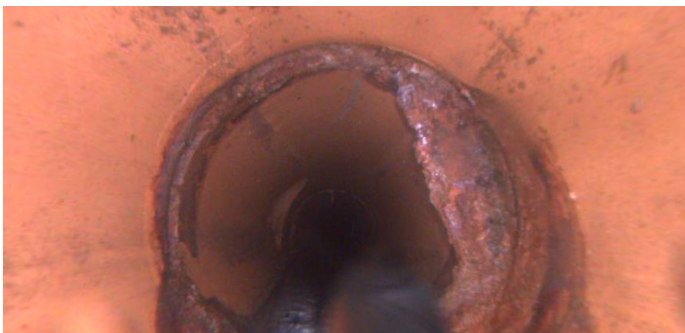
Code: **IW**
Description: **Infil Weeper**

Distance (ft): **305.8**
Structural Grade: **0**
O&M Grade: **2**
Clock Start/From: **8**
Clock To: **4**
1st Value:
2nd Value:
Value Percent:
Continuous Index:
Within 8" of Joint: **YES**
Remarks:

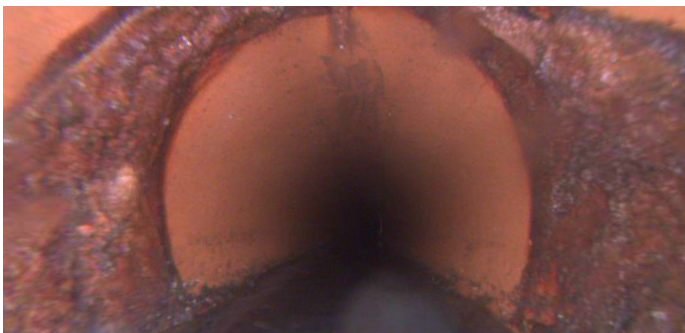
Code: **DAE**
Description: **Deposits Attached Encrustation**

Distance (ft): **308.1**
Structural Grade: **0**
O&M Grade: **2**
Clock Start/From: **8**
Clock To: **4**
1st Value:
2nd Value:
Value Percent: **5.000**
Continuous Index:
Within 8" of Joint: **YES**
Remarks:

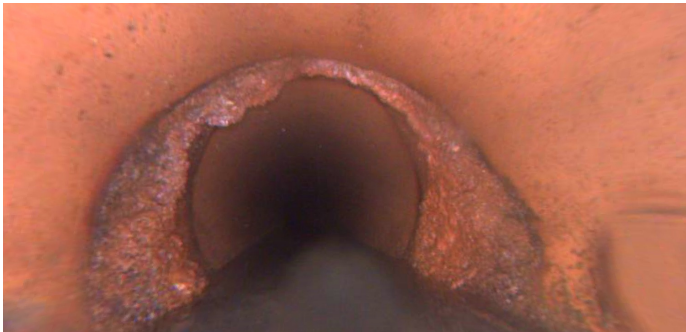
Code: **DAE**
Description: **Deposits Attached Encrustation**

Distance (ft): **318.0**
Structural Grade: **0**
O&M Grade: **2**
Clock Start/From: **8**
Clock To: **4**
1st Value:
2nd Value:
Value Percent: **10.000**
Continuous Index:
Within 8" of Joint: **YES**
Remarks:

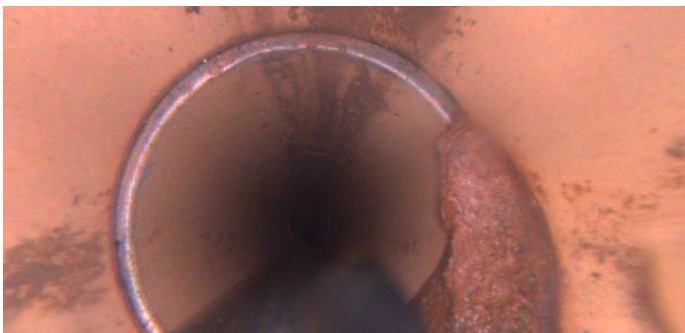
Code: **DAE**
Description: **Deposits Attached Encrustation**

Distance (ft): **338.8**
Structural Grade: **0**
O&M Grade: **2**
Clock Start/From: **2**
Clock To: **4**
1st Value:
2nd Value:
Value Percent: **5.000**
Continuous Index:
Within 8" of Joint: **YES**
Remarks:

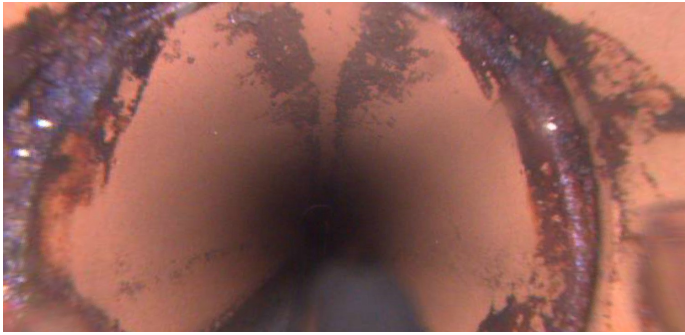
Code: **IW**
Description: **Infil Weeper**

Distance (ft): **354.7**
Structural Grade: **0**
O&M Grade: **2**
Clock Start/From: **8**
Clock To: **4**
1st Value:
2nd Value:
Value Percent:
Continuous Index:
Within 8" of Joint: **YES**
Remarks:

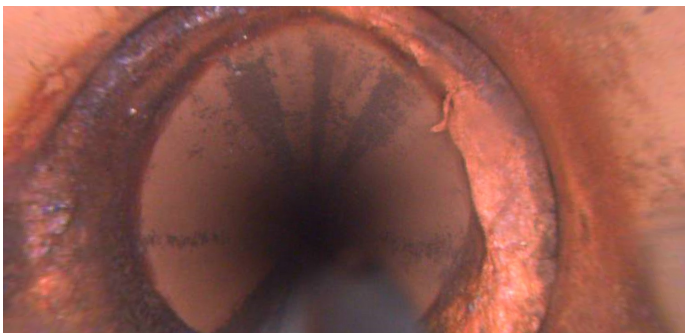
Code: **IW**
Description: **Infil Weeper**

Distance (ft): **365.0**
Structural Grade: **0**
O&M Grade: **2**
Clock Start/From: **8**
Clock To: **4**
1st Value:
2nd Value:
Value Percent:
Continuous Index:
Within 8" of Joint: **YES**
Remarks:

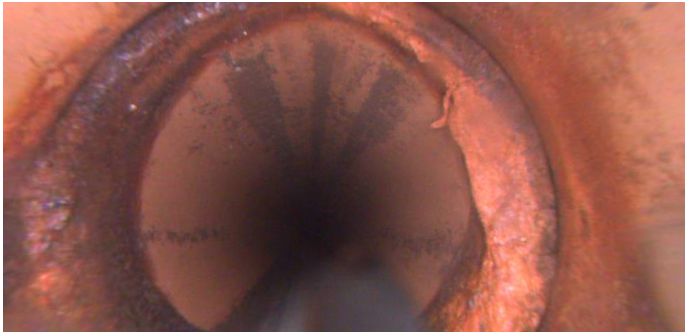
Code: **DAE**
Description: **Deposits Attached Encrustation**

Distance (ft): **365.0**
Structural Grade: **0**
O&M Grade: **2**
Clock Start/From: **8**
Clock To: **4**
1st Value:
2nd Value:
Value Percent: **10.000**
Continuous Index:
Within 8" of Joint: **YES**
Remarks:

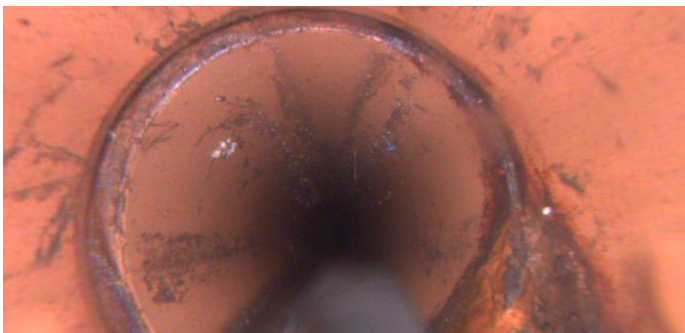
Code: **DAE**
Description: **Deposits Attached Encrustation**

Distance (ft): **375.3**
Structural Grade: **0**
O&M Grade: **2**
Clock Start/From: **3**
Clock To: **4**
1st Value:
2nd Value:
Value Percent: **5.000**
Continuous Index:
Within 8" of Joint: **YES**
Remarks:

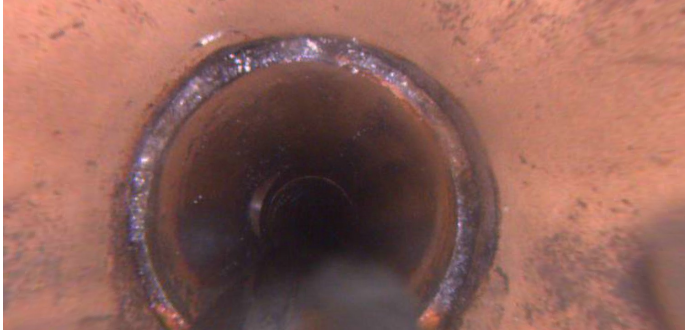
Code: **IW**
Description: **Infil Weeper**

Distance (ft): **380.3**
Structural Grade: **0**
O&M Grade: **2**
Clock Start/From: **8**
Clock To: **4**
1st Value:
2nd Value:
Value Percent:
Continuous Index:
Within 8" of Joint: **YES**
Remarks:

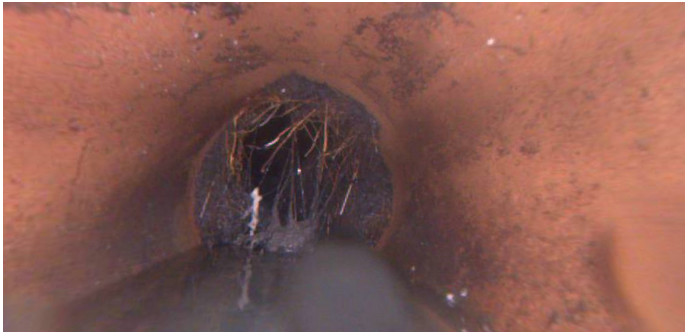
Code: **RMJ**
Description: **Roots Medium Joint**

Distance (ft): **390.8**
Structural Grade: **0**
O&M Grade: **3**
Clock Start/From: **8**
Clock To: **4**
1st Value:
2nd Value:
Value Percent: **40.000**
Continuous Index:
Within 8" of Joint: **YES**
Remarks: **at MH**
