Profile/Photo Observation Report

Street:	W 37TH PL & N COLORADO ST	Flow Control:	Not Controlled
City:	Hobart, IN	Year Renewed:	
Location:	Other	Tape/Media #:	
Purpose:	Not Known	Dia/Height:	10"
Use:	Sanitary	Material:	VCP
Drain Area:	NA	Lining:	
Category:	NA		
Comment:

Location Details:		Direction of Survey:	Upstream
US MH:	M-503-075	DS MH:	M-503-078
		Total Length Surveyed (ft):	8.8

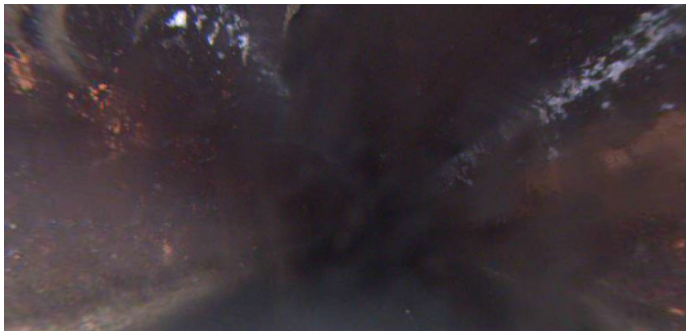
Code: **AMH**
Description: **Manhole**

Distance (ft): **.0**
Structural Grade: **0**
O&M Grade: **0**
Clock Start/From:
Clock To:
1st Value:
2nd Value:
Value Percent:
Continuous Index:
Within 8" of Joint: **NO**
Remarks: **M-503-075**

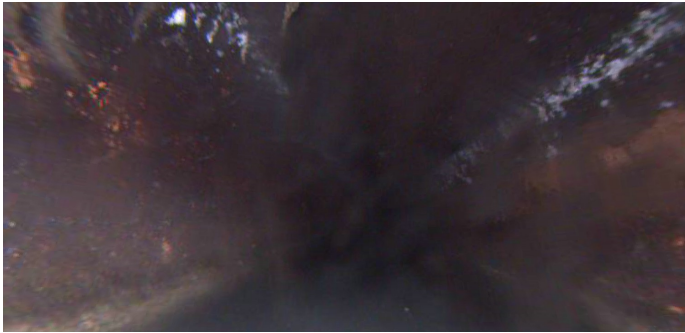
Code:	MWL
Description:	Water Level

Distance (ft):	.0
Structural Grade:	0
O&M Grade:	0
Clock Start/From:	
Clock To:	
1st Value:	
2nd Value:	
Value Percent:	10.000
Continuous Index:	
Within 8" of Joint:	NO
Remarks:

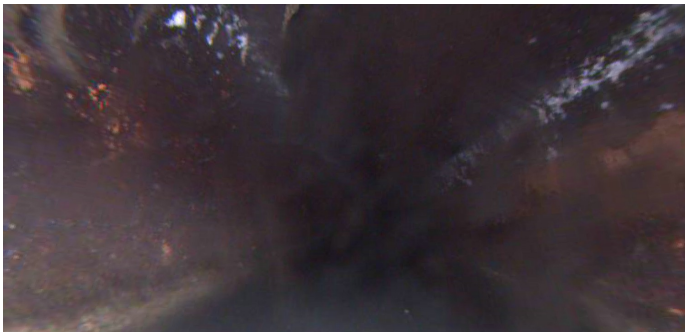
Code:	DAGS
Description:	Deposits Attached Grease

Distance (ft):	.0
Structural Grade:	0
O&M Grade:	2
Clock Start/From:	8
Clock To:	4
1st Value:	
2nd Value:	
Value Percent:	5.000
Continuous Index:	S01
Within 8" of Joint:	NO
Remarks:

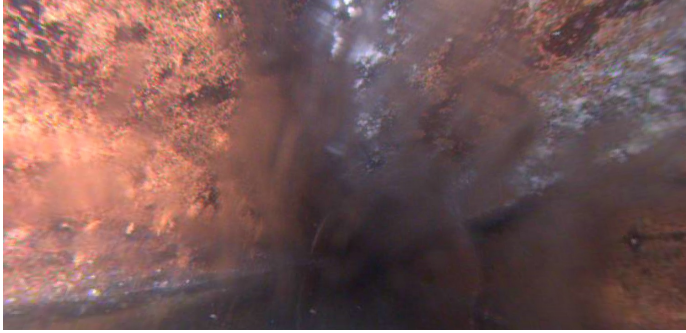
Code: **MSA**
Description: **Abandoned Survey**

Distance (ft): **8.8**
Structural Grade: **0**
O&M Grade: **0**
Clock Start/From:
Clock To:
1st Value:
2nd Value:
Value Percent:
Continuous Index:
Within 8" of Joint: **NO**
Remarks: **OVERTURNED**

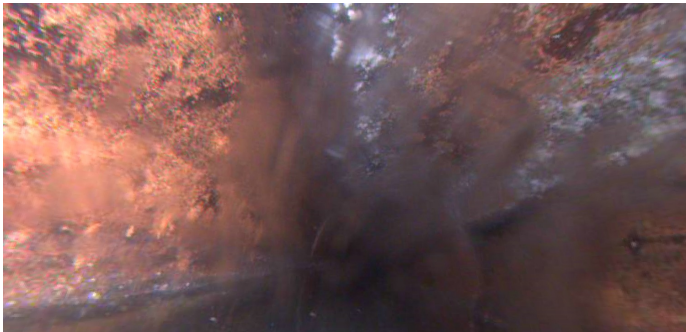
Code: **DAGS**
Description: **Deposits Attached Grease**

Distance (ft): **8.8**
Structural Grade: **0**
O&M Grade: **2**
Clock Start/From: **8**
Clock To: **4**
1st Value:
2nd Value:
Value Percent: **5.000**
Continuous Index: **F01**
Within 8" of Joint: **NO**
Remarks:
