Profile/Photo Observation Report

Street:	W 40th ave	Flow Control:	Not Controlled
City:	Hobart, IN	Year Renewed:	
Location:	Other	Tape/Media #:	
Purpose:	Not Known	Dia/Height:	10"
Use:	Sanitary	Material:	VCP
Drain Area:	NA	Lining:	
Category:	NA		
Comment:

Location Details:		Direction of Survey:	Upstream
US MH:	M-503-075	DS MH:	M-503-078
		Total Length Surveyed (ft):	8.8

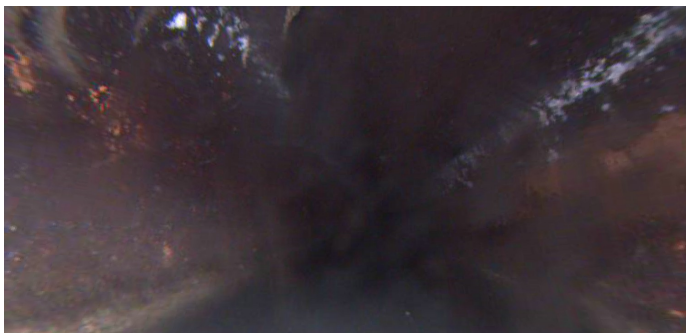
Code: **AMH**
Description: **Manhole**

Distance (ft): **.0**
Structural Grade: **0**
O&M Grade: **0**
Clock Start/From:
Clock To:
1st Value:
2nd Value:
Value Percent:
Continuous Index:
Within 8" of Joint: **NO**
Remarks: **M-503-075**

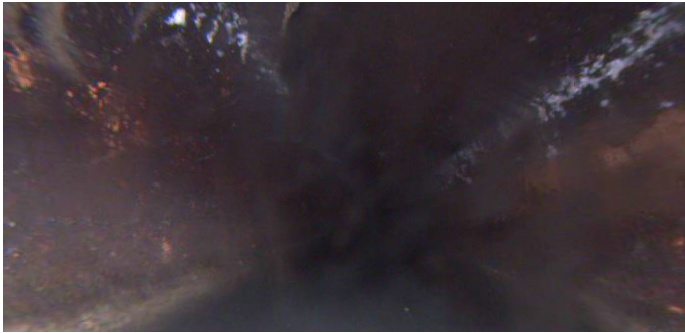
Code:	MWL
Description:	Water Level

Distance (ft):	.0
Structural Grade:	0
O&M Grade:	0
Clock Start/From:	
Clock To:	
1st Value:	
2nd Value:	
Value Percent:	10.000
Continuous Index:	
Within 8" of Joint:	NO
Remarks:

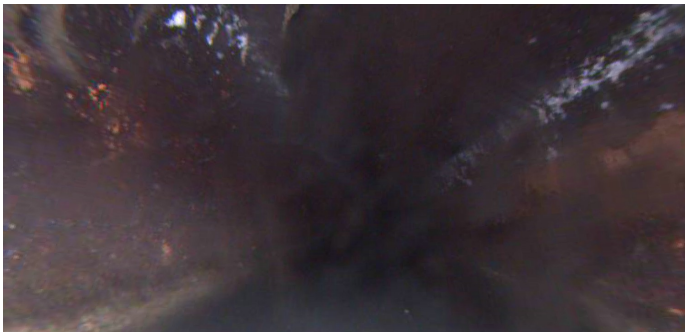
Code:	DAGS
Description:	Deposits Attached Grease

Distance (ft):	.0
Structural Grade:	0
O&M Grade:	2
Clock Start/From:	8
Clock To:	4
1st Value:	
2nd Value:	
Value Percent:	5.000
Continuous Index:	S01
Within 8" of Joint:	NO
Remarks:

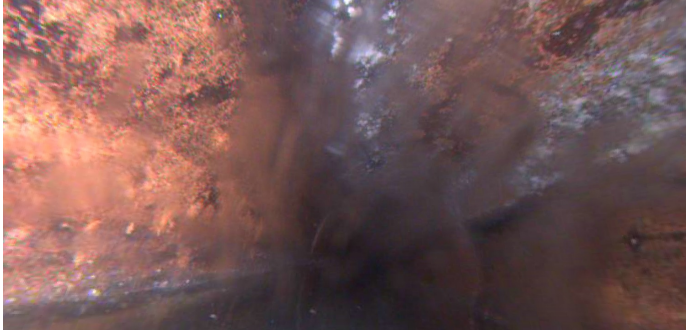
Code: **MSA**
Description: **Abandoned Survey**

Distance (ft): **8.8**
Structural Grade: **0**
O&M Grade: **0**
Clock Start/From:
Clock To:
1st Value:
2nd Value:
Value Percent:
Continuous Index:
Within 8" of Joint: **NO**
Remarks: **OVERTURNED**

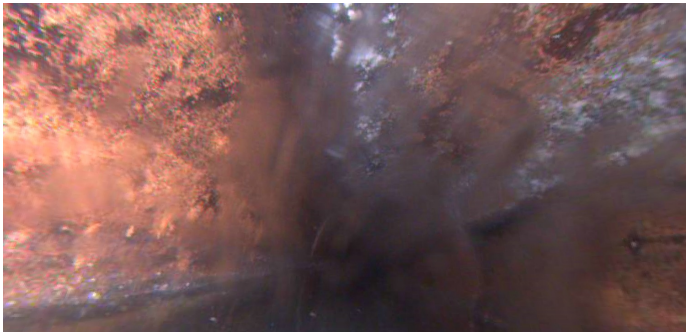
Code: **DAGS**
Description: **Deposits Attached Grease**

Distance (ft): **8.8**
Structural Grade: **0**
O&M Grade: **2**
Clock Start/From: **8**
Clock To: **4**
1st Value:
2nd Value:
Value Percent: **5.000**
Continuous Index: **F01**
Within 8" of Joint: **NO**
Remarks:
