Profile/Photo Observation Report

Date:	04/13/2018	Weather:		Coding:	PACP 6.0
Pipe Length (ft):	319.0	Owner:	NA	Pre Clean:	Not Known
P.O.#:		Surveyor:	Jen Costello	PSR:	P-503-077-076
Customer:		Clean Date:	01/01/1900	Shape:	C

Street:	ALLEY BETWEEN W 38TH AVE & W 3	Flow Control:	Not Controlled
City:	Hobart, IN	Year Renewed:	
Location:	Other	Tape/Media #:	
Purpose:	Not Known	Dia/Height:	10"
Use:	Sanitary	Material:	VCP
Drain Area:	NA	Lining:	
Category:	NA		
Comment:

Location Details:		Direction of Survey:	Downstream
US MH:	M-503-076	DS MH:	M-503-077
		Total Length Surveyed (ft):	122.0

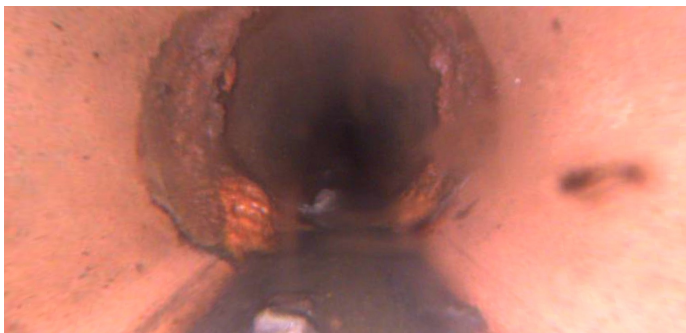
Code: **AMH**
Description: **Manhole**

Distance (ft): **.0**
Structural Grade: **0**
O&M Grade: **0**
Clock Start/From:
Clock To:
1st Value:
2nd Value:
Value Percent:
Continuous Index:
Within 8" of Joint: **NO**
Remarks: **M-503-076**

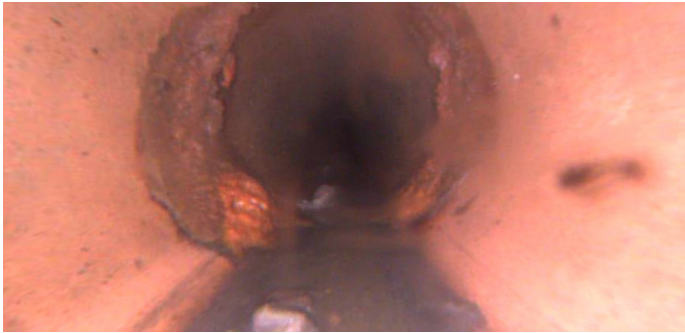
Code:	MWL
Description:	Water Level

Distance (ft):	.0
Structural Grade:	0
O&M Grade:	0
Clock Start/From:	
Clock To:	
1st Value:	
2nd Value:	
Value Percent:	5.000
Continuous Index:	
Within 8" of Joint:	NO
Remarks:

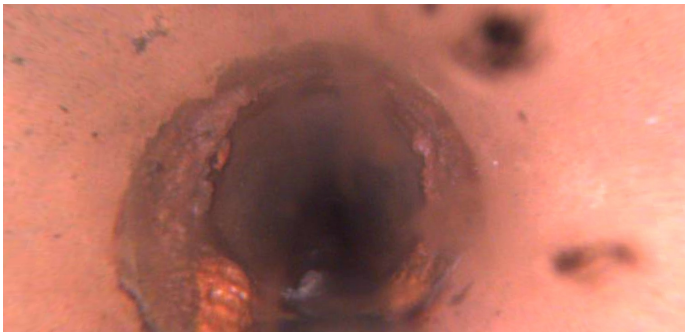
Code:	DAE
Description:	Deposits Attached Encrustation

Distance (ft):	.0
Structural Grade:	0
O&M Grade:	2
Clock Start/From:	8
Clock To:	4
1st Value:	
2nd Value:	
Value Percent:	10.000
Continuous Index:	
Within 8" of Joint:	YES
Remarks:

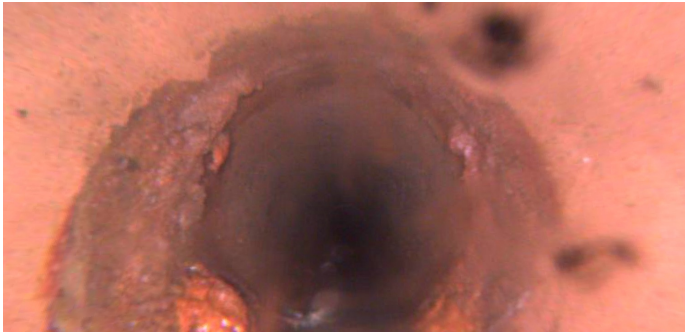
Code: **IW**
Description: **Infil Weeper**

Distance (ft): **.5**
Structural Grade: **0**
O&M Grade: **2**
Clock Start/From: **8**
Clock To: **4**
1st Value:
2nd Value:
Value Percent:
Continuous Index:
Within 8" of Joint: **YES**
Remarks:

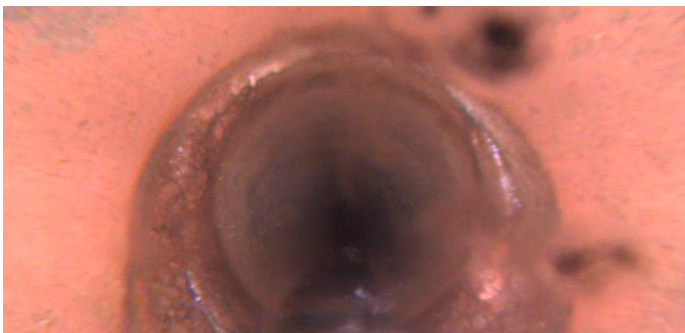
Code: **DAE**
Description: **Deposits Attached Encrustation**

Distance (ft): **11.1**
Structural Grade: **0**
O&M Grade: **2**
Clock Start/From: **8**
Clock To: **4**
1st Value:
2nd Value:
Value Percent: **5.000**
Continuous Index:
Within 8" of Joint: **YES**
Remarks:

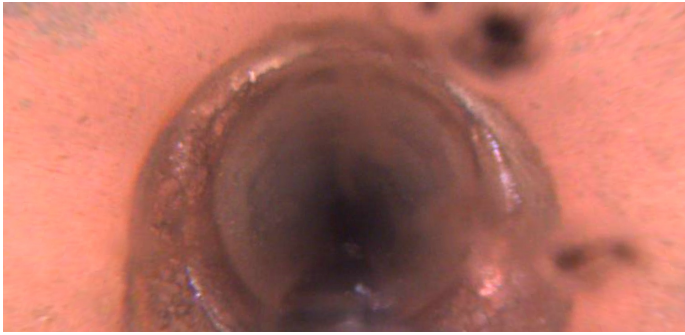
Code: **IW**
Description: **Infil Weeper**

Distance (ft): **11.1**
Structural Grade: **0**
O&M Grade: **2**
Clock Start/From: **8**
Clock To: **4**
1st Value:
2nd Value:
Value Percent:
Continuous Index:
Within 8" of Joint: **YES**
Remarks:

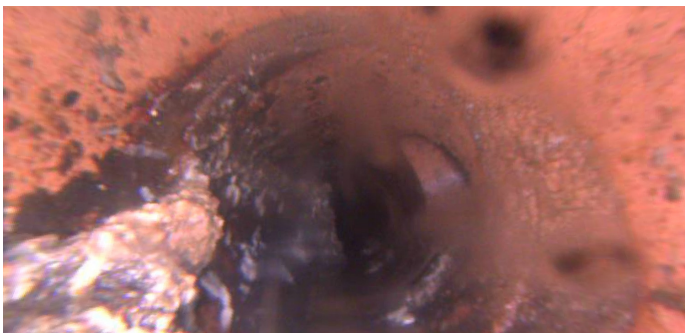
Code: **DAGS**
Description: **Deposits Attached Grease**

Distance (ft): **21.0**
Structural Grade: **0**
O&M Grade: **2**
Clock Start/From: **7**
Clock To: **9**
1st Value:
2nd Value:
Value Percent: **10.000**
Continuous Index:
Within 8" of Joint: **YES**
Remarks:

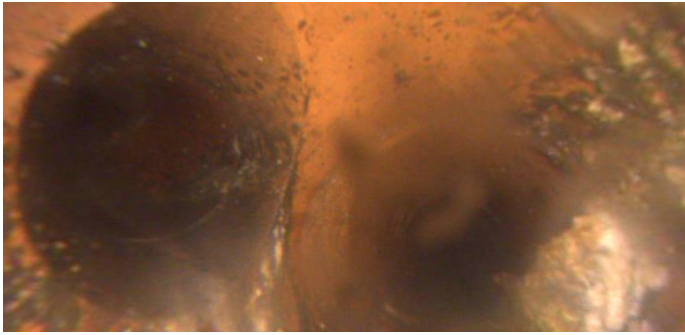
Code: **TFA**
Description: **Tap Factory Active**

Distance (ft): **22.7**
Structural Grade: **0**
O&M Grade: **0**
Clock Start/From: **3**
Clock To:
1st Value: **4.000**
2nd Value:
Value Percent:
Continuous Index:
Within 8" of Joint:
Remarks:

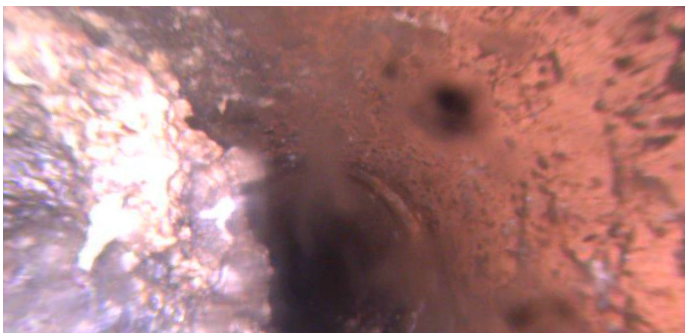
Code: **DAGS**
Description: **Deposits Attached Grease**

Distance (ft): **22.7**
Structural Grade: **0**
O&M Grade: **2**
Clock Start/From: **7**
Clock To: **10**
1st Value:
2nd Value:
Value Percent: **10.000**
Continuous Index:
Within 8" of Joint: **NO**
Remarks:

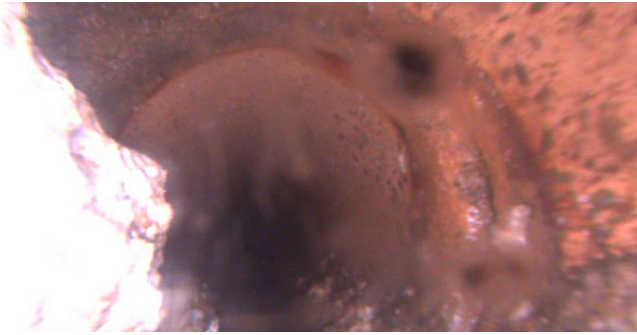
Code: **IW**
Description: **Infil Weeper**

Distance (ft): **23.2**
Structural Grade: **0**
O&M Grade: **2**
Clock Start/From: **8**
Clock To: **4**
1st Value:
2nd Value:
Value Percent:
Continuous Index:
Within 8" of Joint: **YES**
Remarks:

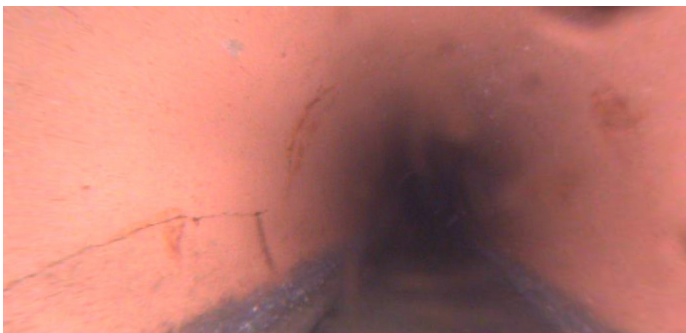
Code: **FL**
Description: **Fracture Longitudinal**

Distance (ft): **39.8**
Structural Grade: **3**
O&M Grade: **0**
Clock Start/From: **9**
Clock To:
1st Value:
2nd Value:
Value Percent:
Continuous Index:
Within 8" of Joint:
Remarks:

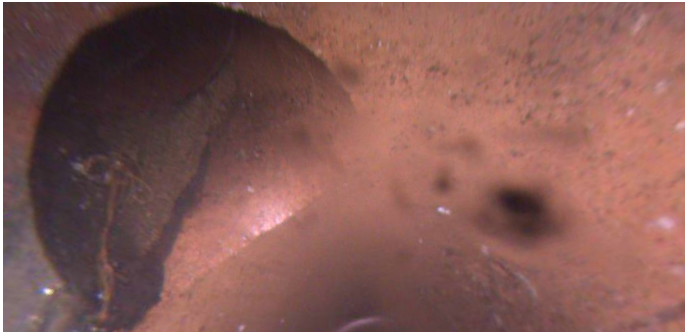
Code: **TFD**
Description: **Tap Factory Defective**

Distance (ft): **43.8**
Structural Grade: **0**
O&M Grade: **2**
Clock Start/From: **11**
Clock To:
1st Value: **4.000**
2nd Value:
Value Percent:
Continuous Index:
Within 8" of Joint:
Remarks: **rfl**

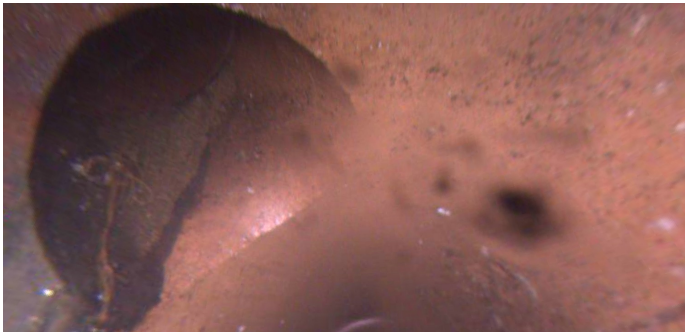
Code: **RFL**
Description: **Roots Fine Lateral**

Distance (ft): **43.8**
Structural Grade: **0**
O&M Grade: **1**
Clock Start/From: **11**
Clock To:
1st Value:
2nd Value:
Value Percent:
Continuous Index:
Within 8" of Joint: **NO**
Remarks:

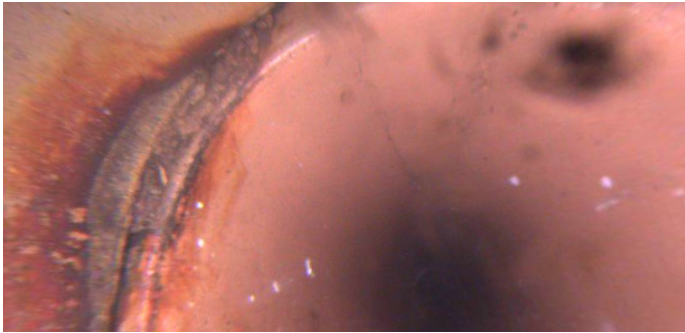
Code: **IW**
Description: **Infil Weeper**

Distance (ft): **45.1**
Structural Grade: **0**
O&M Grade: **2**
Clock Start/From: **9**
Clock To: **11**
1st Value:
2nd Value:
Value Percent:
Continuous Index:
Within 8" of Joint: **YES**
Remarks:

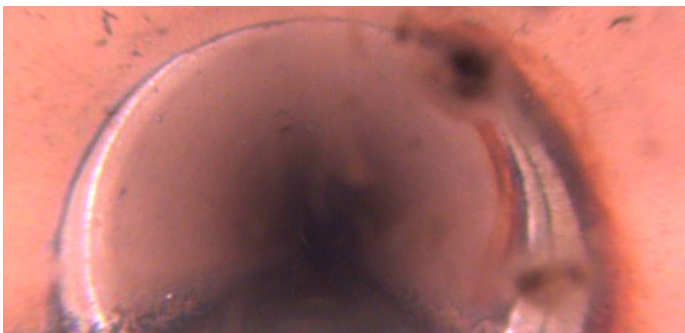
Code: **IW**
Description: **Infil Weeper**

Distance (ft): **59.7**
Structural Grade: **0**
O&M Grade: **2**
Clock Start/From: **1**
Clock To: **4**
1st Value:
2nd Value:
Value Percent:
Continuous Index:
Within 8" of Joint: **YES**
Remarks:

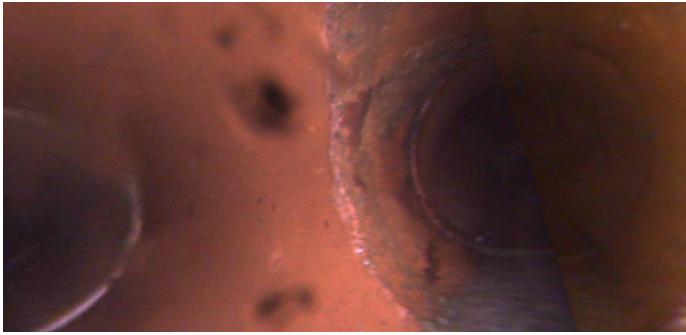
Code: **TF**
Description: **Tap Factory**

Distance (ft): **70.5**
Structural Grade: **0**
O&M Grade: **0**
Clock Start/From: **3**
Clock To:
1st Value: **4.000**
2nd Value:
Value Percent:
Continuous Index:
Within 8" of Joint:
Remarks:

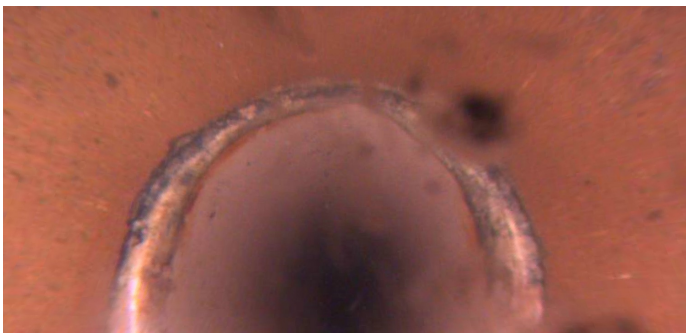
Code: **IW**
Description: **Infil Weeper**

Distance (ft): **71.5**
Structural Grade: **0**
O&M Grade: **2**
Clock Start/From: **9**
Clock To: **3**
1st Value:
2nd Value:
Value Percent:
Continuous Index: **S01**
Within 8" of Joint: **YES**
Remarks:

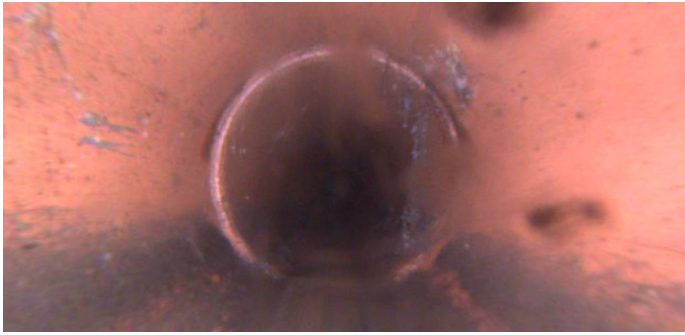
Code: **RFJ**
Description: **Roots Fine Joint**

Distance (ft): **115.5**
Structural Grade: **0**
O&M Grade: **1**
Clock Start/From: **1**
Clock To:
1st Value:
2nd Value:
Value Percent:
Continuous Index:
Within 8" of Joint: **YES**
Remarks:

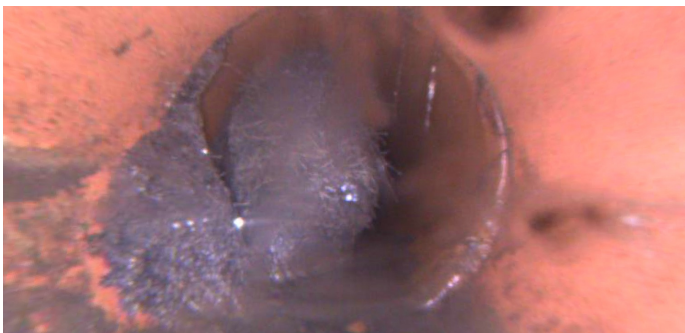
Code: **RMJ**
Description: **Roots Medium Joint**

Distance (ft): **120.7**
Structural Grade: **0**
O&M Grade: **3**
Clock Start/From: **8**
Clock To: **4**
1st Value:
2nd Value:
Value Percent: **10.000**
Continuous Index:
Within 8" of Joint: **YES**
Remarks:

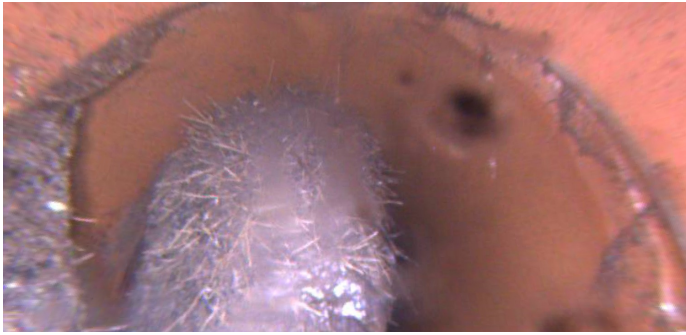
Code: **RBB**
Description: **Roots Ball Barrel**

Distance (ft): **121.0**
Structural Grade: **0**
O&M Grade: **5**
Clock Start/From: **12**
Clock To: **12**
1st Value:
2nd Value:
Value Percent: **70.000**
Continuous Index:
Within 8" of Joint: **NO**
Remarks:
