Profile/Photo Observation Report

Date:	04/12/2018	Weather:		Coding:	PACP 6.0
Pipe Length (ft):	245.3	Owner:	NA	Pre Clean:	Not Known
P.O.#:		Surveyor:	Jen Costello	PSR:	P-503-079-078
Customer:		Clean Date:	01/01/1900	Shape:	C

Street:	N COLORADO ST	Flow Control:	Not Controlled
City:	Hobart, IN	Year Renewed:	
Location:	Other	Tape/Media #:	
Purpose:	Not Known	Dia/Height:	10"
Use:	Sanitary	Material:	VCP
Drain Area:	NA	Lining:	
Category:	NA		
Comment:

Location Details:		Direction of Survey:	Downstream
US MH:	M-503-078	DS MH:	M-503-079
		Total Length Surveyed (ft):	212.5

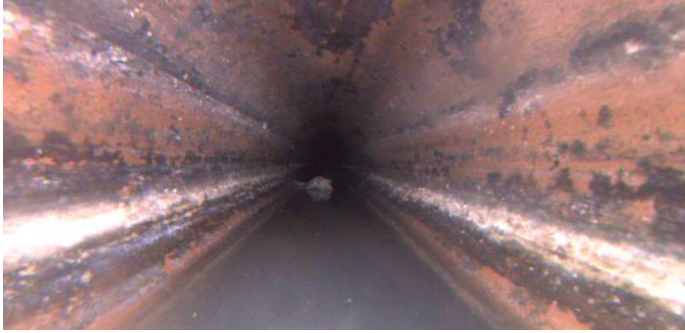
Code: **AMH**
Description: **Manhole**

Distance (ft): **.0**
Structural Grade: **0**
O&M Grade: **0**
Clock Start/From:
Clock To:
1st Value:
2nd Value:
Value Percent:
Continuous Index:
Within 8" of Joint: **NO**
Remarks: **M-503-078**

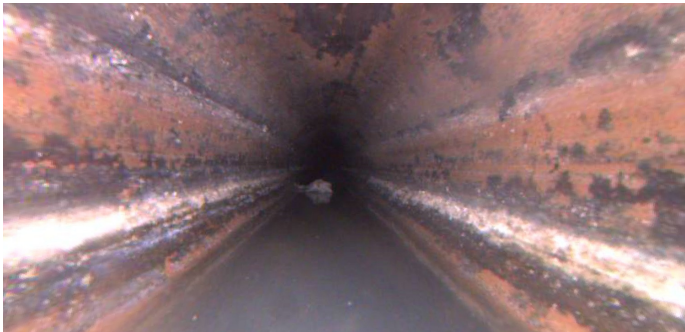
Code: **MWL**
Description: **Water Level**

Distance (ft): **.0**
Structural Grade: **0**
O&M Grade: **0**
Clock Start/From:
Clock To:
1st Value:
2nd Value:
Value Percent: **10.000**
Continuous Index:
Within 8" of Joint: **NO**
Remarks:

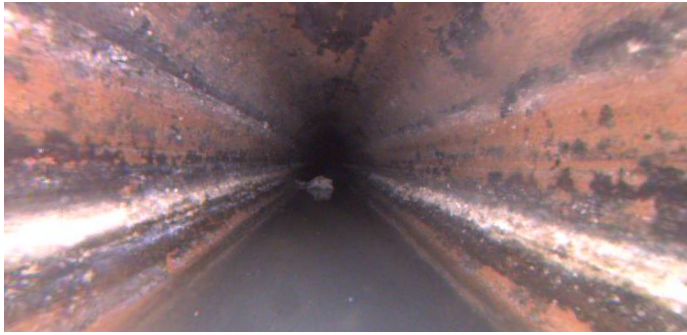
Code:	DAGS
Description:	Deposits Attached Grease
Distance (ft):	.0
Structural Grade:	0
O&M Grade:	2
Clock Start/From:	8
Clock To:	4
1st Value:	
2nd Value:	
Value Percent:	5.000
Continuous Index:	S01
Within 8" of Joint:	NO
Remarks:

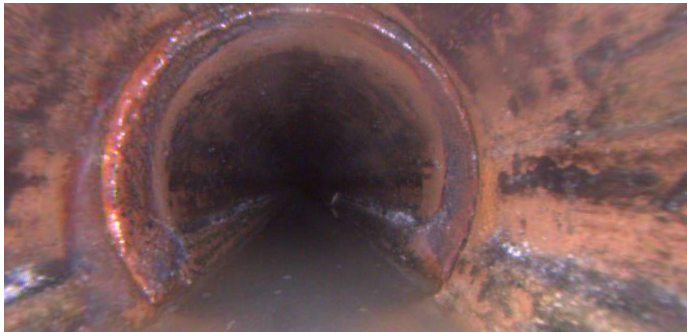
Code:	IW
Description:	Infil Weeper
Distance (ft):	8.4
Structural Grade:	0
O&M Grade:	2
Clock Start/From:	8
Clock To:	4
1st Value:	
2nd Value:	
Value Percent:	
Continuous Index:	
Within 8" of Joint:	YES
Remarks:

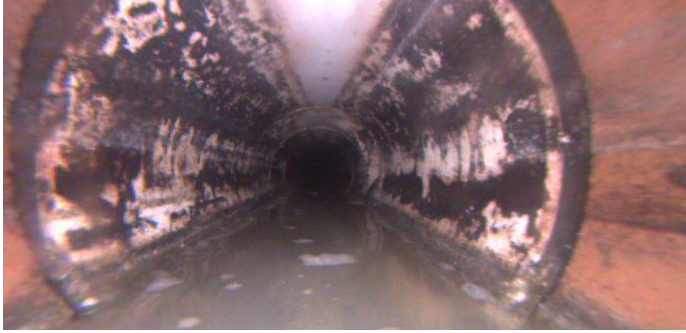
Code: **MMC**
Description: **Material Change**

Distance (ft): **20.7**
Structural Grade: **0**
O&M Grade: **0**
Clock Start/From:
Clock To:
1st Value:
2nd Value:
Value Percent:
Continuous Index:
Within 8" of Joint: **NO**
Remarks: **pvc**

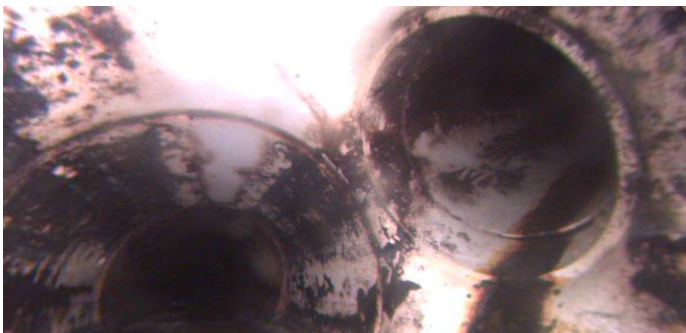
Code: **TF**
Description: **Tap Factory**

Distance (ft): **22.6**
Structural Grade: **0**
O&M Grade: **0**
Clock Start/From: **3**
Clock To:
1st Value: **4.000**
2nd Value:
Value Percent:
Continuous Index:
Within 8" of Joint:
Remarks:

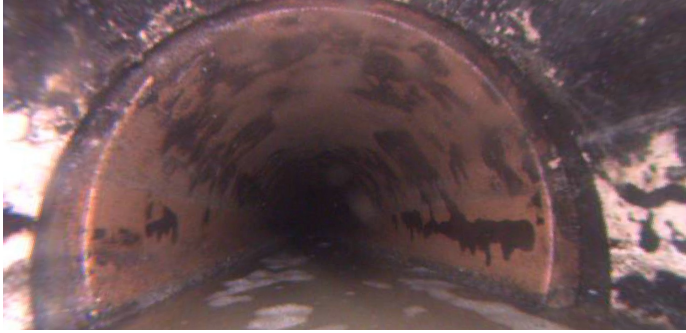
Code: **MMC**
Description: **Material Change**

Distance (ft): **23.8**
Structural Grade: **0**
O&M Grade: **0**
Clock Start/From:
Clock To:
1st Value:
2nd Value:
Value Percent:
Continuous Index:
Within 8" of Joint: **NO**
Remarks: **VCP**

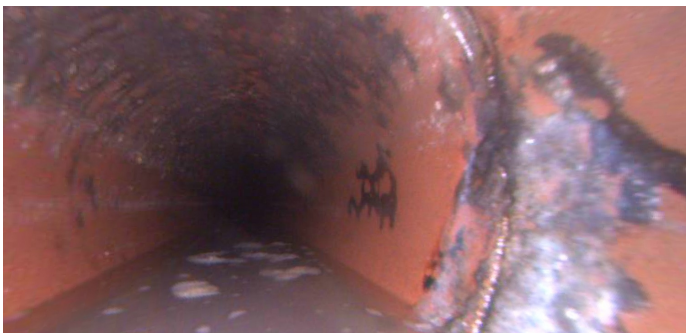
Code: **IW**
Description: **Infil Weeper**

Distance (ft): **70.1**
Structural Grade: **0**
O&M Grade: **2**
Clock Start/From: **3**
Clock To: **5**
1st Value:
2nd Value:
Value Percent:
Continuous Index:
Within 8" of Joint: **YES**
Remarks:

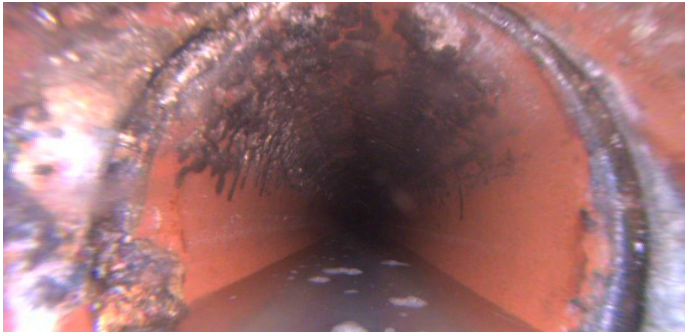
Code: **IW**
Description: **Infil Weeper**

Distance (ft): **75.2**
Structural Grade: **0**
O&M Grade: **2**
Clock Start/From: **8**
Clock To: **4**
1st Value:
2nd Value:
Value Percent:
Continuous Index: **S02**
Within 8" of Joint: **YES**
Remarks:

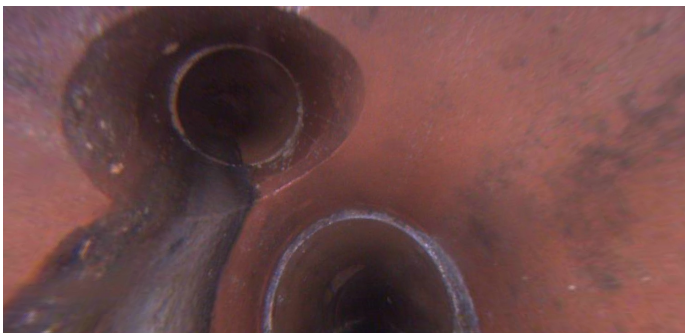
Code: **TFA**
Description: **Tap Factory Active**

Distance (ft): **81.6**
Structural Grade: **0**
O&M Grade: **0**
Clock Start/From: **11**
Clock To:
1st Value: **4.000**
2nd Value:
Value Percent:
Continuous Index:
Within 8" of Joint:
Remarks:

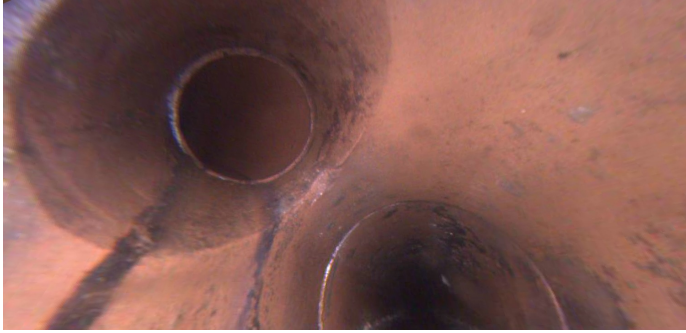
Code: **TF**
Description: **Tap Factory**

Distance (ft): **83.9**
Structural Grade: **0**
O&M Grade: **0**
Clock Start/From: **11**
Clock To:
1st Value: **4.000**
2nd Value:
Value Percent:
Continuous Index:
Within 8" of Joint:
Remarks:

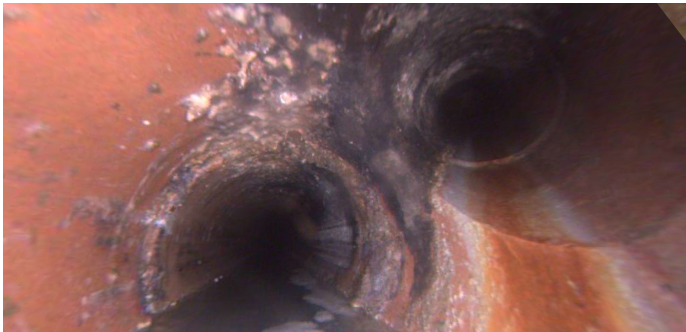
Code: **TF**
Description: **Tap Factory**

Distance (ft): **101.4**
Structural Grade: **0**
O&M Grade: **0**
Clock Start/From: **2**
Clock To:
1st Value: **4.000**
2nd Value:
Value Percent:
Continuous Index:
Within 8" of Joint:
Remarks:

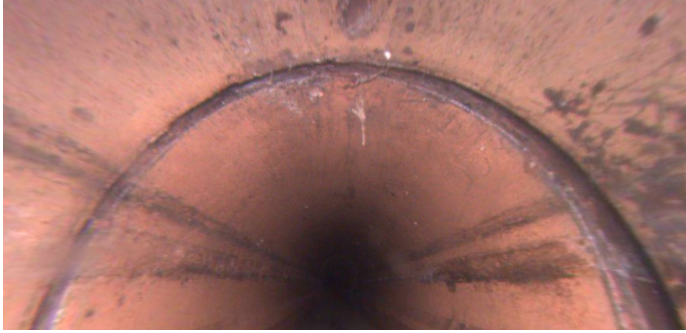
Code: **RFJ**
Description: **Roots Fine Joint**

Distance (ft): **107.0**
Structural Grade: **0**
O&M Grade: **1**
Clock Start/From: **12**
Clock To:
1st Value:
2nd Value:
Value Percent:
Continuous Index:
Within 8" of Joint: **YES**
Remarks:

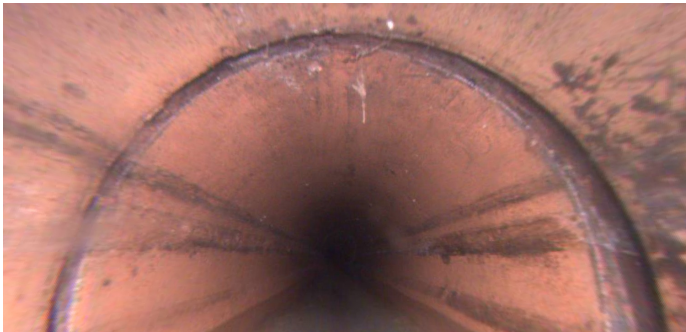
Code: **DAGS**
Description: **Deposits Attached Grease**

Distance (ft): **107.0**
Structural Grade: **0**
O&M Grade: **2**
Clock Start/From: **8**
Clock To: **4**
1st Value:
2nd Value:
Value Percent: **5.000**
Continuous Index: **F01**
Within 8" of Joint: **NO**
Remarks:

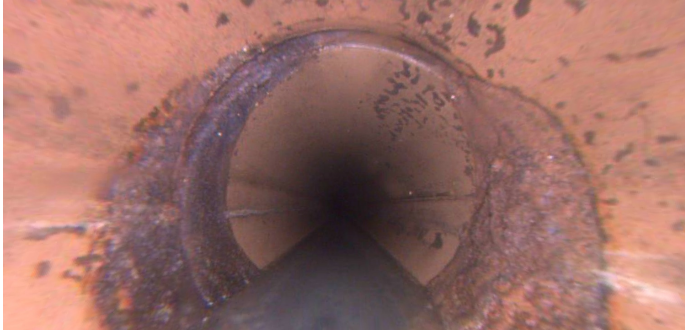
Code: **DAE**
Description: **Deposits Attached Encrustation**

Distance (ft): **111.9**
Structural Grade: **0**
O&M Grade: **2**
Clock Start/From: **8**
Clock To: **4**
1st Value:
2nd Value:
Value Percent: **5.000**
Continuous Index: **S03**
Within 8" of Joint: **YES**
Remarks:

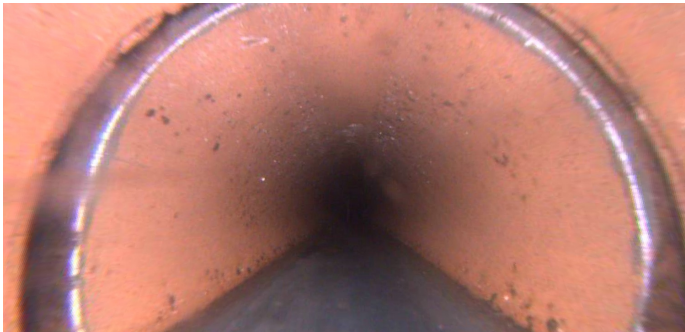
Code: **DAE**
Description: **Deposits Attached Encrustation**

Distance (ft): **143.0**
Structural Grade: **0**
O&M Grade: **2**
Clock Start/From: **8**
Clock To: **4**
1st Value:
2nd Value:
Value Percent: **5.000**
Continuous Index: **F03**
Within 8" of Joint: **YES**
Remarks:

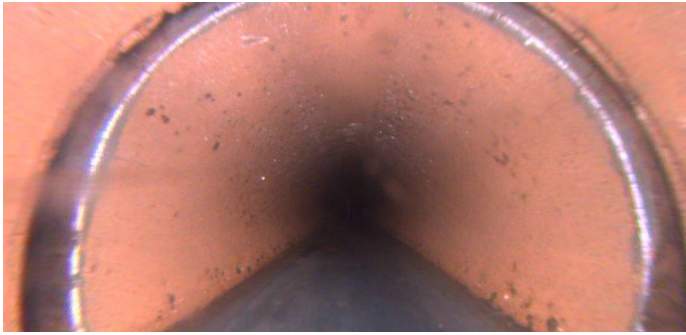
Code: **IW**
Description: **Infil Weeper**

Distance (ft): **143.0**
Structural Grade: **0**
O&M Grade: **2**
Clock Start/From: **8**
Clock To: **4**
1st Value:
2nd Value:
Value Percent:
Continuous Index: **F02**
Within 8" of Joint: **YES**
Remarks:

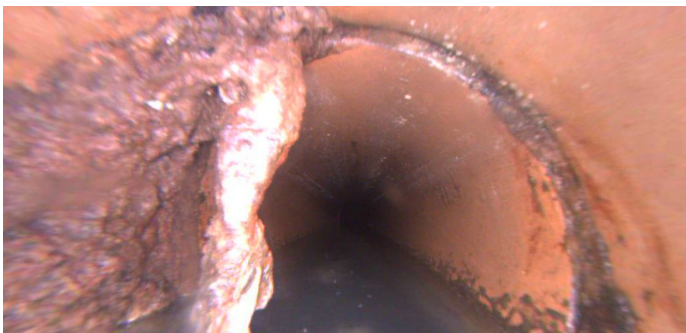
Code: **DAE**
Description: **Deposits Attached Encrustation**

Distance (ft): **153.1**
Structural Grade: **0**
O&M Grade: **3**
Clock Start/From: **8**
Clock To: **4**
1st Value:
2nd Value:
Value Percent: **20.000**
Continuous Index:
Within 8" of Joint: **YES**
Remarks:

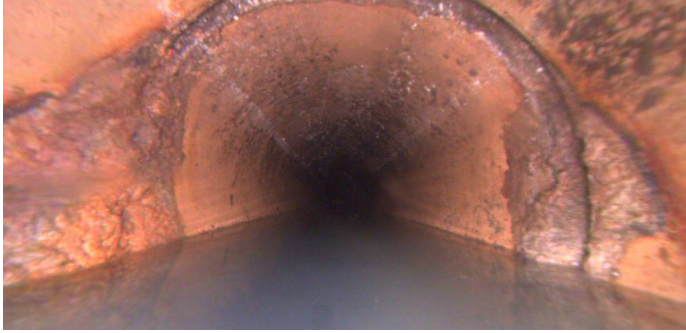
Code: **DAE**
Description: **Deposits Attached Encrustation**

Distance (ft): **158.3**
Structural Grade: **0**
O&M Grade: **2**
Clock Start/From: **8**
Clock To: **4**
1st Value:
2nd Value:
Value Percent: **5.000**
Continuous Index:
Within 8" of Joint: **YES**
Remarks:

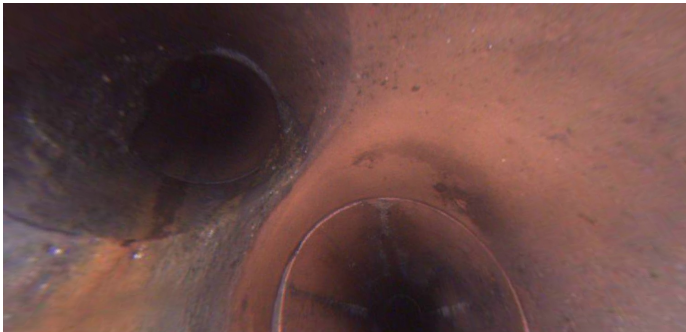
Code: **TF**
Description: **Tap Factory**

Distance (ft): **165.0**
Structural Grade: **0**
O&M Grade: **0**
Clock Start/From: **10**
Clock To:
1st Value: **4.000**
2nd Value:
Value Percent:
Continuous Index:
Within 8" of Joint:
Remarks:

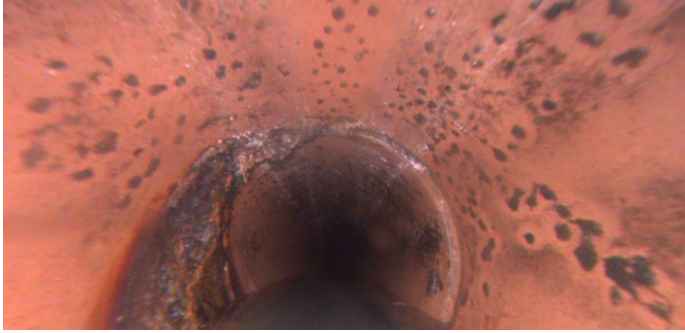
Code: **ID**
Description: **Infil Dripper**

Distance (ft): **170.3**
Structural Grade: **0**
O&M Grade: **3**
Clock Start/From: **10**
Clock To:
1st Value:
2nd Value:
Value Percent:
Continuous Index:
Within 8" of Joint: **YES**
Remarks:

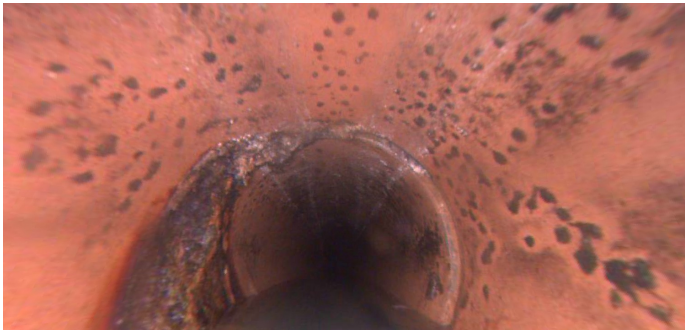
Code: **DAE**
Description: **Deposits Attached Encrustation**

Distance (ft): **170.3**
Structural Grade: **0**
O&M Grade: **2**
Clock Start/From: **8**
Clock To: **12**
1st Value:
2nd Value:
Value Percent: **10.000**
Continuous Index:
Within 8" of Joint: **YES**
Remarks:

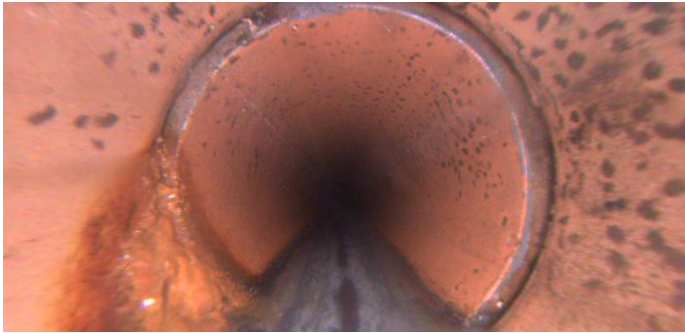
Code: **IW**
Description: **Infil Weeper**

Distance (ft): **175.7**
Structural Grade: **0**
O&M Grade: **2**
Clock Start/From: **7**
Clock To: **9**
1st Value:
2nd Value:
Value Percent:
Continuous Index:
Within 8" of Joint: **YES**
Remarks:

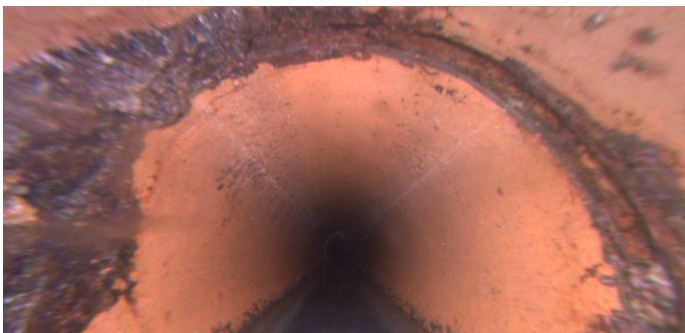
Code: **DAE**
Description: **Deposits Attached Encrustation**

Distance (ft): **181.2**
Structural Grade: **0**
O&M Grade: **2**
Clock Start/From: **8**
Clock To: **4**
1st Value:
2nd Value:
Value Percent: **5.000**
Continuous Index:
Within 8" of Joint: **YES**
Remarks:

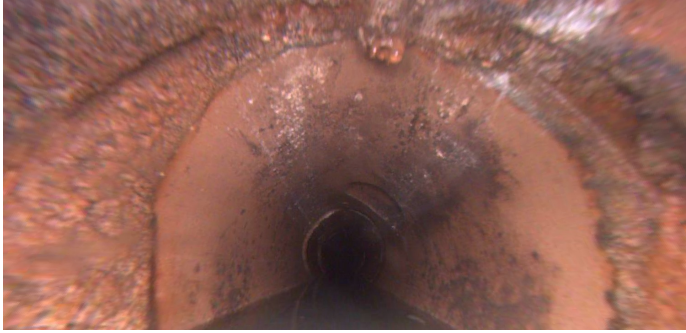
Code: ID
Description: Infil Dripper

Distance (ft): 186.4
Structural Grade: 0
O&M Grade: 3
Clock Start/From: 12
Clock To:
1st Value:
2nd Value:
Value Percent:
Continuous Index:
Within 8" of Joint: YES
Remarks:

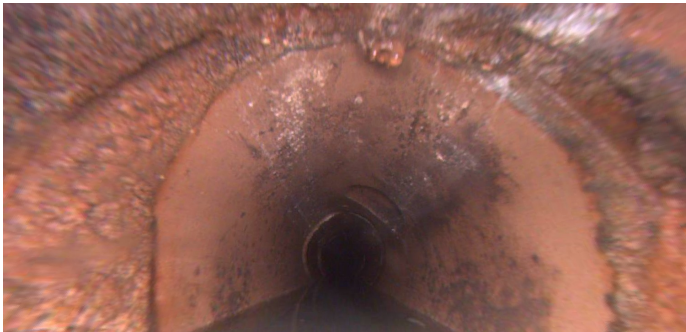
Code: DAE
Description: Deposits Attached Encrustation

Distance (ft): 186.4
Structural Grade: 0
O&M Grade: 2
Clock Start/From: 8
Clock To: 4
1st Value:
2nd Value:
Value Percent: 10.000
Continuous Index:
Within 8" of Joint: YES
Remarks:

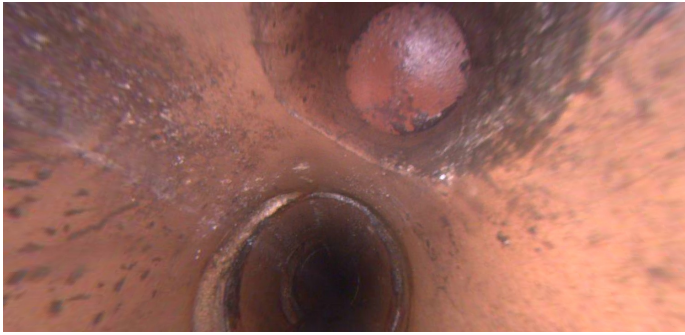
Code: **TFC**
Description: **Tap Factory Capped**

Distance (ft): **187.6**
Structural Grade: **0**
O&M Grade: **0**
Clock Start/From: **1**
Clock To:
1st Value: **4.000**
2nd Value:
Value Percent:
Continuous Index:
Within 8" of Joint:
Remarks:

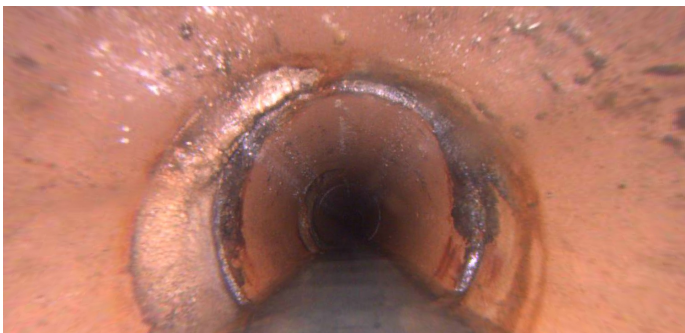
Code: **DAE**
Description: **Deposits Attached Encrustation**

Distance (ft): **188.1**
Structural Grade: **0**
O&M Grade: **2**
Clock Start/From: **8**
Clock To: **4**
1st Value:
2nd Value:
Value Percent: **5.000**
Continuous Index:
Within 8" of Joint: **YES**
Remarks:

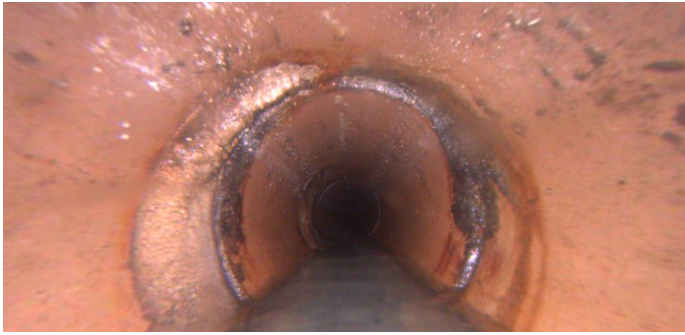
Code: **IW**
Description: **Infil Weeper**

Distance (ft): **188.1**
Structural Grade: **0**
O&M Grade: **2**
Clock Start/From: **8**
Clock To: **4**
1st Value:
2nd Value:
Value Percent:
Continuous Index:
Within 8" of Joint: **YES**
Remarks:

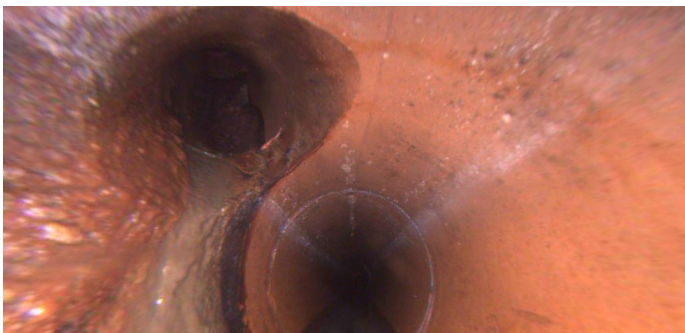
Code: **TFA**
Description: **Tap Factory Active**

Distance (ft): **189.6**
Structural Grade: **0**
O&M Grade: **0**
Clock Start/From: **10**
Clock To:
1st Value: **4.000**
2nd Value:
Value Percent:
Continuous Index:
Within 8" of Joint:
Remarks:

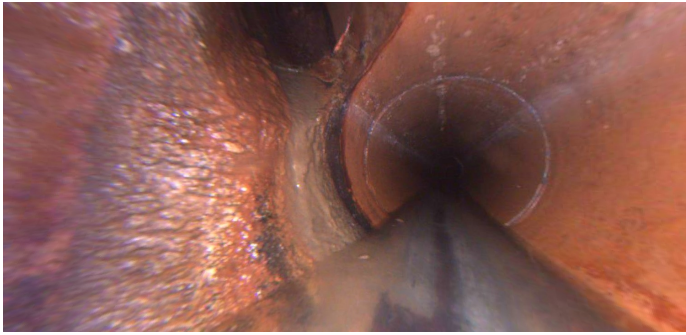
Code: **DAE**
Description: **Deposits Attached Encrustation**

Distance (ft): **189.6**
Structural Grade: **0**
O&M Grade: **2**
Clock Start/From: **8**
Clock To: **10**
1st Value:
2nd Value:
Value Percent: **5.000**
Continuous Index:
Within 8" of Joint: **NO**
Remarks:

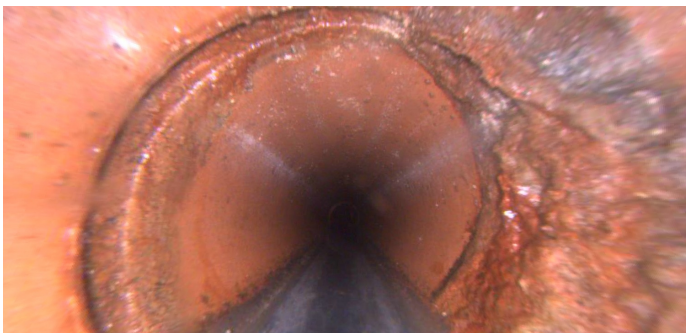
Code: **IW**
Description: **Infil Weeper**

Distance (ft): **195.5**
Structural Grade: **0**
O&M Grade: **2**
Clock Start/From: **8**
Clock To: **4**
1st Value:
2nd Value:
Value Percent:
Continuous Index: **S05**
Within 8" of Joint: **YES**
Remarks:

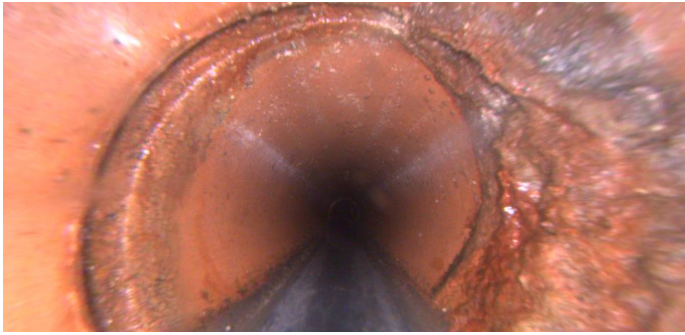
Code: **DAE**
Description: **Deposits Attached Encrustation**

Distance (ft): **195.5**
Structural Grade: **0**
O&M Grade: **2**
Clock Start/From: **8**
Clock To: **4**
1st Value:
2nd Value:
Value Percent: **10.000**
Continuous Index: **S04**
Within 8" of Joint: **YES**
Remarks:

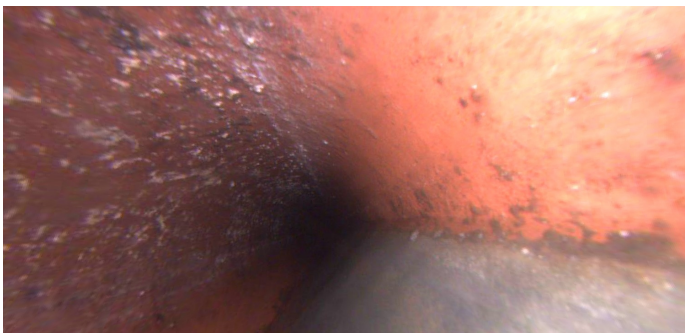
Code: **IW**
Description: **Infil Weeper**

Distance (ft): **212.5**
Structural Grade: **0**
O&M Grade: **2**
Clock Start/From: **8**
Clock To: **4**
1st Value:
2nd Value:
Value Percent:
Continuous Index: **F05**
Within 8" of Joint: **YES**
Remarks:

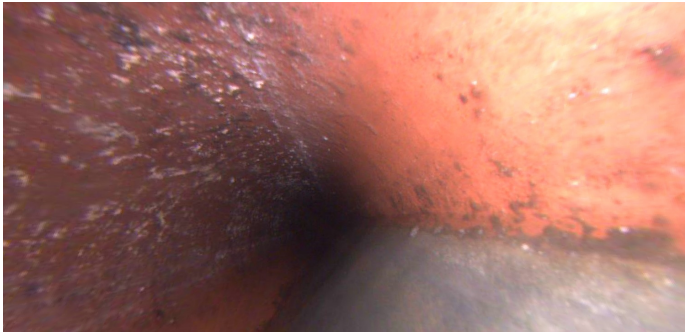
Code: **DAE**
Description: **Deposits Attached Encrustation**

Distance (ft): **212.5**
Structural Grade: **0**
O&M Grade: **2**
Clock Start/From: **8**
Clock To: **4**
1st Value:
2nd Value:
Value Percent: **10.000**
Continuous Index: **F04**
Within 8" of Joint: **YES**
Remarks:

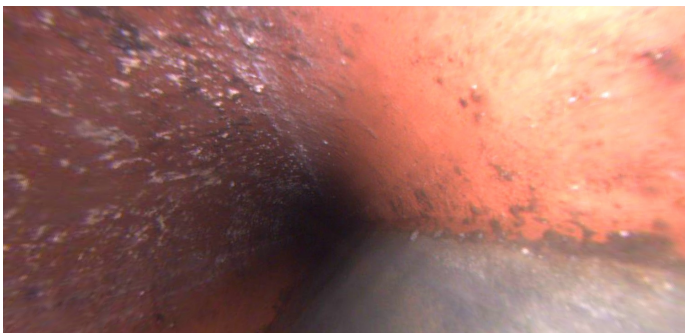
Code: **MSA**
Description: **Abandoned Survey**

Distance (ft): **212.5**
Structural Grade: **0**
O&M Grade: **0**
Clock Start/From:
Clock To:
1st Value:
2nd Value:
Value Percent:
Continuous Index:
Within 8" of Joint: **NO**
Remarks: **OVERTURNED**
