Profile/Photo Observation Report

Date:	04/12/2018	Weather:		Coding:	PACP 6.0
Pipe Length (ft):	245.3	Owner:	NA	Pre Clean:	Not Known
P.O.#:		Surveyor:	Jen Costello	PSR:	P-503-079-078
Customer:		Clean Date:	01/01/1900	Shape:	C

Street:	W 40th ave	Flow Control:	Not Controlled
City:	Hobart, IN	Year Renewed:	
Location:	Other	Tape/Media #:	
Purpose:	Not Known	Dia/Height:	10"
Use:	Sanitary	Material:	VCP
Drain Area:	NA	Lining:	
Category:	NA		
Comment:

Location Details:		Direction of Survey:	Downstream
US MH:	M-503-078	DS MH:	M-503-079
		Total Length Surveyed (ft):	212.5

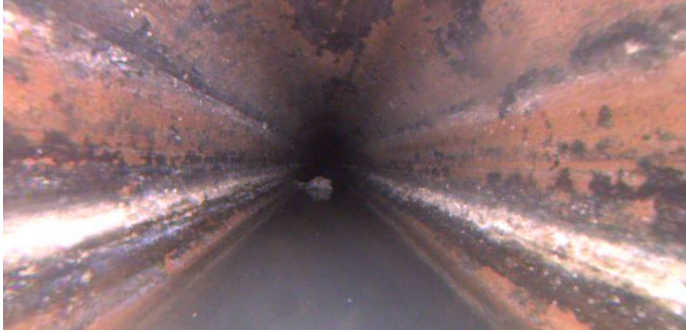
Code: **AMH**
Description: **Manhole**

Distance (ft): **.0**
Structural Grade: **0**
O&M Grade: **0**
Clock Start/From:
Clock To:
1st Value:
2nd Value:
Value Percent:
Continuous Index:
Within 8" of Joint: **NO**
Remarks: **M-503-078**

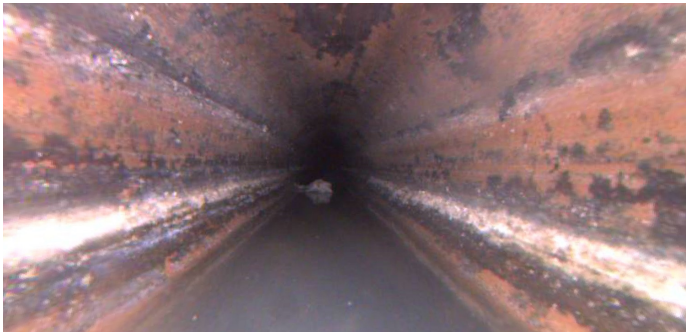
Code: **MWL**
Description: **Water Level**

Distance (ft): **.0**
Structural Grade: **0**
O&M Grade: **0**
Clock Start/From:
Clock To:
1st Value:
2nd Value:
Value Percent: **10.000**
Continuous Index:
Within 8" of Joint: **NO**
Remarks:

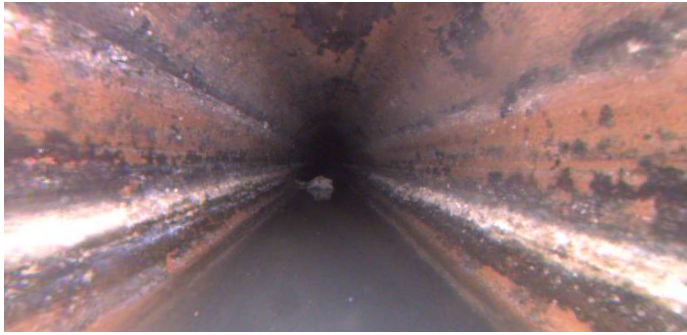
Code:	DAGS
Description:	Deposits Attached Grease
Distance (ft):	.0
Structural Grade:	0
O&M Grade:	2
Clock Start/From:	8
Clock To:	4
1st Value:	
2nd Value:	
Value Percent:	5.000
Continuous Index:	S01
Within 8" of Joint:	NO
Remarks:

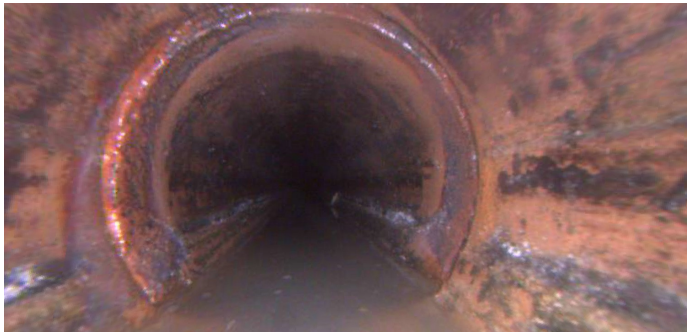
Code:	IW
Description:	Infil Weeper
Distance (ft):	8.4
Structural Grade:	0
O&M Grade:	2
Clock Start/From:	8
Clock To:	4
1st Value:	
2nd Value:	
Value Percent:	
Continuous Index:	
Within 8" of Joint:	YES
Remarks:

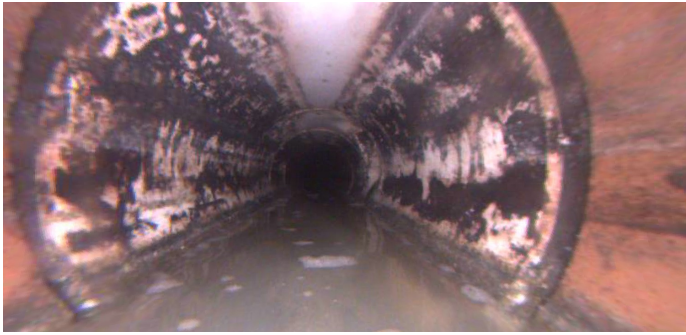
Code: **MMC**
Description: **Material Change**

Distance (ft): **20.7**
Structural Grade: **0**
O&M Grade: **0**
Clock Start/From:
Clock To:
1st Value:
2nd Value:
Value Percent:
Continuous Index:
Within 8" of Joint: **NO**
Remarks: **pvc**

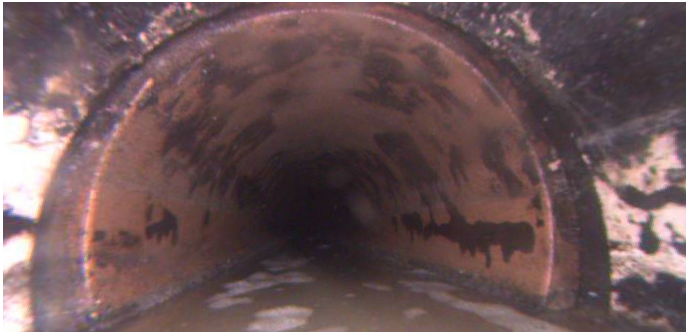
Code: **MMC**
Description: **Material Change**

Distance (ft): **23.8**
Structural Grade: **0**
O&M Grade: **0**
Clock Start/From:
Clock To:
1st Value:
2nd Value:
Value Percent:
Continuous Index:
Within 8" of Joint: **NO**
Remarks: **VCP**

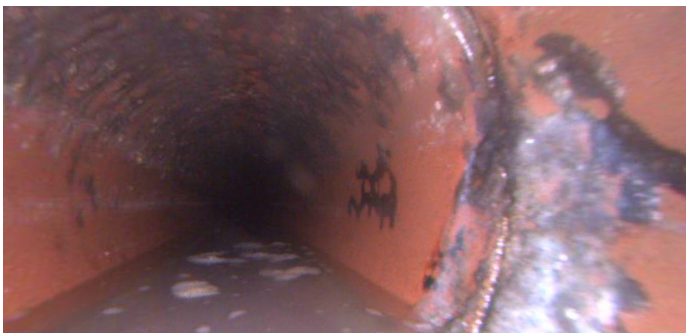
Code: **IW**
Description: **Infil Weeper**

Distance (ft): **70.1**
Structural Grade: **0**
O&M Grade: **2**
Clock Start/From: **3**
Clock To: **5**
1st Value:
2nd Value:
Value Percent:
Continuous Index:
Within 8" of Joint: **YES**
Remarks:

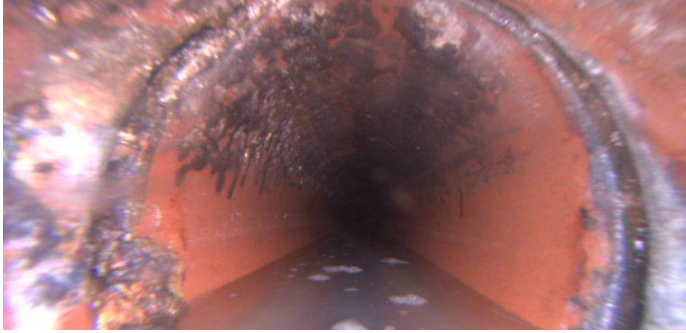
Code: **IW**
Description: **Infil Weeper**

Distance (ft): **75.2**
Structural Grade: **0**
O&M Grade: **2**
Clock Start/From: **8**
Clock To: **4**
1st Value:
2nd Value:
Value Percent:
Continuous Index: **S02**
Within 8" of Joint: **YES**
Remarks:

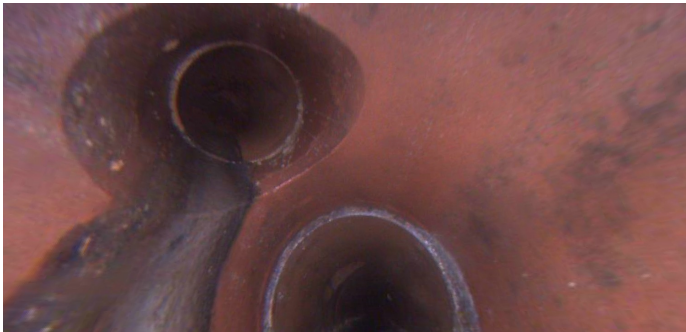
Code: **TFA**
Description: **Tap Factory Active**

Distance (ft): **81.6**
Structural Grade: **0**
O&M Grade: **0**
Clock Start/From: **11**
Clock To:
1st Value: **4.000**
2nd Value:
Value Percent:
Continuous Index:
Within 8" of Joint:
Remarks:

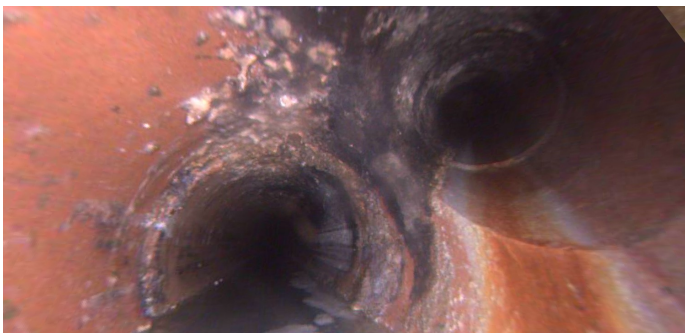
Code: **TF**
Description: **Tap Factory**

Distance (ft): **101.4**
Structural Grade: **0**
O&M Grade: **0**
Clock Start/From: **2**
Clock To:
1st Value: **4.000**
2nd Value:
Value Percent:
Continuous Index:
Within 8" of Joint:
Remarks:

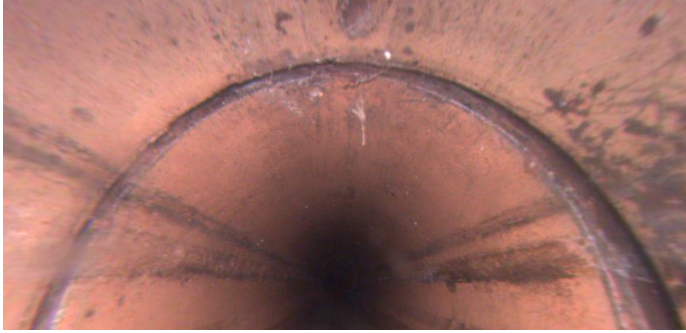
Code: **RFJ**
Description: **Roots Fine Joint**

Distance (ft): **107.0**
Structural Grade: **0**
O&M Grade: **1**
Clock Start/From: **12**
Clock To:
1st Value:
2nd Value:
Value Percent:
Continuous Index:
Within 8" of Joint: **YES**
Remarks:

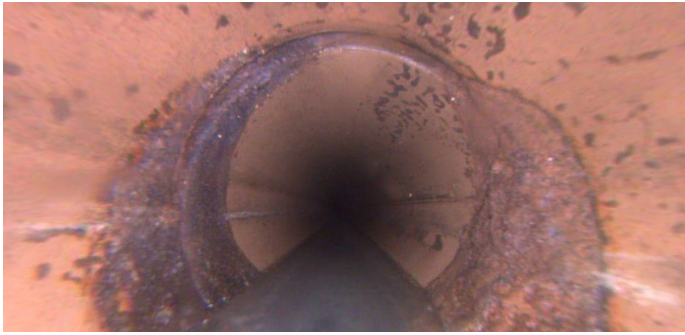
Code: **DAE**
Description: **Deposits Attached Encrustation**

Distance (ft): **111.9**
Structural Grade: **0**
O&M Grade: **2**
Clock Start/From: **8**
Clock To: **4**
1st Value:
2nd Value:
Value Percent: **5.000**
Continuous Index: **S03**
Within 8" of Joint: **YES**
Remarks:

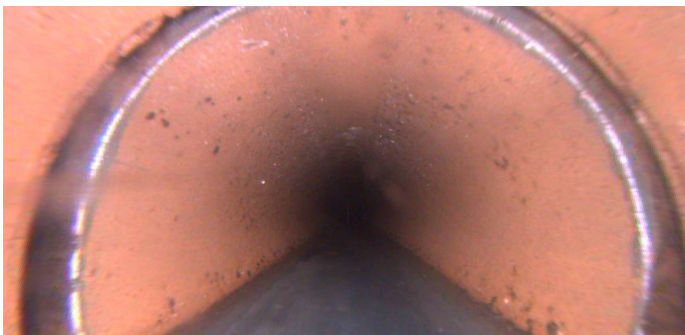
Code: **DAE**
Description: **Deposits Attached Encrustation**

Distance (ft): **143.0**
Structural Grade: **0**
O&M Grade: **2**
Clock Start/From: **8**
Clock To: **4**
1st Value:
2nd Value:
Value Percent: **5.000**
Continuous Index: **F03**
Within 8" of Joint: **YES**
Remarks:

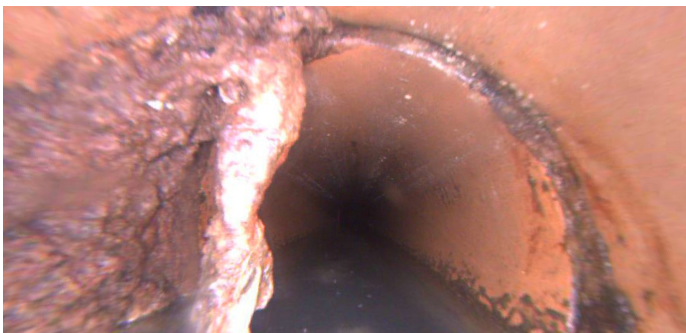
Code: **DAE**
Description: **Deposits Attached Encrustation**

Distance (ft): **153.1**
Structural Grade: **0**
O&M Grade: **3**
Clock Start/From: **8**
Clock To: **4**
1st Value:
2nd Value:
Value Percent: **20.000**
Continuous Index:
Within 8" of Joint: **YES**
Remarks:

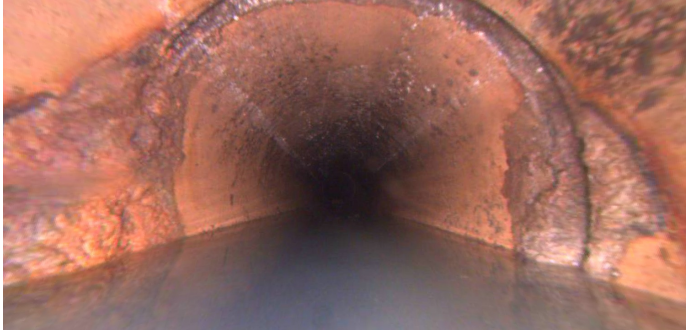
Code: **DAE**
Description: **Deposits Attached Encrustation**

Distance (ft): **158.3**
Structural Grade: **0**
O&M Grade: **2**
Clock Start/From: **8**
Clock To: **4**
1st Value:
2nd Value:
Value Percent: **5.000**
Continuous Index:
Within 8" of Joint: **YES**
Remarks:

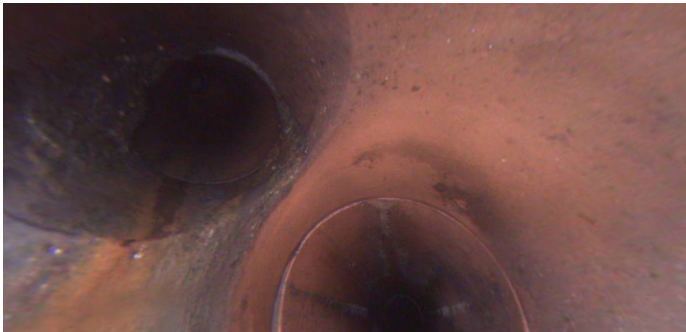
Code: **TF**
Description: **Tap Factory**

Distance (ft): **165.0**
Structural Grade: **0**
O&M Grade: **0**
Clock Start/From: **10**
Clock To:
1st Value: **4.000**
2nd Value:
Value Percent:
Continuous Index:
Within 8" of Joint:
Remarks:

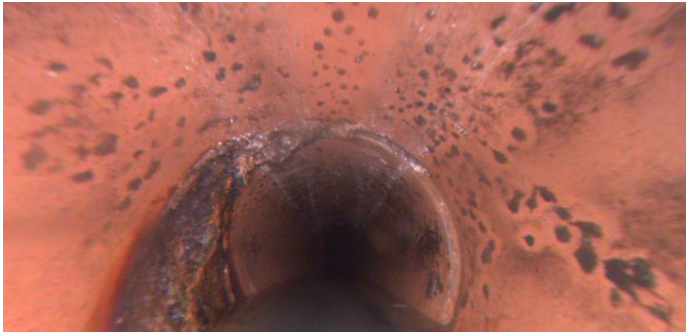
Code: **ID**
Description: **Infil Dripper**

Distance (ft): **170.3**
Structural Grade: **0**
O&M Grade: **3**
Clock Start/From: **10**
Clock To:
1st Value:
2nd Value:
Value Percent:
Continuous Index:
Within 8" of Joint: **YES**
Remarks:

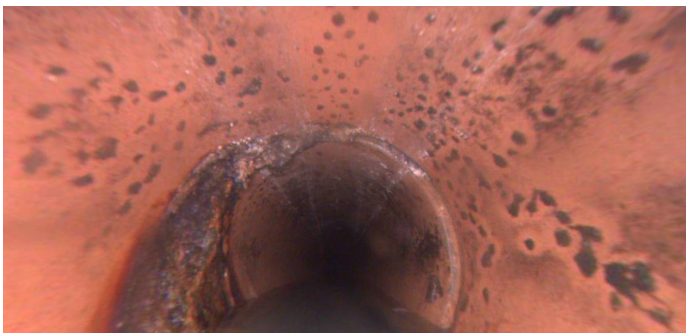
Code: **DAE**
Description: **Deposits Attached Encrustation**

Distance (ft): **170.3**
Structural Grade: **0**
O&M Grade: **2**
Clock Start/From: **8**
Clock To: **12**
1st Value:
2nd Value:
Value Percent: **10.000**
Continuous Index:
Within 8" of Joint: **YES**
Remarks:

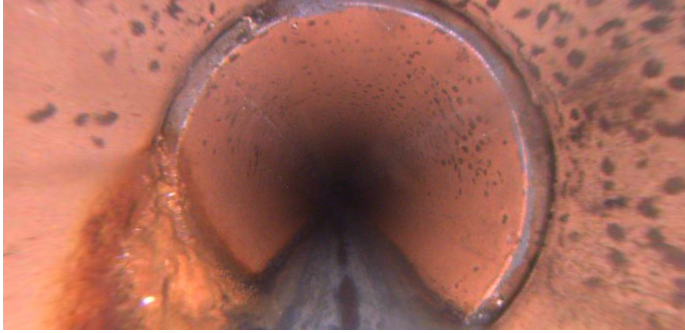
Code: **IW**
Description: **Infil Weeper**

Distance (ft): **175.7**
Structural Grade: **0**
O&M Grade: **2**
Clock Start/From: **7**
Clock To: **9**
1st Value:
2nd Value:
Value Percent:
Continuous Index:
Within 8" of Joint: **YES**
Remarks:

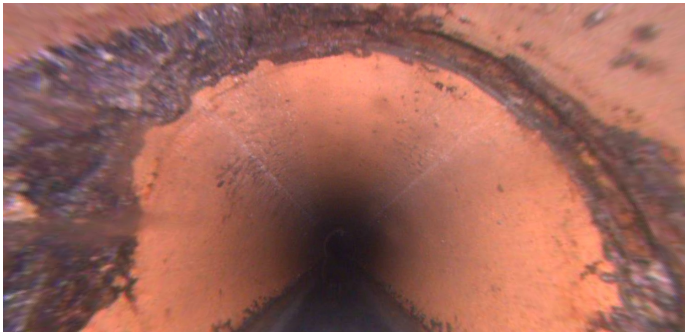
Code: **DAE**
Description: **Deposits Attached Encrustation**

Distance (ft): **181.2**
Structural Grade: **0**
O&M Grade: **2**
Clock Start/From: **8**
Clock To: **4**
1st Value:
2nd Value:
Value Percent: **5.000**
Continuous Index:
Within 8" of Joint: **YES**
Remarks:

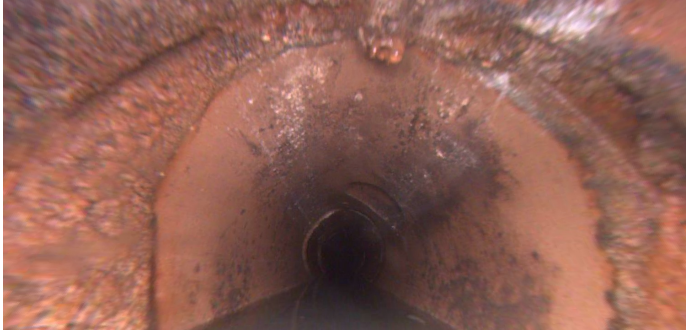
Code: ID
Description: Infil Dripper

Distance (ft): 186.4
Structural Grade: 0
O&M Grade: 3
Clock Start/From: 12
Clock To:
1st Value:
2nd Value:
Value Percent:
Continuous Index:
Within 8" of Joint: YES
Remarks:

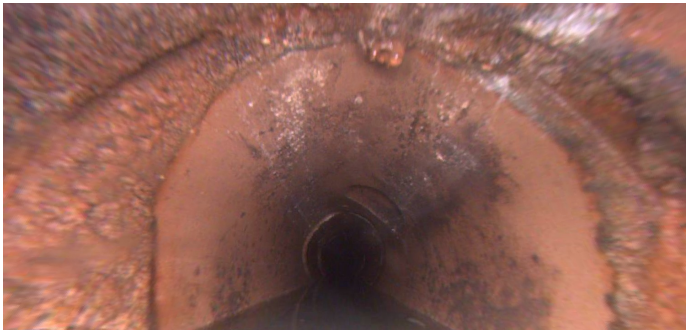
Code: DAE
Description: Deposits Attached Encrustation

Distance (ft): 186.4
Structural Grade: 0
O&M Grade: 2
Clock Start/From: 8
Clock To: 4
1st Value:
2nd Value:
Value Percent: 10.000
Continuous Index:
Within 8" of Joint: YES
Remarks:

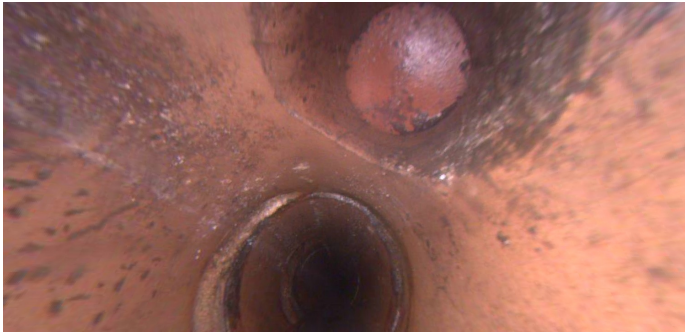
Code: **TFC**
Description: **Tap Factory Capped**

Distance (ft): **187.6**
Structural Grade: **0**
O&M Grade: **0**
Clock Start/From: **1**
Clock To:
1st Value: **4.000**
2nd Value:
Value Percent:
Continuous Index:
Within 8" of Joint:
Remarks:

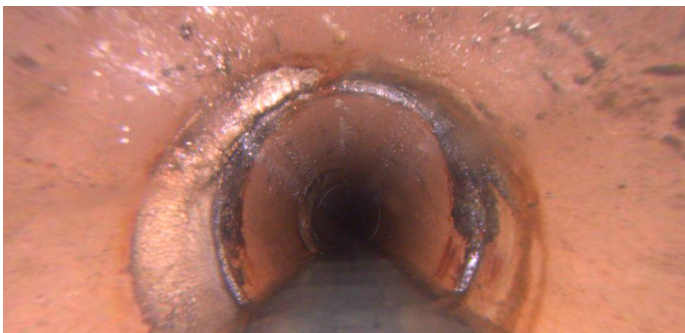
Code: **DAE**
Description: **Deposits Attached Encrustation**

Distance (ft): **188.1**
Structural Grade: **0**
O&M Grade: **2**
Clock Start/From: **8**
Clock To: **4**
1st Value:
2nd Value:
Value Percent: **5.000**
Continuous Index:
Within 8" of Joint: **YES**
Remarks:

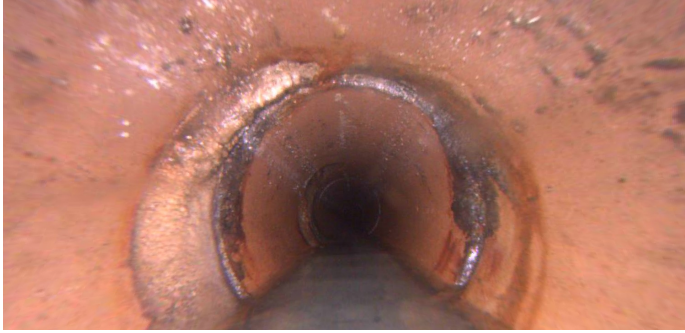
Code: **IW**
Description: **Infil Weeper**

Distance (ft): **188.1**
Structural Grade: **0**
O&M Grade: **2**
Clock Start/From: **8**
Clock To: **4**
1st Value:
2nd Value:
Value Percent:
Continuous Index:
Within 8" of Joint: **YES**
Remarks:

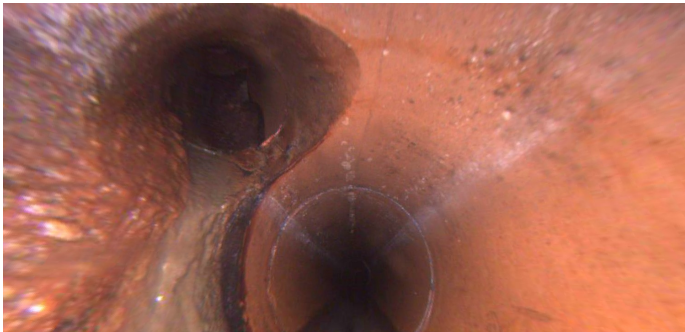
Code: **TFA**
Description: **Tap Factory Active**

Distance (ft): **189.6**
Structural Grade: **0**
O&M Grade: **0**
Clock Start/From: **10**
Clock To:
1st Value: **4.000**
2nd Value:
Value Percent:
Continuous Index:
Within 8" of Joint:
Remarks:

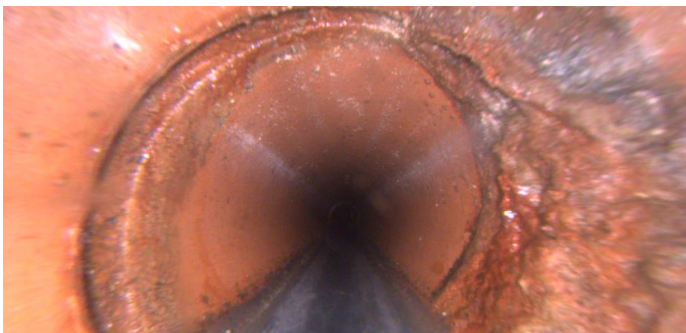
Code: **IW**
Description: **Infil Weeper**

Distance (ft): **195.5**
Structural Grade: **0**
O&M Grade: **2**
Clock Start/From: **8**
Clock To: **4**
1st Value:
2nd Value:
Value Percent:
Continuous Index: **S05**
Within 8" of Joint: **YES**
Remarks:

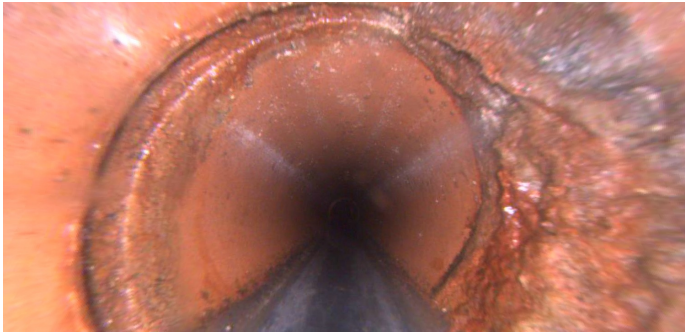
Code: **DAE**
Description: **Deposits Attached Encrustation**

Distance (ft): **195.5**
Structural Grade: **0**
O&M Grade: **2**
Clock Start/From: **8**
Clock To: **4**
1st Value:
2nd Value:
Value Percent: **10.000**
Continuous Index: **S04**
Within 8" of Joint: **YES**
Remarks:

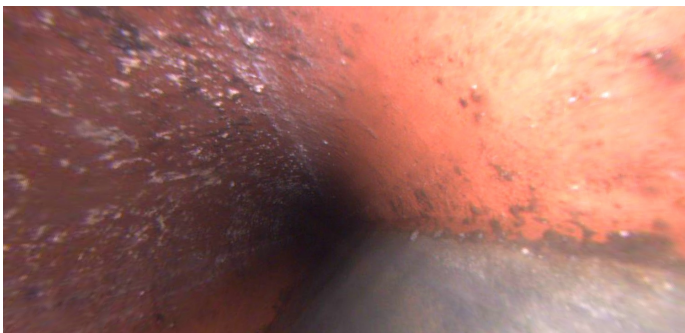
Code: **IW**
Description: **Infil Weeper**

Distance (ft): **212.5**
Structural Grade: **0**
O&M Grade: **2**
Clock Start/From: **8**
Clock To: **4**
1st Value:
2nd Value:
Value Percent:
Continuous Index: **F05**
Within 8" of Joint: **YES**
Remarks:

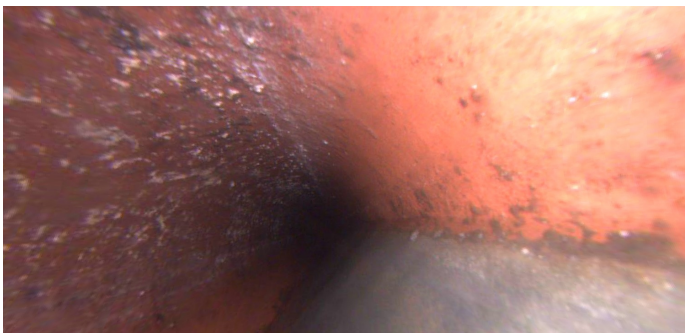
Code: **MSA**
Description: **Abandoned Survey**

Distance (ft): **212.5**
Structural Grade: **0**
O&M Grade: **0**
Clock Start/From:
Clock To:
1st Value:
2nd Value:
Value Percent:
Continuous Index:
Within 8" of Joint: **NO**
Remarks: **OVERTURNED**
