Profile/Photo Observation Report

Street:	ALLEY BETWEEN W 37TH PL & W 37	Flow Control:	Not Controlled
City:	Hobart, IN	Year Renewed:	
Location:	Other	Tape/Media #:	
Purpose:	Not Known	Dia/Height:	10"
Use:	Sanitary	Material:	VCP
Drain Area:	NA	Lining:	
Category:	NA		
Comment:

Location Details:		Direction of Survey:	Downstream
US MH:	M-503-079	DS MH:	M-503-080
		Total Length Surveyed (ft):	224.7

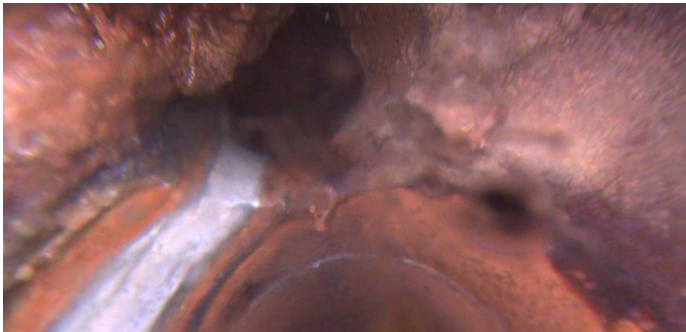
Code: **TFD**
Description: **Tap Factory Defective**

Distance (ft): **36.4**
Structural Grade: **0**
O&M Grade: **2**
Clock Start/From: **12**
Clock To:
1st Value: **4.000**
2nd Value:
Value Percent:
Continuous Index:
Within 8" of Joint:
Remarks: **DAE**

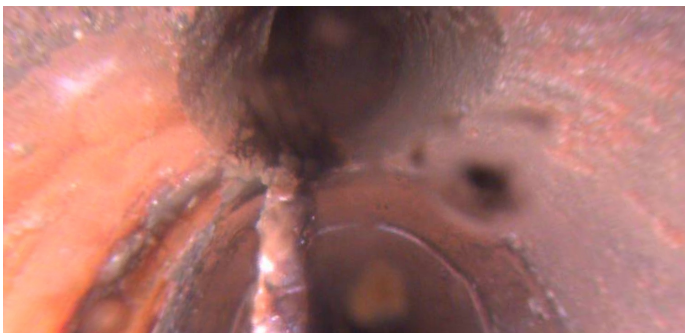
Code: **RFL**
Description: **Roots Fine Lateral**

Distance (ft): **57.8**
Structural Grade: **0**
O&M Grade: **1**
Clock Start/From: **12**
Clock To:
1st Value:
2nd Value:
Value Percent:
Continuous Index:
Within 8" of Joint: **NO**
Remarks:

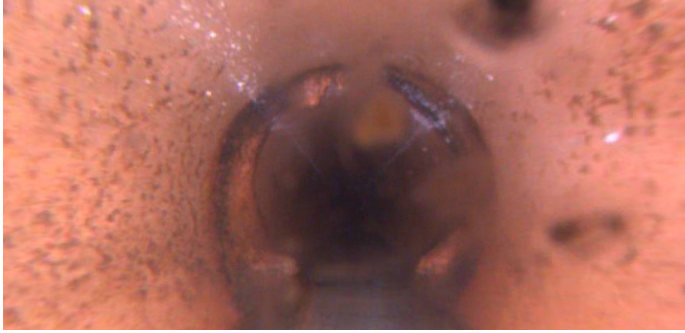
Code: ID
Description: Infil Dripper

Distance (ft): 98.9
Structural Grade: 0
O&M Grade: 3
Clock Start/From: 12
Clock To:
1st Value:
2nd Value:
Value Percent:
Continuous Index:
Within 8" of Joint: YES
Remarks:

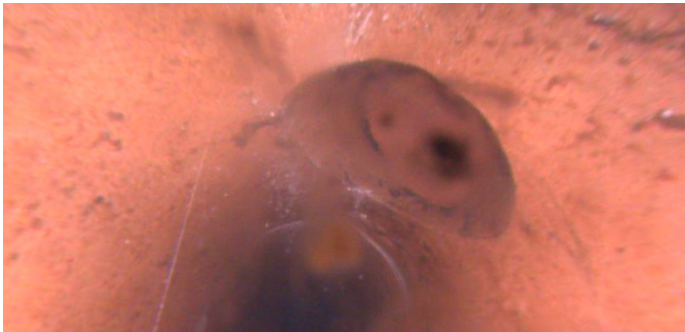
Code: TFC
Description: Tap Factory Capped

Distance (ft): 115.4
Structural Grade: 0
O&M Grade: 0
Clock Start/From: 1
Clock To:
1st Value: 4.000
2nd Value:
Value Percent:
Continuous Index:
Within 8" of Joint:
Remarks:

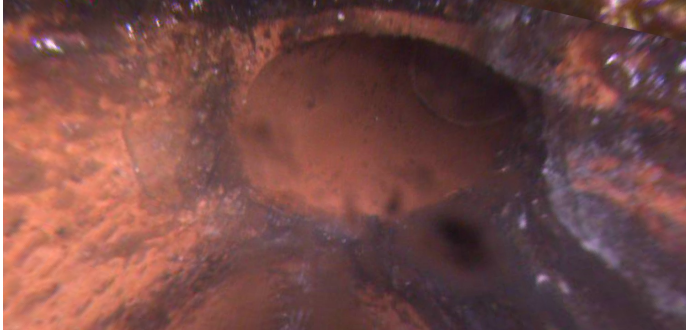
Code: **TB**
Description: **Tap Break-in**

Distance (ft): **128.1**
Structural Grade: **0**
O&M Grade: **0**
Clock Start/From: **1**
Clock To:
1st Value: **4.000**
2nd Value:
Value Percent:
Continuous Index:
Within 8" of Joint:
Remarks:

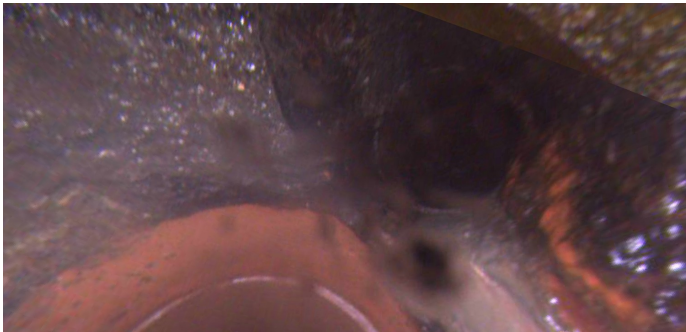
Code: **TFA**
Description: **Tap Factory Active**

Distance (ft): **147.0**
Structural Grade: **0**
O&M Grade: **0**
Clock Start/From: **2**
Clock To:
1st Value: **4.000**
2nd Value:
Value Percent:
Continuous Index:
Within 8" of Joint:
Remarks:

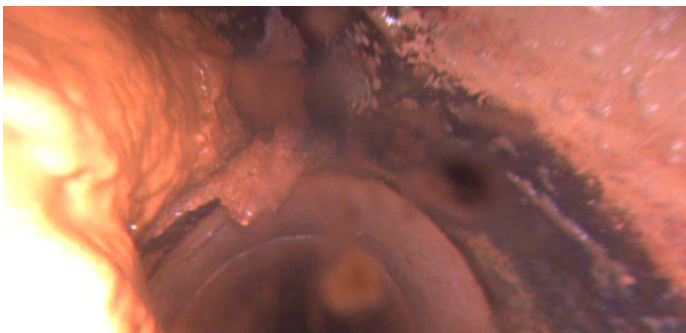
Code: **TFD**
Description: **Tap Factory Defective**

Distance (ft): **148.8**
Structural Grade: **0**
O&M Grade: **2**
Clock Start/From: **12**
Clock To:
1st Value: **4.000**
2nd Value:
Value Percent:
Continuous Index:
Within 8" of Joint:
Remarks: **AE**
