Profile/Photo Observation Report

Date:	04/13/2018	Weather:		Coding:	PACP 6.0
Pipe Length (ft):	226.7	Owner:	NA	Pre Clean:	Not Known
P.O.#:		Surveyor:	Jen Costello	PSR:	P-503-081-080
Customer:		Clean Date:	01/01/1900	Shape:	C

Street:	ALLEY BETWEEN W 37TH PL & W 37	Flow Control:	Not Controlled
City:	Hobart, IN	Year Renewed:	
Location:	Other	Tape/Media #:	
Purpose:	Not Known	Dia/Height:	10"
Use:	Sanitary	Material:	VCP
Drain Area:	NA	Lining:	
Category:	NA		
Comment:			
Location Details:		Direction of Survey:	Downstream
US MH:	M-503-081	DS MH:	M-503-080
		Total Length Surveyed (ft):	224.4

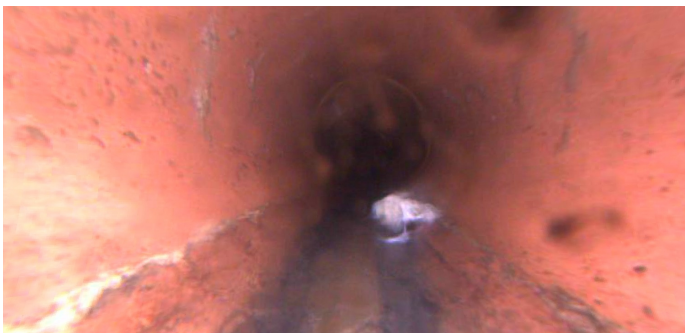
Code: **AMH**
Description: **Manhole**

Distance (ft): **.0**
Structural Grade: **0**
O&M Grade: **0**
Clock Start/From:
Clock To:
1st Value:
2nd Value:
Value Percent:
Continuous Index:
Within 8" of Joint: **NO**
Remarks: **M-503-081**

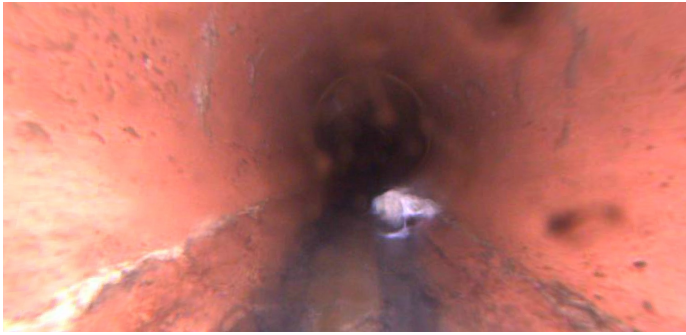
Code: **MWL**
Description: **Water Level**

Distance (ft): **.0**
Structural Grade: **0**
O&M Grade: **0**
Clock Start/From:
Clock To:
1st Value:
2nd Value:
Value Percent: **5.000**
Continuous Index:
Within 8" of Joint: **NO**
Remarks:

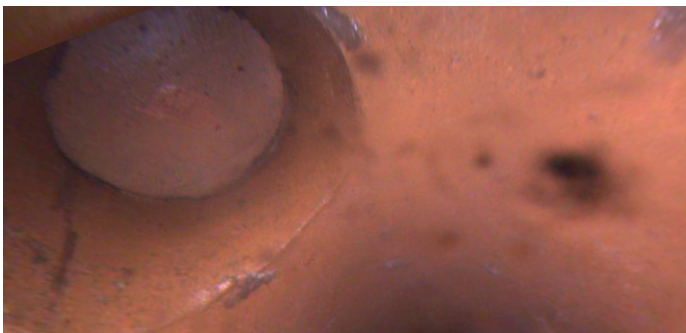
Code: **TFC**
Description: **Tap Factory Capped**

Distance (ft): **3.3**
Structural Grade: **0**
O&M Grade: **0**
Clock Start/From: **11**
Clock To:
1st Value: **4.000**
2nd Value:
Value Percent:
Continuous Index:
Within 8" of Joint:
Remarks:

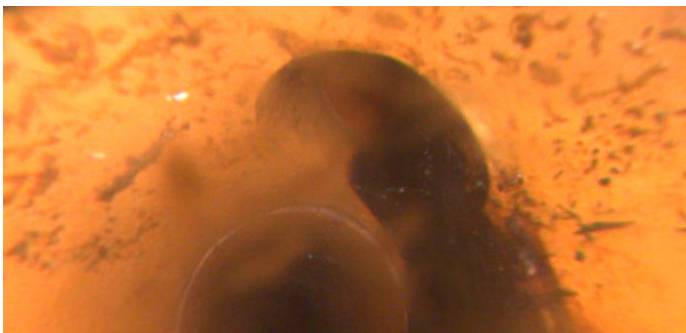
Code: **TFA**
Description: **Tap Factory Active**

Distance (ft): **32.5**
Structural Grade: **0**
O&M Grade: **0**
Clock Start/From: **11**
Clock To:
1st Value: **4.000**
2nd Value:
Value Percent:
Continuous Index:
Within 8" of Joint:
Remarks:

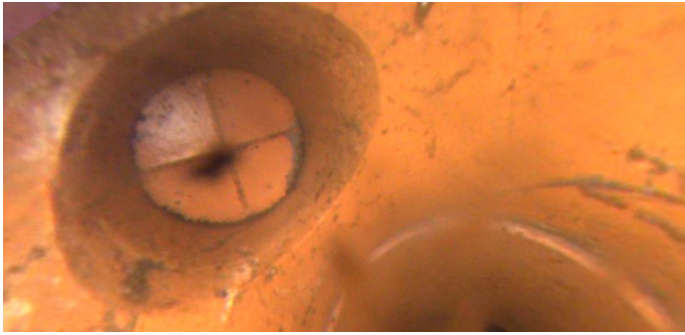
Code: **TFC**
Description: **Tap Factory Capped**

Distance (ft): **34.2**
Structural Grade: **0**
O&M Grade: **0**
Clock Start/From: **2**
Clock To:
1st Value: **4.000**
2nd Value:
Value Percent:
Continuous Index:
Within 8" of Joint:
Remarks:

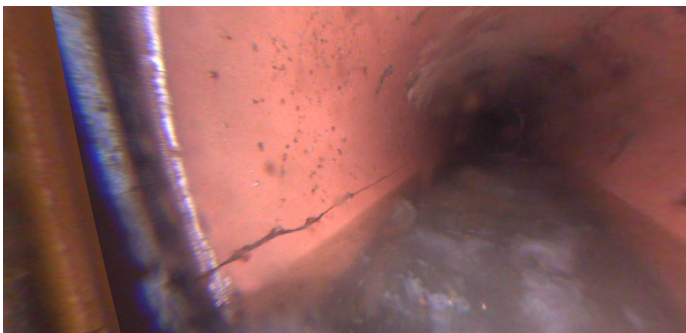
Code: **RFJ**
Description: **Roots Fine Joint**

Distance (ft): **74.7**
Structural Grade: **0**
O&M Grade: **1**
Clock Start/From: **8**
Clock To:
1st Value:
2nd Value:
Value Percent:
Continuous Index:
Within 8" of Joint: **YES**
Remarks:

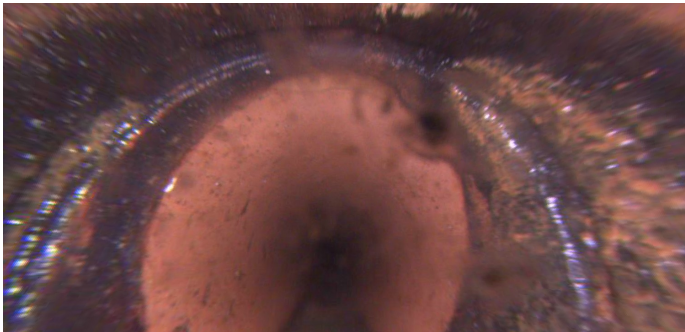
Code: **IW**
Description: **Infil Weeper**

Distance (ft): **96.1**
Structural Grade: **0**
O&M Grade: **2**
Clock Start/From: **8**
Clock To: **4**
1st Value:
2nd Value:
Value Percent:
Continuous Index:
Within 8" of Joint: **YES**
Remarks:

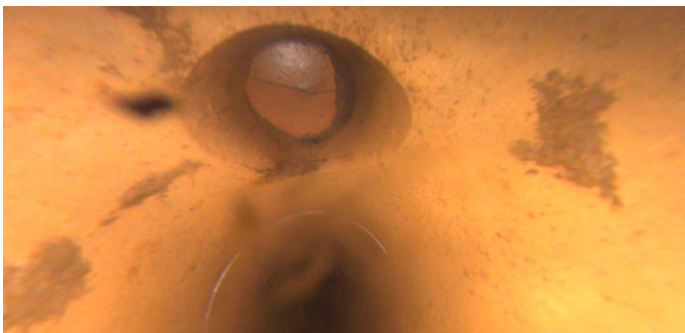
Code: **TFC**
Description: **Tap Factory Capped**

Distance (ft): **124.0**
Structural Grade: **0**
O&M Grade: **0**
Clock Start/From: **12**
Clock To:
1st Value: **4.000**
2nd Value:
Value Percent:
Continuous Index:
Within 8" of Joint:
Remarks:

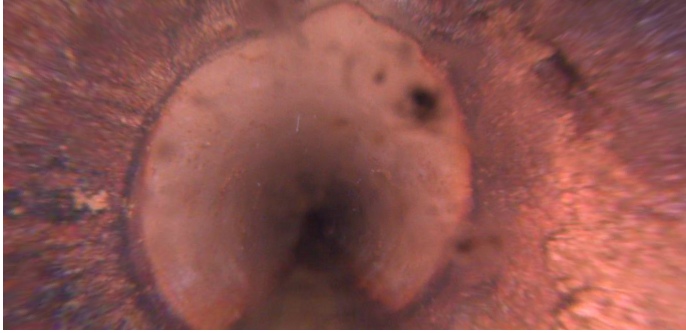
Code: **DAE**
Description: **Deposits Attached Encrustation**

Distance (ft): **156.1**
Structural Grade: **0**
O&M Grade: **2**
Clock Start/From: **8**
Clock To: **4**
1st Value:
2nd Value:
Value Percent: **5.000**
Continuous Index:
Within 8" of Joint: **YES**
Remarks:

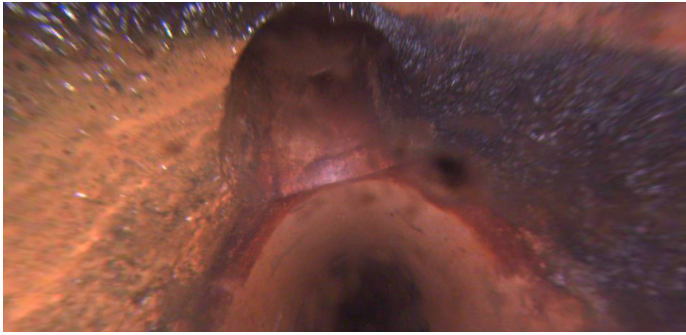
Code: **TFA**
Description: **Tap Factory Active**

Distance (ft): **183.2**
Structural Grade: **0**
O&M Grade: **0**
Clock Start/From: **12**
Clock To:
1st Value: **4.000**
2nd Value:
Value Percent:
Continuous Index:
Within 8" of Joint:
Remarks:

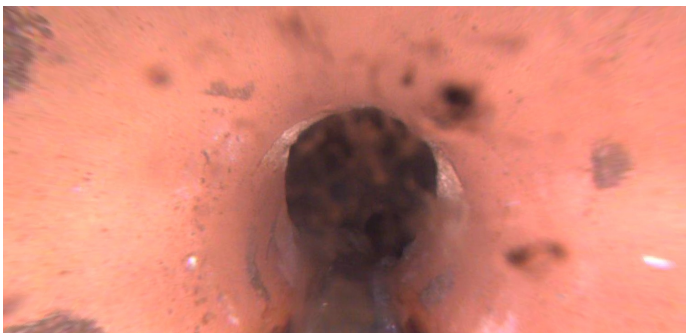
Code: **IW**
Description: **Infil Weeper**

Distance (ft): **222.3**
Structural Grade: **0**
O&M Grade: **2**
Clock Start/From: **8**
Clock To: **4**
1st Value:
2nd Value:
Value Percent:
Continuous Index: **F02**
Within 8" of Joint: **YES**
Remarks:
