Profile/Photo Observation Report

Date:	04/13/2018	Weather:		Coding:	PACP 6.0
Pipe Length (ft):	226.7	Owner:	NA	Pre Clean:	Not Known
P.O.#:		Surveyor:	Jen Costello	PSR:	P-503-081-080
Customer:		Clean Date:	01/01/1900	Shape:	C

Street:	W 40th ave	Flow Control:	Not Controlled
City:	Hobart, IN	Year Renewed:	
Location:	Other	Tape/Media #:	
Purpose:	Not Known	Dia/Height:	10"
Use:	Sanitary	Material:	VCP
Drain Area:	NA	Lining:	
Category:	NA		
Comment:			
Location Details:		Direction of Survey:	Downstream
US MH:	M-503-081	DS MH:	M-503-080
		Total Length Surveyed (ft):	224.4

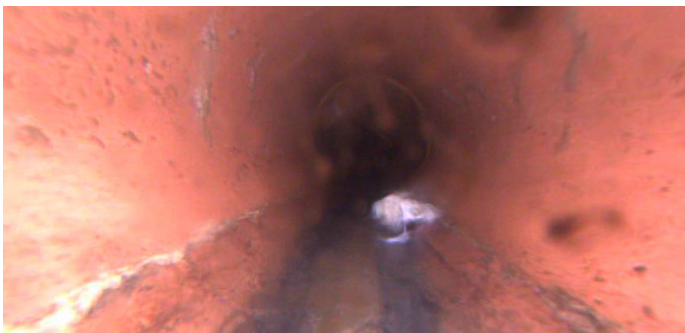
Code: **AMH**
Description: **Manhole**

Distance (ft): **.0**
Structural Grade: **0**
O&M Grade: **0**
Clock Start/From:
Clock To:
1st Value:
2nd Value:
Value Percent:
Continuous Index:
Within 8" of Joint: **NO**
Remarks: **M-503-081**

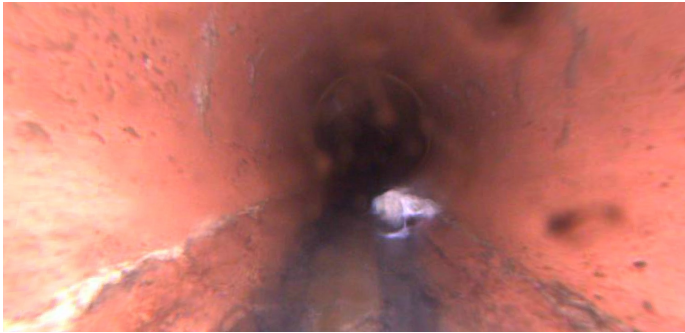
Code: **MWL**
Description: **Water Level**

Distance (ft): **.0**
Structural Grade: **0**
O&M Grade: **0**
Clock Start/From:
Clock To:
1st Value:
2nd Value:
Value Percent: **5.000**
Continuous Index:
Within 8" of Joint: **NO**
Remarks:

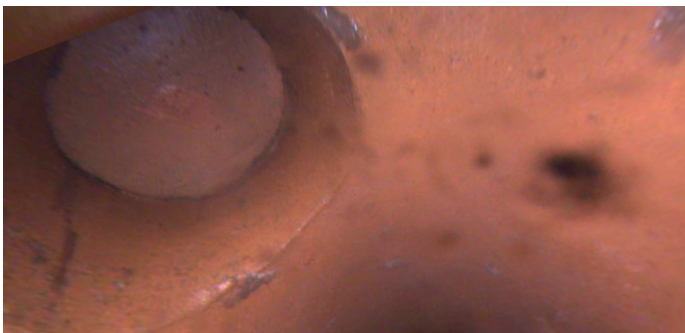
Code: **TFC**
Description: **Tap Factory Capped**

Distance (ft): **3.3**
Structural Grade: **0**
O&M Grade: **0**
Clock Start/From: **11**
Clock To:
1st Value: **4.000**
2nd Value:
Value Percent:
Continuous Index:
Within 8" of Joint:
Remarks:

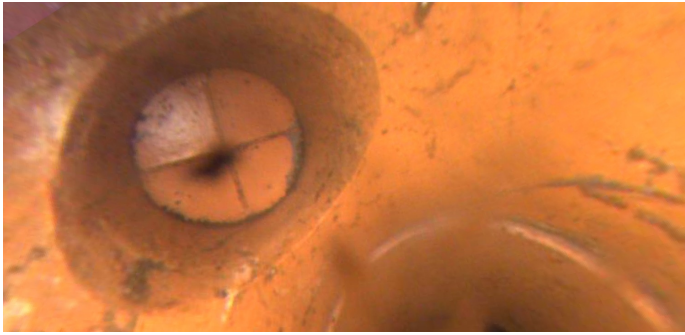
Code: **TFC**
Description: **Tap Factory Capped**

Distance (ft): **34.2**
Structural Grade: **0**
O&M Grade: **0**
Clock Start/From: **2**
Clock To:
1st Value: **4.000**
2nd Value:
Value Percent:
Continuous Index:
Within 8" of Joint:
Remarks:

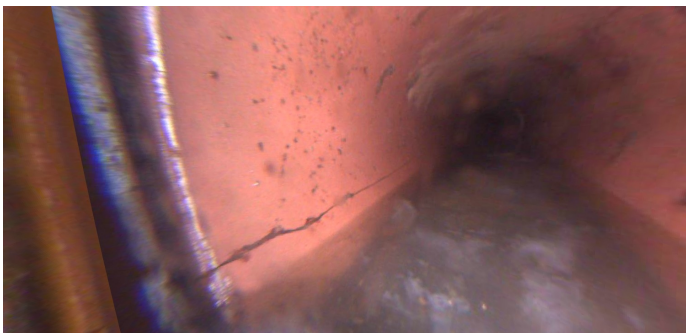
Code: **RFJ**
Description: **Roots Fine Joint**

Distance (ft): **74.7**
Structural Grade: **0**
O&M Grade: **1**
Clock Start/From: **8**
Clock To:
1st Value:
2nd Value:
Value Percent:
Continuous Index:
Within 8" of Joint: **YES**
Remarks:

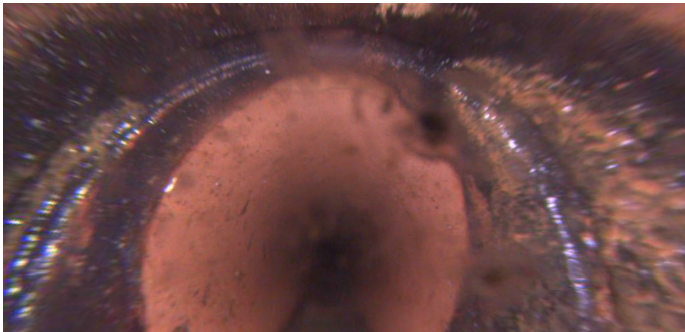
Code: **IW**
Description: **Infil Weeper**

Distance (ft): **96.1**
Structural Grade: **0**
O&M Grade: **2**
Clock Start/From: **8**
Clock To: **4**
1st Value:
2nd Value:
Value Percent:
Continuous Index:
Within 8" of Joint: **YES**
Remarks:

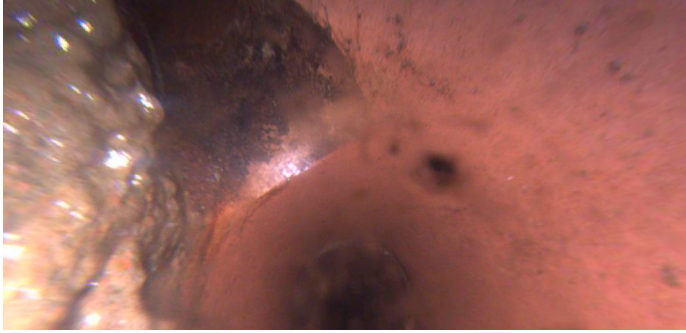
Code: **TFD**
Description: **Tap Factory Defective**

Distance (ft): **111.5**
Structural Grade: **0**
O&M Grade: **2**
Clock Start/From: **11**
Clock To:
1st Value: **4.000**
2nd Value:
Value Percent:
Continuous Index:
Within 8" of Joint:
Remarks: **DAE**

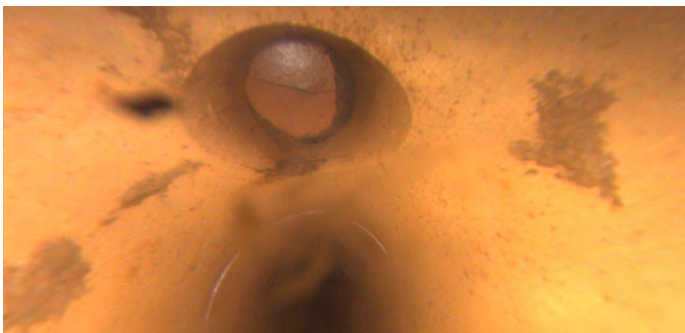
Code: **TFC**
Description: **Tap Factory Capped**

Distance (ft): **124.0**
Structural Grade: **0**
O&M Grade: **0**
Clock Start/From: **12**
Clock To:
1st Value: **4.000**
2nd Value:
Value Percent:
Continuous Index:
Within 8" of Joint:
Remarks:

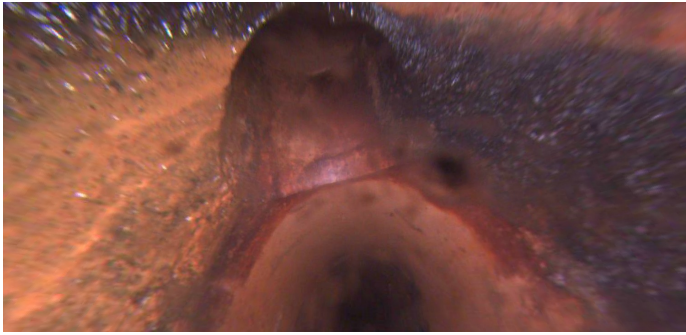
Code: **TFA**
Description: **Tap Factory Active**

Distance (ft): **183.2**
Structural Grade: **0**
O&M Grade: **0**
Clock Start/From: **12**
Clock To:
1st Value: **4.000**
2nd Value:
Value Percent:
Continuous Index:
Within 8" of Joint:
Remarks:

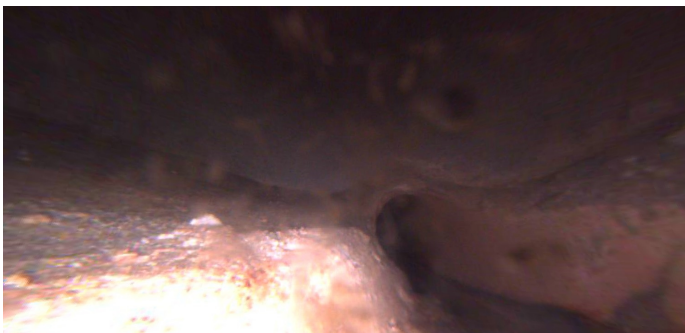
Code: **AMH**
Description: **Manhole**

Distance (ft): **224.4**
Structural Grade: **0**
O&M Grade: **0**
Clock Start/From:
Clock To:
1st Value:
2nd Value:
Value Percent:
Continuous Index:
Within 8" of Joint: **NO**
Remarks: **M-503-080**
