## Profile/Photo Observation Report

Street:	<b>W 40th ave</b>	Flow Control:	<b>Not Controlled</b>
City:	<b>Hobart, IN</b>	Year Renewed:	
Location:	<b>Other</b>	Tape/Media #:	
Purpose:	<b>Not Known</b>	Dia/Height:	<b>10"</b>
Use:	<b>Sanitary</b>	Material:	<b>VCP</b>
Drain Area:	<b>NA</b>	Lining:	
Category:	<b>NA</b>		
Comment:

Location Details:		Direction of Survey:	<b>Downstream</b>
US MH:	<b>M-503-083</b>	DS MH:	<b>M-503-084</b>
		Total Length Surveyed (ft):	<b>23.4</b>

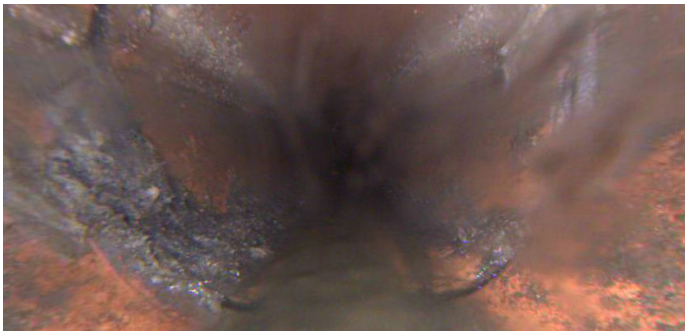
Code: **AMH**  
Description: **Manhole**

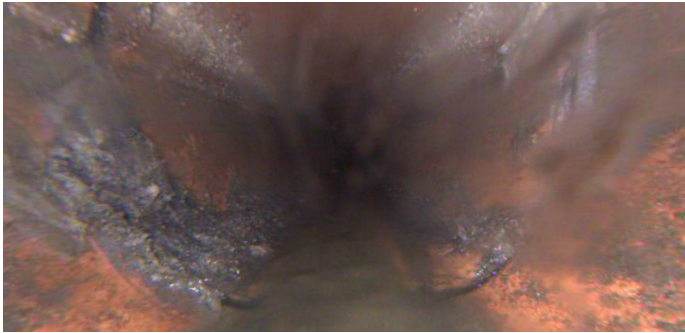
Code:	<b>MWL</b>
Description:	<b>Water Level</b>

Distance (ft):	<b>.0</b>
Structural Grade:	<b>0</b>
O&M Grade:	<b>0</b>
Clock Start/From:	
Clock To:	
1st Value:	
2nd Value:	
Value Percent:	<b>5.000</b>
Continuous Index:	
Within 8" of Joint:	<b>NO</b>
Remarks:

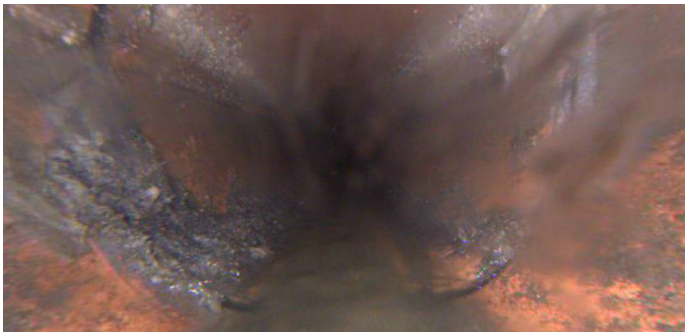
Code:	<b>DAGS</b>
Description:	<b>Deposits Attached Grease</b>

Distance (ft):	<b>.0</b>
Structural Grade:	<b>0</b>
O&M Grade:	<b>2</b>
Clock Start/From:	<b>8</b>
Clock To:	<b>4</b>
1st Value:	
2nd Value:	
Value Percent:	<b>5.000</b>
Continuous Index:	<b>S01</b>
Within 8" of Joint:	<b>NO</b>
Remarks:

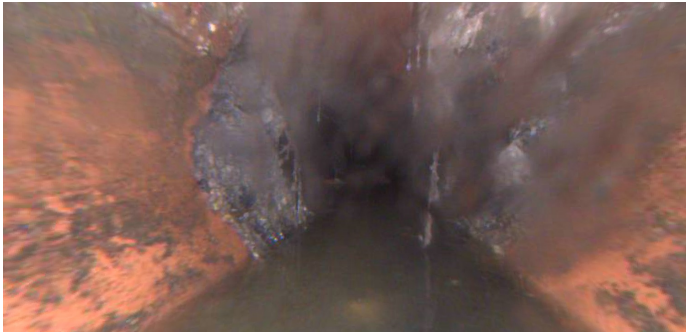
Code: **RMJ**  
Description: **Roots Medium Joint**

Distance (ft): **5.8**  
Structural Grade: **0**  
O&M Grade: **3**  
Clock Start/From: **8**  
Clock To: **4**  
1st Value:  
2nd Value:  
Value Percent: **20.000**  
Continuous Index:  
Within 8" of Joint: **YES**  
Remarks:

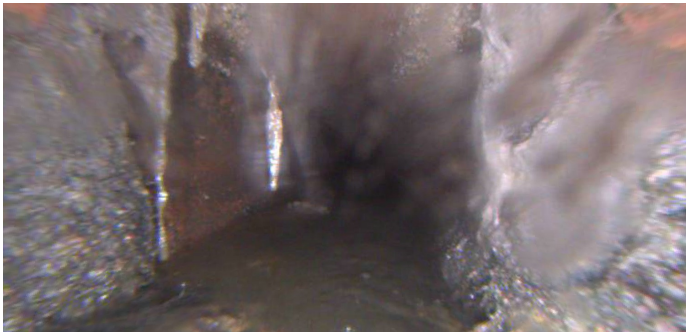
Code: **RMJ**  
Description: **Roots Medium Joint**

Distance (ft): **8.1**  
Structural Grade: **0**  
O&M Grade: **3**  
Clock Start/From: **8**  
Clock To: **4**  
1st Value:  
2nd Value:  
Value Percent: **20.000**  
Continuous Index:  
Within 8" of Joint: **YES**  
Remarks:

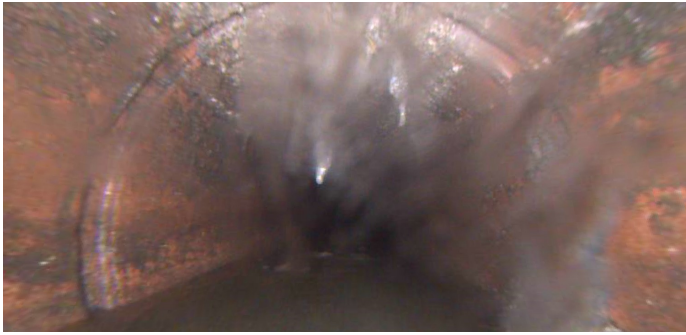
Code: **RMJ**  
Description: **Roots Medium Joint**

Distance (ft): **12.9**  
Structural Grade: **0**  
O&M Grade: **3**  
Clock Start/From: **8**  
Clock To: **4**  
1st Value:  
2nd Value:  
Value Percent: **5.000**  
Continuous Index:  
Within 8" of Joint: **YES**  
Remarks:

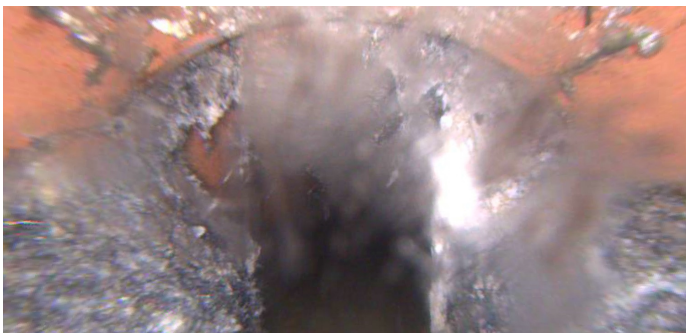
Code: **RMJ**  
Description: **Roots Medium Joint**

Distance (ft): **18.0**  
Structural Grade: **0**  
O&M Grade: **3**  
Clock Start/From: **8**  
Clock To: **4**  
1st Value:  
2nd Value:  
Value Percent: **30.000**  
Continuous Index:  
Within 8" of Joint: **YES**  
Remarks:

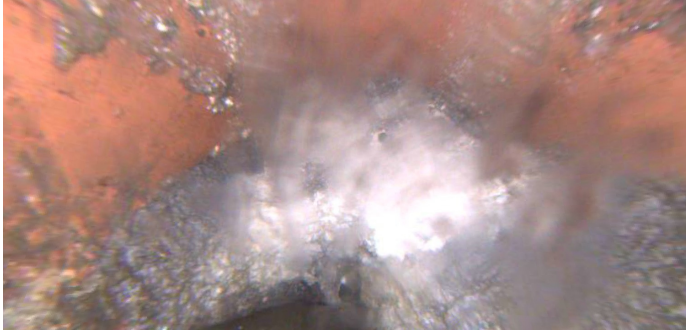
Code: **RBJ**  
Description: **Roots Ball Joint**

Distance (ft): **22.5**  
Structural Grade: **0**  
O&M Grade: **4**  
Clock Start/From: **7**  
Clock To: **5**  
1st Value:  
2nd Value:  
Value Percent: **90.000**  
Continuous Index:  
Within 8" of Joint: **YES**  
Remarks:
