# Profile/Photo Observation Report

Street:	<b>ALLEY BETWEEN N WILSON ST &amp; N G</b>	Flow Control:	<b>Not Controlled</b>
City:	<b>Hobart, IN</b>	Year Renewed:	
Location:	<b>Other</b>	Tape/Media #:	
Purpose:	<b>Not Known</b>	Dia/Height:	<b>10"</b>
Use:	<b>Sanitary</b>	Material:	<b>VCP</b>
Drain Area:	<b>NA</b>	Lining:	
Category:	<b>NA</b>		
Comment:			
Location Details:		Direction of Survey:	<b>Downstream</b>
US MH:	<b>M-503-084</b>	DS MH:	<b>M-503-086</b>
		Total Length Surveyed (ft):	<b>187.2</b>

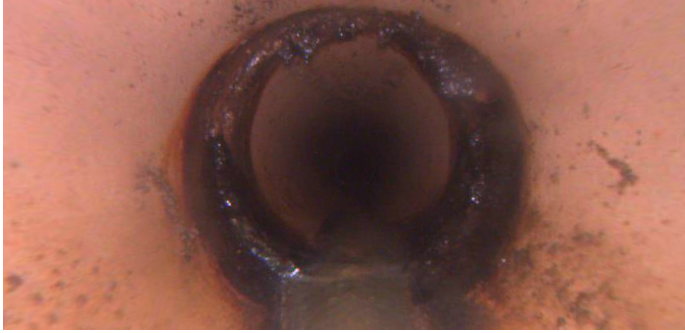
Code: ID  
Description: Infil Dripper

Distance (ft): 15.8  
Structural Grade: 0  
O&M Grade: 3  
Clock Start/From: 12  
Clock To:  
1st Value:  
2nd Value:  
Value Percent:  
Continuous Index:  
Within 8" of Joint: YES  
Remarks:

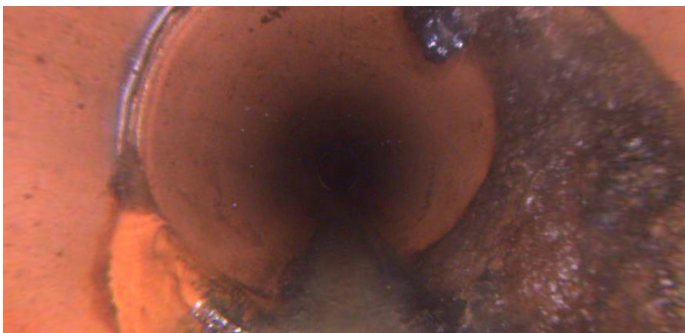
Code: DAE  
Description: Deposits Attached Encrustation

Distance (ft): 36.7  
Structural Grade: 0  
O&M Grade: 2  
Clock Start/From: 8  
Clock To: 4  
1st Value:  
2nd Value:  
Value Percent: 5.000  
Continuous Index:  
Within 8" of Joint: YES  
Remarks:

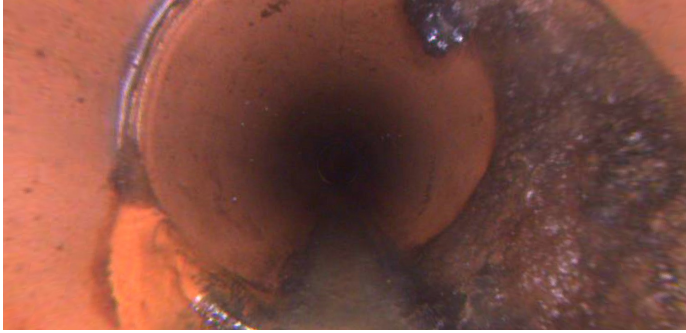
Code: ID  
Description: Infil Dripper

Distance (ft): 36.7  
Structural Grade: 0  
O&M Grade: 3  
Clock Start/From: 1  
Clock To:  
1st Value:  
2nd Value:  
Value Percent:  
Continuous Index:  
Within 8" of Joint: YES  
Remarks:

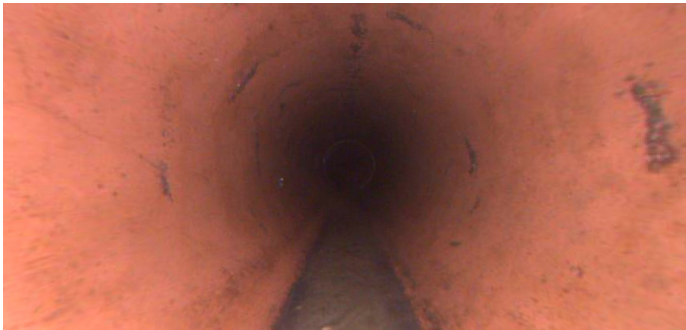
Code: IW  
Description: Infil Weeper

Distance (ft): 47.8  
Structural Grade: 0  
O&M Grade: 2  
Clock Start/From: 8  
Clock To: 4  
1st Value:  
2nd Value:  
Value Percent:  
Continuous Index: F01  
Within 8" of Joint: YES  
Remarks:

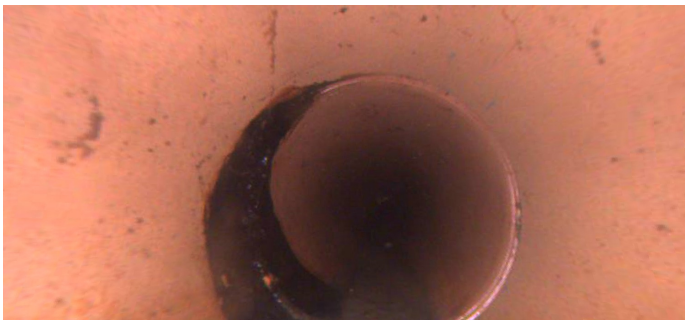
Code: **CL**  
Description: **Crack Longitudinal**

Distance (ft): **53.8**  
Structural Grade: **2**  
O&M Grade: **0**  
Clock Start/From: **11**  
Clock To:  
1st Value:  
2nd Value:  
Value Percent:  
Continuous Index:  
Within 8" of Joint: **YES**  
Remarks:

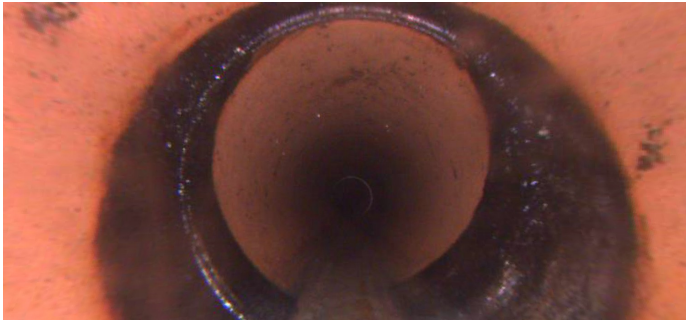
Code: **IW**  
Description: **Infil Weeper**

Distance (ft): **64.2**  
Structural Grade: **0**  
O&M Grade: **2**  
Clock Start/From: **8**  
Clock To: **4**  
1st Value:  
2nd Value:  
Value Percent:  
Continuous Index:  
Within 8" of Joint: **YES**  
Remarks:

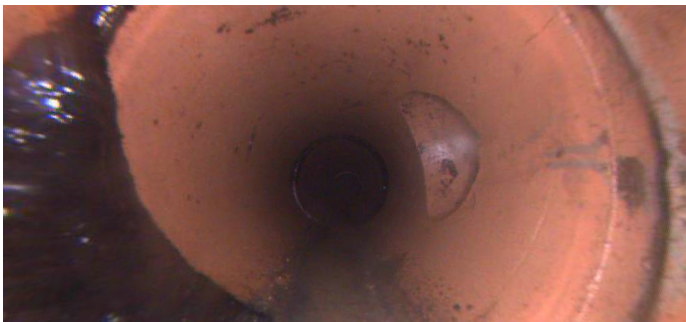
Code: **IW**  
Description: **Infil Weeper**

Distance (ft): **95.3**  
Structural Grade: **0**  
O&M Grade: **2**  
Clock Start/From: **7**  
Clock To: **11**  
1st Value:  
2nd Value:  
Value Percent:  
Continuous Index:  
Within 8" of Joint: **YES**  
Remarks:

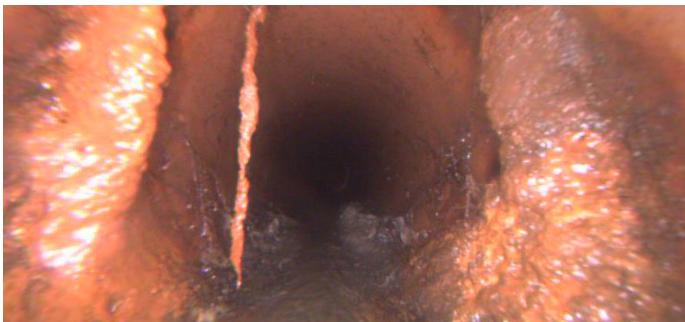
Code: **DAE**  
Description: **Deposits Attached Encrustation**

Distance (ft): **120.0**  
Structural Grade: **0**  
O&M Grade: **3**  
Clock Start/From: **8**  
Clock To: **4**  
1st Value:  
2nd Value:  
Value Percent: **20.000**  
Continuous Index:  
Within 8" of Joint: **YES**  
Remarks:

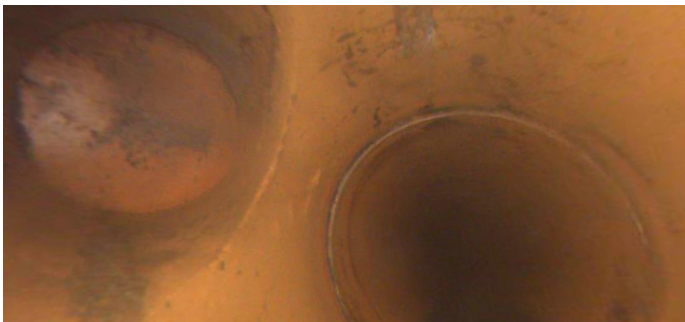
Code: **TFC**  
Description: **Tap Factory Capped**

Distance (ft): **152.4**  
Structural Grade: **0**  
O&M Grade: **0**  
Clock Start/From: **2**  
Clock To:  
1st Value: **4.000**  
2nd Value:  
Value Percent:  
Continuous Index:  
Within 8" of Joint:  
Remarks:

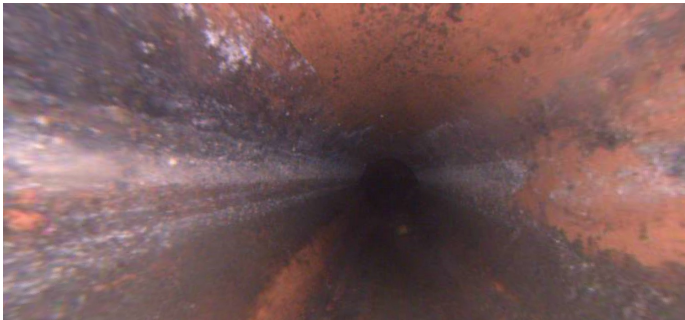
Code: **DAGS**  
Description: **Deposits Attached Grease**

Distance (ft): **181.8**  
Structural Grade: **0**  
O&M Grade: **2**  
Clock Start/From: **8**  
Clock To: **4**  
1st Value:  
2nd Value:  
Value Percent: **5.000**  
Continuous Index: **S03**  
Within 8" of Joint: **NO**  
Remarks:

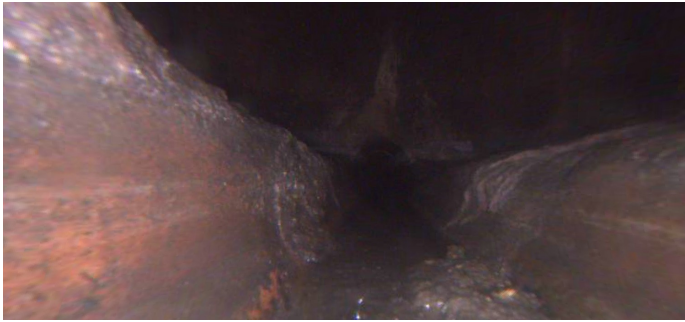
Code: **DAGS**  
Description: **Deposits Attached Grease**

Distance (ft): **185.3**  
Structural Grade: **0**  
O&M Grade: **2**  
Clock Start/From: **8**  
Clock To: **4**  
1st Value:  
2nd Value:  
Value Percent: **5.000**  
Continuous Index: **F03**  
Within 8" of Joint: **NO**  
Remarks:

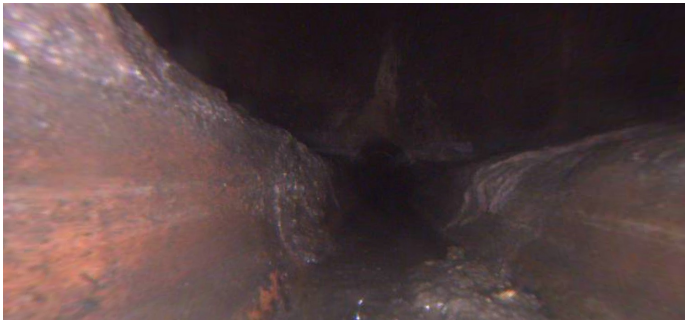
Code: **RFJ**  
Description: **Roots Fine Joint**

Distance (ft): **185.3**  
Structural Grade: **0**  
O&M Grade: **1**  
Clock Start/From: **8**  
Clock To: **4**  
1st Value:  
2nd Value:  
Value Percent:  
Continuous Index: **F02**  
Within 8" of Joint: **YES**  
Remarks:
