Profile/Photo Observation Report

Street:	W 40th ave	Flow Control:	Not Controlled
City:	Hobart, IN	Year Renewed:	
Location:	Other	Tape/Media #:	
Purpose:	Not Known	Dia/Height:	10"
Use:	Sanitary	Material:	VCP
Drain Area:	NA	Lining:	
Category:	NA		
Comment:

Location Details:		Direction of Survey:	Downstream
US MH:	M-503-086	DS MH:	M-503-085
		Total Length Surveyed (ft):	109.6

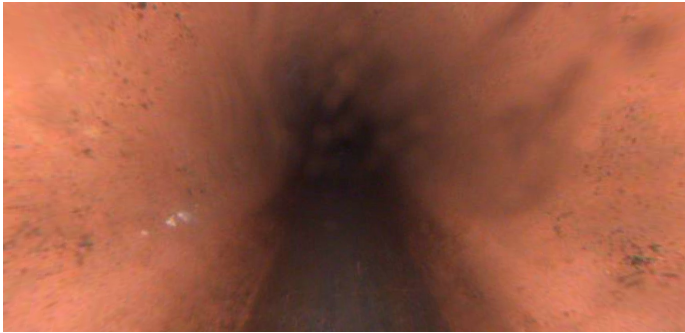
Code:	MWL
Description:	Water Level

Distance (ft):	.0
Structural Grade:	0
O&M Grade:	0
Clock Start/From:	
Clock To:	
1st Value:	
2nd Value:	
Value Percent:	5.000
Continuous Index:	
Within 8" of Joint:	NO
Remarks:

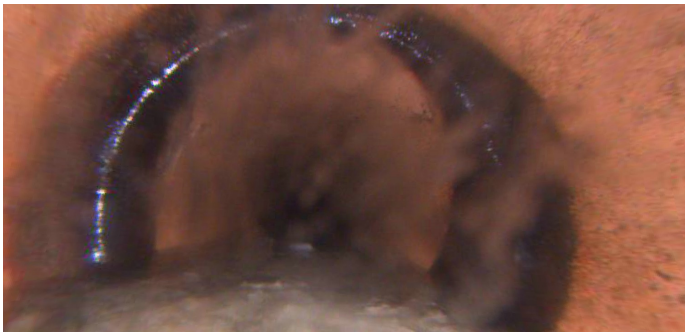
Code:	IW
Description:	Infil Weeper

Distance (ft):	5.1
Structural Grade:	0
O&M Grade:	2
Clock Start/From:	8
Clock To:	4
1st Value:	
2nd Value:	
Value Percent:	
Continuous Index:	
Within 8" of Joint:	YES
Remarks:

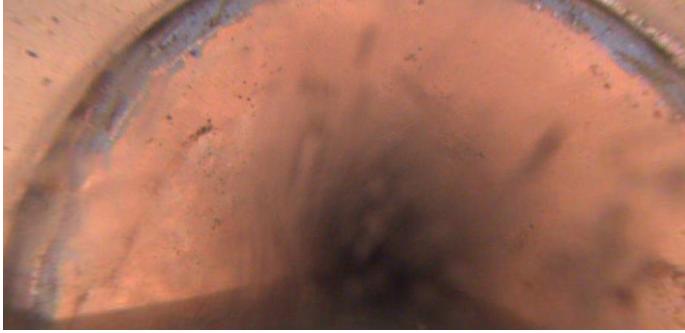
Code: **FC**
Description: **Fracture Circumferential**

Distance (ft): **10.4**
Structural Grade: **2**
O&M Grade: **0**
Clock Start/From: **9**
Clock To: **11**
1st Value:
2nd Value:
Value Percent:
Continuous Index:
Within 8" of Joint: **YES**
Remarks:

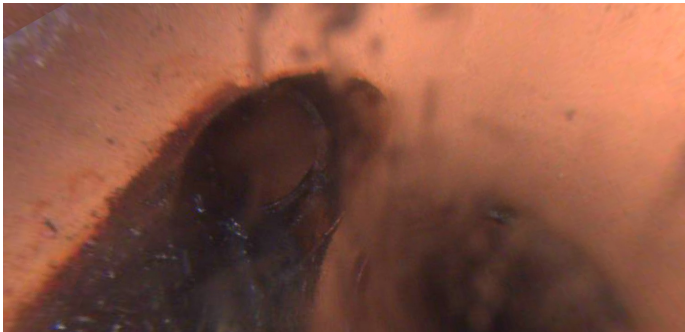
Code: **TFA**
Description: **Tap Factory Active**

Distance (ft): **41.7**
Structural Grade: **0**
O&M Grade: **0**
Clock Start/From: **10**
Clock To:
1st Value: **4.000**
2nd Value:
Value Percent:
Continuous Index:
Within 8" of Joint:
Remarks:

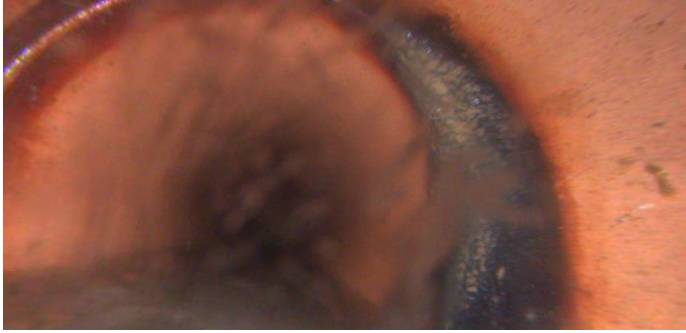
Code: **IW**
Description: **Infil Weeper**

Distance (ft): **42.3**
Structural Grade: **0**
O&M Grade: **2**
Clock Start/From: **8**
Clock To: **4**
1st Value:
2nd Value:
Value Percent:
Continuous Index:
Within 8" of Joint: **YES**
Remarks:

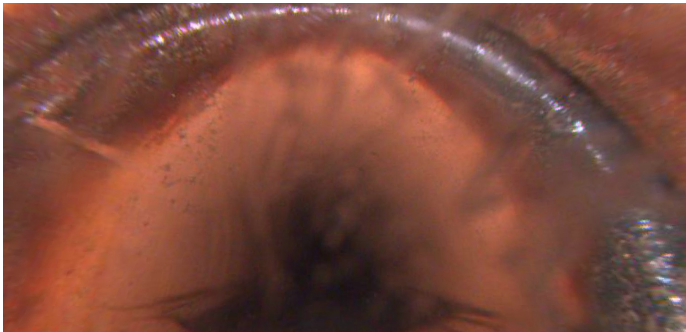
Code: **IW**
Description: **Infil Weeper**

Distance (ft): **52.5**
Structural Grade: **0**
O&M Grade: **2**
Clock Start/From: **8**
Clock To: **4**
1st Value:
2nd Value:
Value Percent:
Continuous Index:
Within 8" of Joint: **YES**
Remarks:

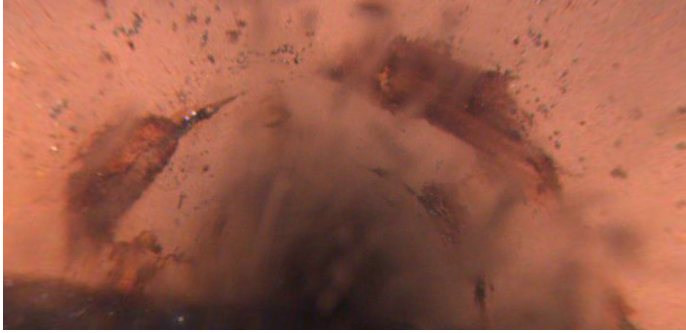
Code: **FC**
Description: **Fracture Circumferential**

Distance (ft): **55.8**
Structural Grade: **2**
O&M Grade: **0**
Clock Start/From: **8**
Clock To: **4**
1st Value:
2nd Value:
Value Percent:
Continuous Index:
Within 8" of Joint:
Remarks:

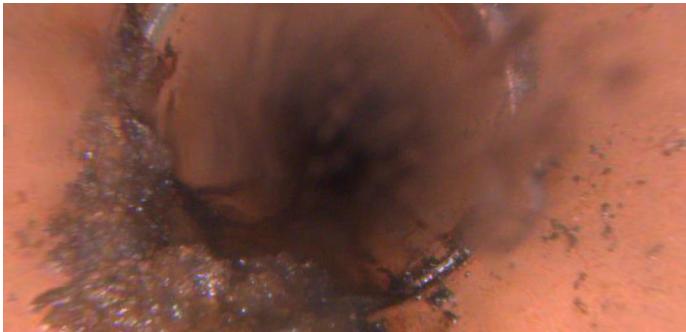
Code: **DAZ**
Description: **Deposits Attached Other**

Distance (ft): **77.4**
Structural Grade: **0**
O&M Grade: **2**
Clock Start/From: **7**
Clock To: **9**
1st Value:
2nd Value:
Value Percent: **5.000**
Continuous Index:
Within 8" of Joint: **YES**
Remarks:

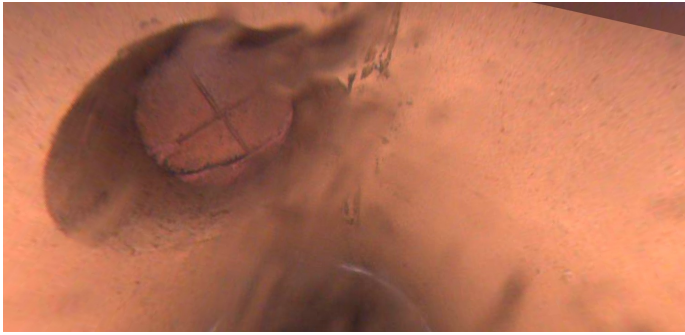
Code: **TFC**
Description: **Tap Factory Capped**

Distance (ft): **89.0**
Structural Grade: **0**
O&M Grade: **0**
Clock Start/From: **11**
Clock To:
1st Value: **4.000**
2nd Value:
Value Percent:
Continuous Index:
Within 8" of Joint:
Remarks:

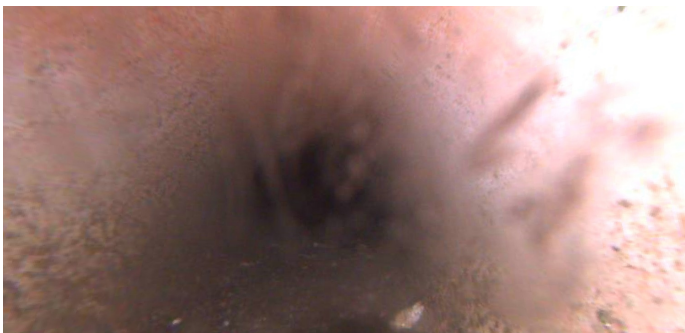
Code: **DSF**
Description: **Deposits Settled Fine**

Distance (ft): **106.3**
Structural Grade: **0**
O&M Grade: **2**
Clock Start/From: **5**
Clock To: **7**
1st Value:
2nd Value:
Value Percent: **5.000**
Continuous Index:
Within 8" of Joint: **NO**
Remarks:

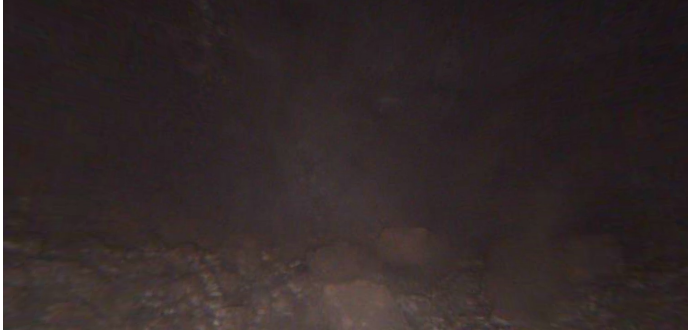
Code:	AMH
Description:	Manhole
Distance (ft):	109.6
Structural Grade:	0
O&M Grade:	0
Clock Start/From:	
Clock To:	
1st Value:	
2nd Value:	
Value Percent:	
Continuous Index:	
Within 8" of Joint:	NO
Remarks:	M-503-085
